AIRPROX REPORT No 2021098

Date: 26 Jun 2021 Time: ~1003Z Position: 5206N 00005E Location: Fowlmere/Duxford circuits

PART A: SUMMARY OF INFORMATION REPORTED TO UKAB

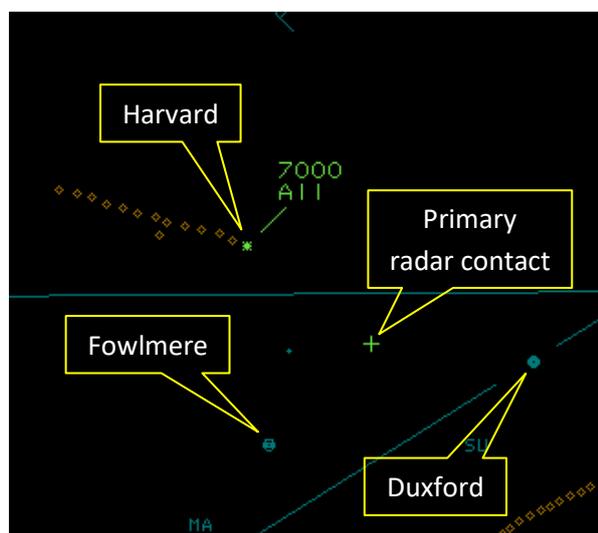
Figure 1 – 1002:23

An analysis of the NATS radar replay was undertaken, utilising the Stansted 10cm resolution radar, which showed the Harvard approaching Duxford from the NW. The Harvard could be seen descending as the pilot positioned for the reported re-join to Duxford RW06. At 1002:23, a primary contact appeared for a single sweep of the radar in a position that could be associated with the reported position of the C140 after take-off (see Figure 1); however, it cannot be verified that this single radar return was the C140.

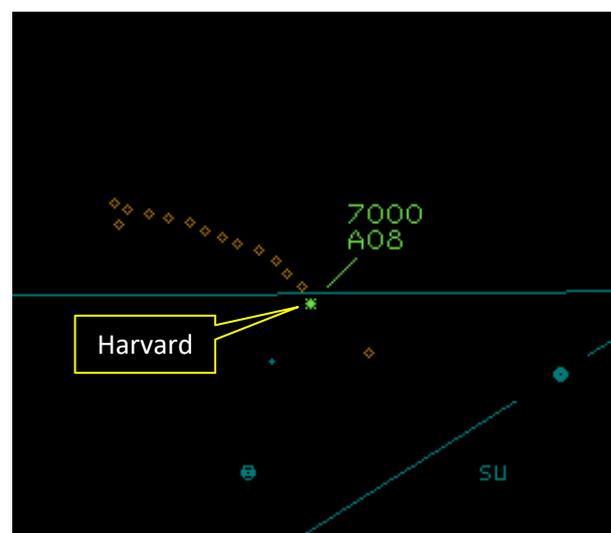
Figure 2 – 1002:47 – CPA

The Harvard continued to descend on a course inbound to Duxford but no further primary radar contacts that could have been the C140 were displayed. CPA is estimated to have occurred at approximately 1002:47 (see Figure 2).

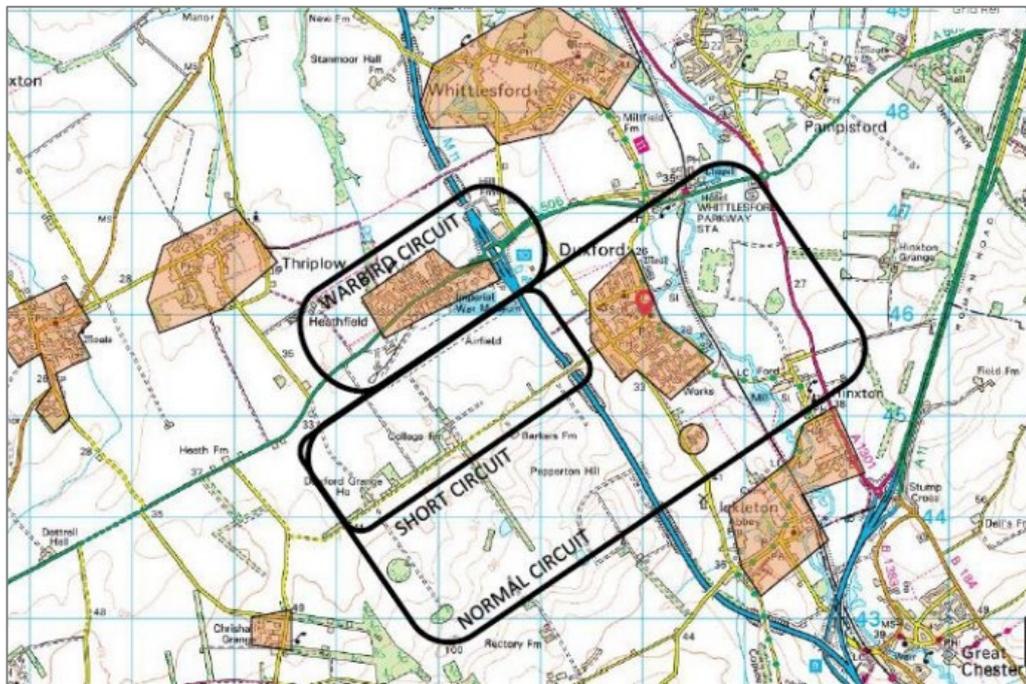
Figure 3 – Duxford Circuit Patterns

Duxford circuit patterns are defined in the Duxford General Flying Orders, available through the IWM Duxford Information For Pilots web page.¹ The circuit pattern diagram and an illustration of the noise sensitive areas from this document are reproduced at Figures 3 and 4 respectively. Additionally, the Airfield Letter of Agreement Between IWM Duxford and Fowlmere is reproduced in the same document and states (*inter alia*) that:

The Board first considered the visual circuit patterns at the 2 airfields and heard from a GA pilot member that the Duxford and Fowlmere circuit patterns are constructed to minimise the likelihood of aircraft in the circuit for one airfield 'interfering' with aircraft in the circuit of the other. To that end, circuits at Fowlmere are flown to the north of RW07/25 whilst circuits at Duxford are flown to the south of RW06/24. However, to avoid complications with aircraft of vastly differing speeds in the visual circuit at Duxford, the Warbird circuit at Duxford is flown to the north of the main RW. The Board agreed that these local operating procedures could lead to the possibility of aircraft departing RW07 at Fowlmere encountering Warbirds recovering to Duxford RW06 from the northwest.
