AIRPROX REPORT No 2021113

Date: 16 Jul 2021 Time: 1146Z Position: 5142N 00010W Location: North Weald

PART A: SUMMARY OF INFORMATION REPORTED TO UKAB

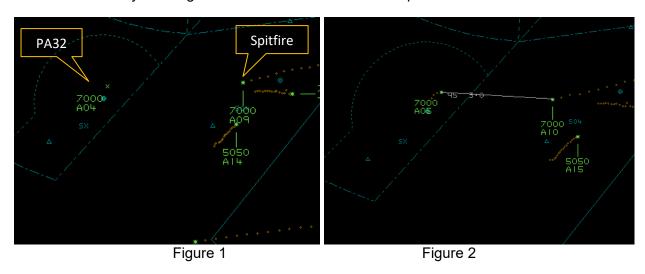
Although North Weald operates with A/G only and does not provide surveillance radar services, the incident could be seen on the NATS radars. At 1145:41 (Figure 1) the Spitfire was 4NM east of North Weald, having just passed VRP Chipping Ongar, indicating 1000ft. The PA32 appeared on the radar for the first time indicating 400ft. By 1145:50 (Figure 2) the PA32 pilot had started their turn onto a southerly heading and the two aircraft were 3NM apart.

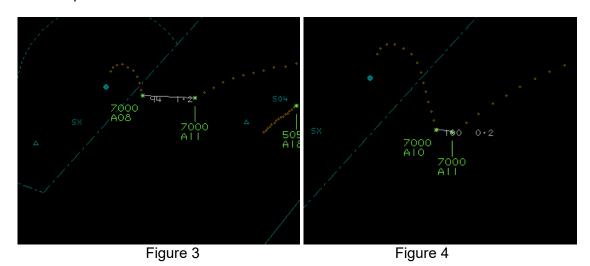
Figure 5 - CPA

The two aircraft continued to close and at 1146:16 were 1.2NM apart (Figure 3), the Spitfire pilot reported becoming visual with the PA32 when about 1NM away with the PA32 in their 2 o'clock. The PA32 indicated 800ft still climbing. At Figure 4 the two aircraft were 0.2NM apart, with the Spitfire indicating slightly above, although it should be remembered that the radar altitude tolerances are +/- 200ft. CPA occurred at 1146:34 (Figure 5) with both aircraft indicating a similar level and less than 0.1NM separation.
