AIRPROX REPORT No 2021114

Date: 16 Jul 2021 Time: 1215Z Position: 5156N 00041W Location: Leighton Buzzard

PART A: SUMMARY OF INFORMATION REPORTED TO UKAB

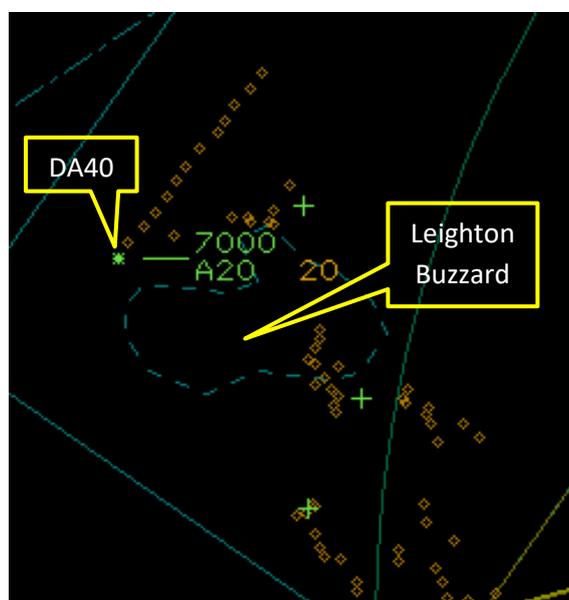
Figure 1 – 1214:56 – CPA

An analysis of the NATS radar replay and the GPS data provided by the ASG29 glider pilot was undertaken. On the NATS radar replay, the DA40 could be seen tracking in a south-westerly direction at 2000ft as indicated on its Mode C. There were numerous primary contacts in the vicinity of Leighton Buzzard, but nothing visible on radar that correlated with the reported position of the ASG29. The GPS log file provided by the glider pilot was overlaid with the radar image and a CPA of ~100ft V and ~0.2NM H (taken from the 2 different data sources) was measured. CPA occurred at 1214:56 (see Figure 1).

Finally, the Board considered the risk involved in this event. Members noted that the recorded separation had been in the order of 100ft vertically and 0.2NM horizontally, but this separation had been measured by comparison of data from 2 different sources (GPS and radar), each of which is subject to its own specific errors and accuracy thresholds. The Board heard again from a glider pilot member that

they considered it highly likely that the measured horizontal displacement was in error because the glider pilot was certain that the DA40 had flown directly over the top of their aircraft. With this in mind, the Board lent more weight to the glider pilot's account of the geometry of the encounter than to the recorded separation (noting that the DA40 pilot did not see the glider so could not estimate the separation) and agreed that there had been a serious risk of collision (**CF5**) and that, because neither pilot had taken any action to increase the separation, it had been entirely providential that the 2 aircraft had missed each other. Therefore, a Risk Category A was assigned to this Airprox.
