AIRPROX REPORT No 2021126

Date: 20 Jul 2021 Time: 1423Z Position: 5104N 00219W Location: 2NM NW of Gillingham

PART A: SUMMARY OF INFORMATION REPORTED TO UKAB

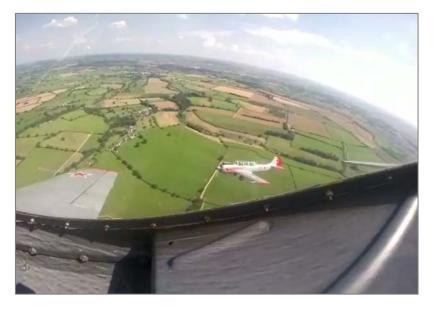
Figure 1 – Yak 52 formation prior to sighting PA28

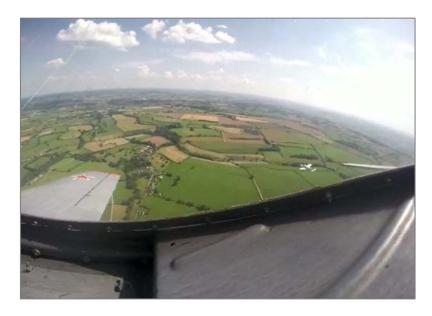
Figure 2 – PA28 passing below/behind lead Yak 52

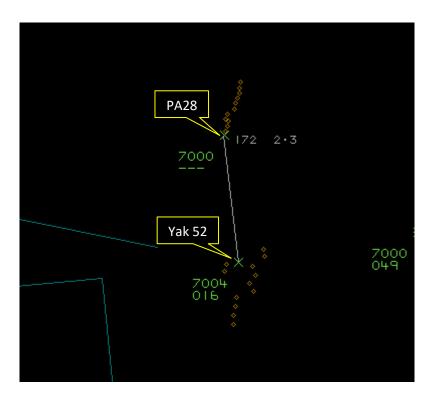
An analysis of the NATS radar replay and the GPS log files provided by both pilots was undertaken. The NATS radars detected the SSR responses of the PA28 and the subordinate element of the formation of Yak 52s, but the track of the Yak 52 was unstable and intermittent. The radar return of the PA28 faded at 1421:10 (see Figure 1) and the aircraft was not detected again by the NATS radars. From the GPS data provided by the pilots, the PA28 crossed in front of the Yak 52 formation at 1422:45, while the formation was in a right-hand turn, at a distance of 0.25NM and with a vertical separation of 300ft (PA28 low). CPA occurred some 3sec later, at 1422:48, with the aircraft separated by 0.1NM horizontally and 300ft vertically.

Figure 1 – 1421:10 – PA28 fades from radar

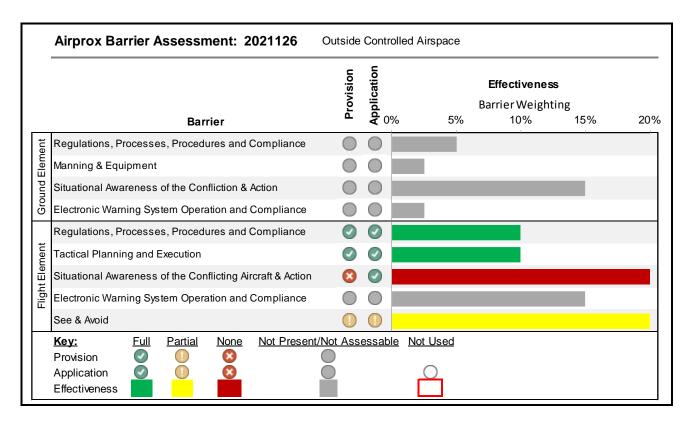
Situational Awareness of the Conflicting Aircraft and Action were assessed as ineffective because neither pilot had any situational awareness of the presence of the other aircraft.

See and Avoid were assessed as **partially effective** because, although the PA28 pilot had sighted the Yak 52 formation at a relatively early stage, by the time they had assimilated the formation's direction of turn, late avoiding action was required by the pilot of the subordinate element of the formation.
