## AIRPROX REPORT No 2021170

Date: 06 Sep 2021 Time: 1311-1315Z Position: Not known Location: ivo Lasham

### PART A: SUMMARY OF INFORMATION REPORTED TO UKAB

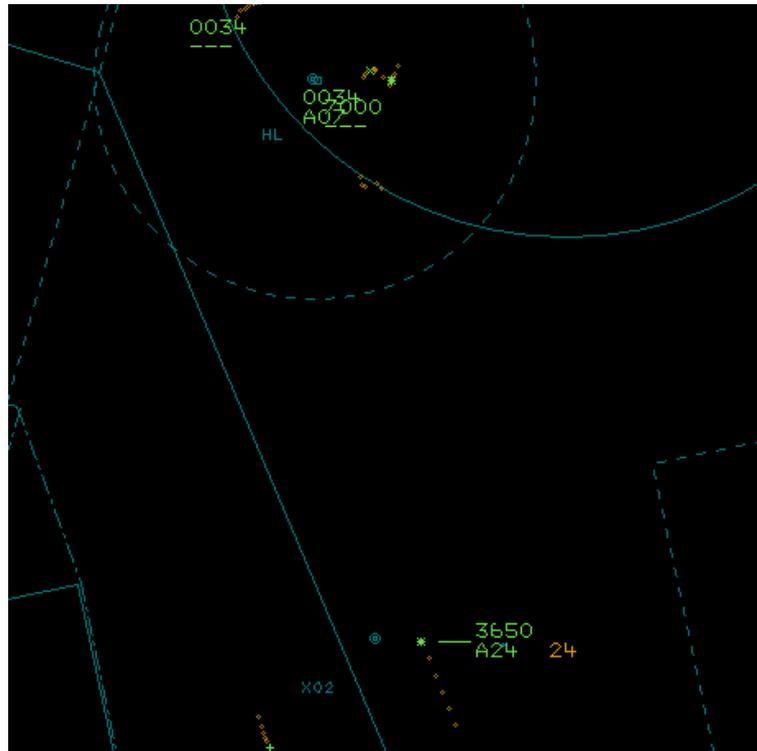
Figure 1: 1310:35 - C130 checks in with Odiham Approach.

The C130 checked in with Odiham Approach following a radar handover from Farnborough when approximately 12NM to the south-southwest of the Odiham overhead. The C130 was identified, placed under a Traffic Service and provided with the airfield short weather.

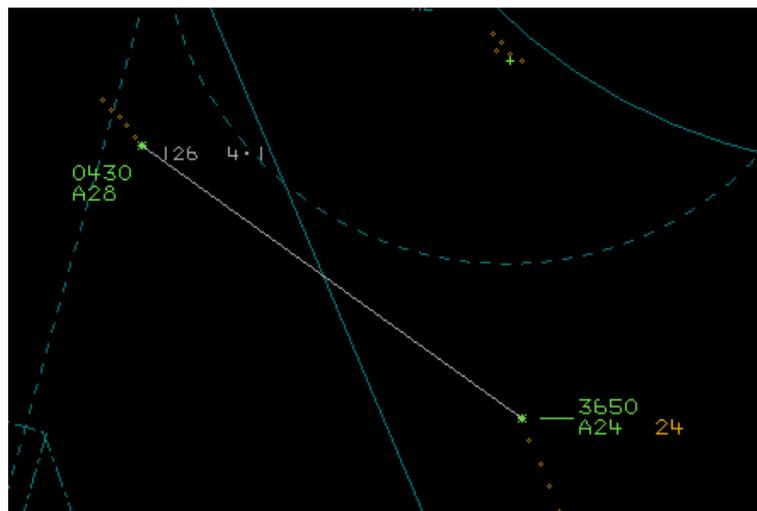
Figure 2: 1311:37 – Traffic Information is passed to C130 on a conflicting 0430 squawk.

Traffic Information was passed by Odiham Approach related to a conflicting 0430 squawk. The controller believed the C130 should have been operating on their own navigation to route to the west of Lasham, as agreed between Odiham and Farnborough controllers during the pre-handover conversation.

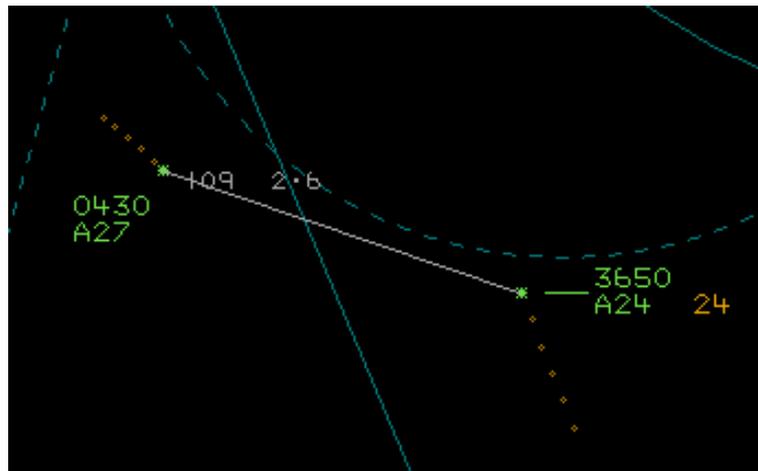
Figure 3: 1312:00 – C130 is turned left to 280 degrees.

The Odiham controller turned the C130 left onto 280° to avoid Lasham Glider Site. Following this the controller confirmed that the C130 was familiar with Odiham before allowing the C130 to resume own navigation and being instructed to remain clear of the Lasham overhead.

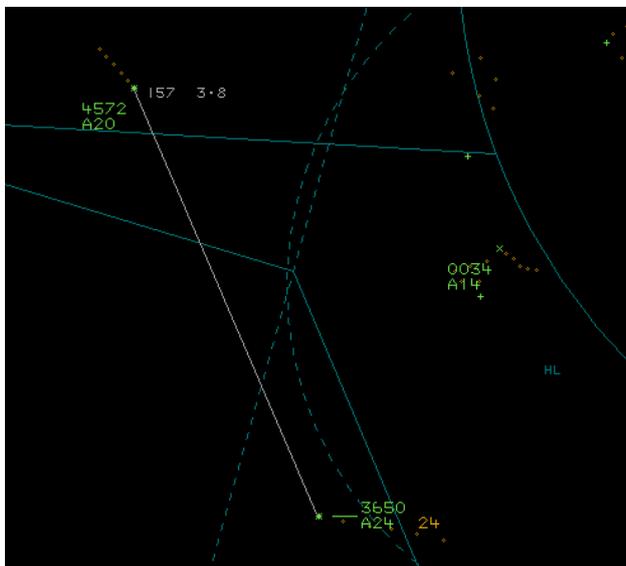
Figure 4: 1313:05 – Traffic Information passed to the C130 on 4572 squawk

Further Traffic Information was passed by Odiham Approach on another conflicting track squawking 4572, swiftly followed by Traffic Information relating multiple contacts operating within the vicinity of Lasham.

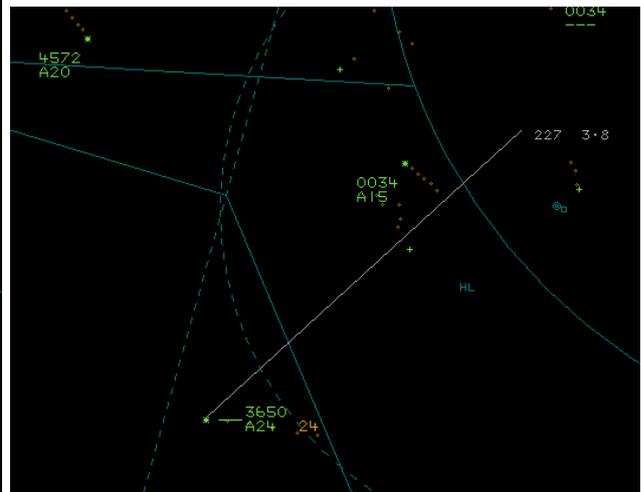
Figure 5: 1313:11 – Traffic Information passed to the C130 on Lasham primary contacts

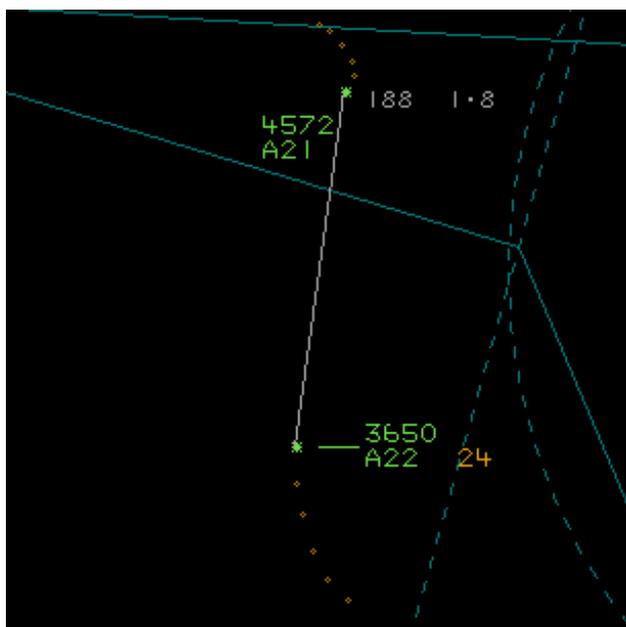
Figure 6: 1313:48 – Traffic Information on the 4572 squawk is updated.

Traffic Information was updated by the Approach controller with the C130 pilot reporting that they were looking. Approximately 15sec later the C130 commenced a right-hand turn.

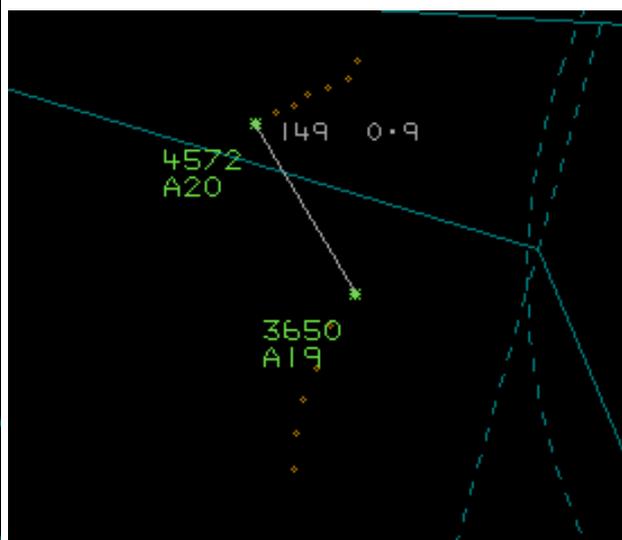
Figure 7: 1314:06 – C130 takes a right-hand turn.

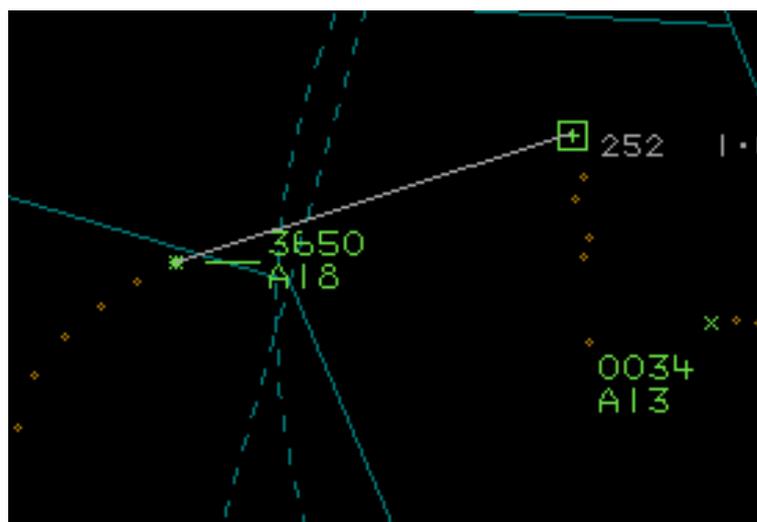
Figure 8: 1314:21 – Traffic Information passed.

The right-hand turn taken by the C130 put them into conflict with glider activity in the vicinity of Lasham. Traffic Information was updated by the Approach controller.

Due to conflicts in the information available it was difficult to ascertain exactly which aircraft the C130 had declared an Airprox against. Potentially, based on the obvious right-hand turn taken by the C130, the Airprox could have involved the 4572 squawk. However, the given timing by the C130 pilot and the reported lack of a transponder from the conflicting track does not match with this assessment. When reviewing the radar replay for the time given by the C130, there were no non-transponding tracks in their vicinity and the tape transcript provided by Odiham ATC show that no Traffic Information was passed relating to non-transponding tracks at this time.

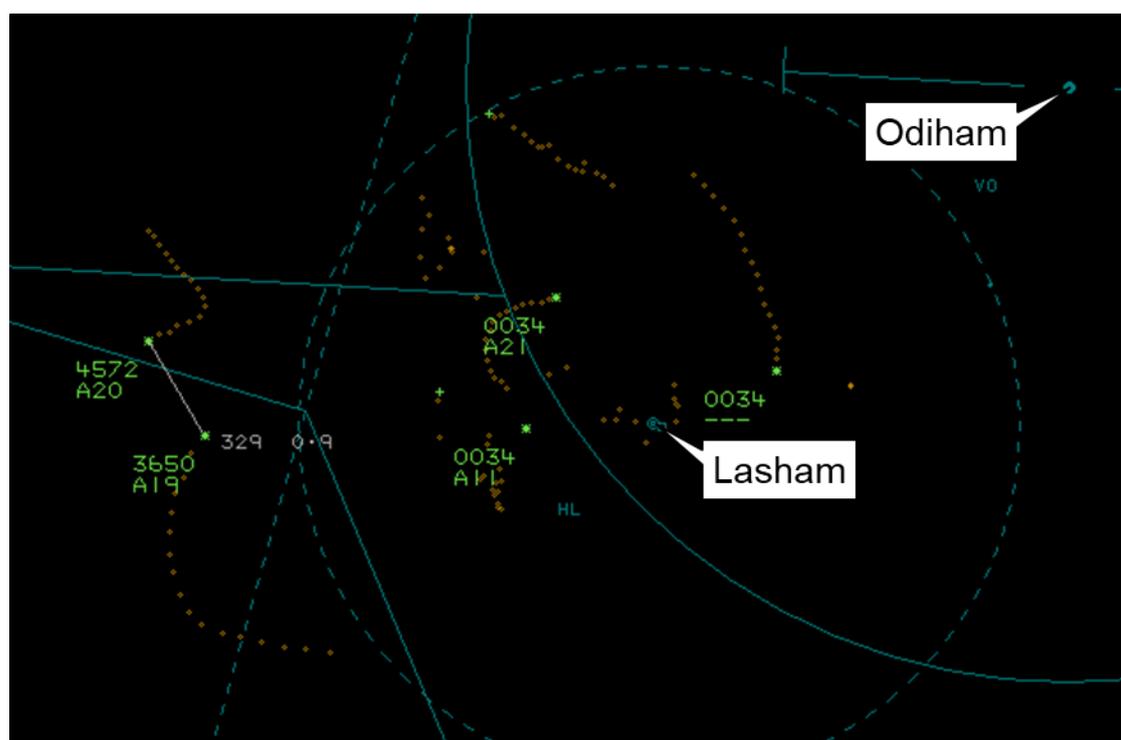
The C130 pilot's description of their avoiding action as *'Right turn and immediate level off before descent re-initiated once clear'* correlates with an event at 1314:07, see figure 9. However, the other aircraft was a squawking, high-wing light aircraft at a range at CPA of 0.9NM, all contrary to the C130 pilot's description of the other aircraft.

Figure 9: 1314:07 - C130 squawking 3650, light aircraft squawking 4572
