AIRPROX REPORT No 2021199

Date: 15 Sep 2021 Time: 1222Z Position: 5214N 00252W Location: Shobdon

An Airprox was reported when a C42 and a Tecnam flew into proximity in the Shobdon visual circuit at 1222Z on Wednesday 15th September 2021. Both pilots were operating under VFR in VMC, both were in receipt of an AFIS from Shobdon.

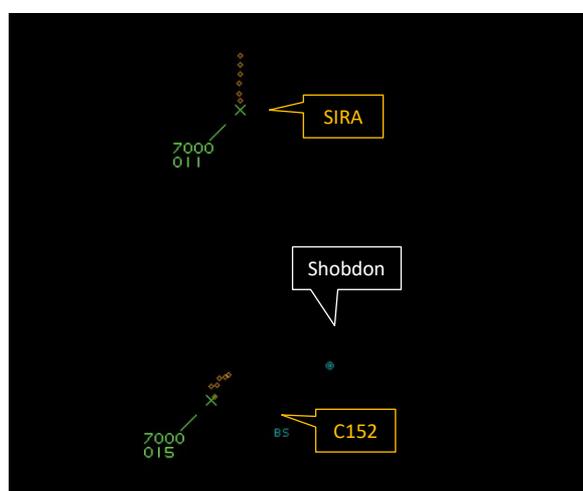
Figure 1 – 1220:35 – note C42 not visible on replay

The AFISO was then occupied with a previously departing aircraft leaving the frequency and the C42, the pilot of which had called on final approach to the RW26 grass. At 1220:35 the pilot of the SIRA reported “just entered the ATZ from the north”, to which the AFISO replied “roger, traffic is a C42 currently er performing a touch and go, will be climbing out shortly”.

The SIRA pilot acknowledged this and asked: “which runway are we on – are we on grass or hard?”. The AFISO replied “that traffic is using the grass runway”, to which the SIRA pilot responded “er roger. I’ll also use the grass” (Figure 1).

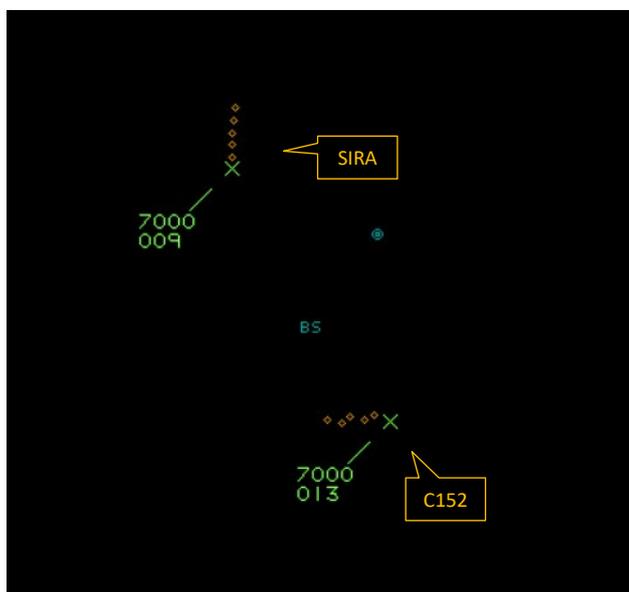
Figure 2 – 1222:17

At 1221:05 the C152 pilot reported downwind left-hand for the main runway “to land” and was instructed to report final. At 1222:17 the SIRA pilot reported “one mile to run on left base Runway 26 grass to land”. The AFISO asked them to repeat their position before immediately passing Traffic Information to the C152: “er keep a good lookout for a Tecnam just reported left base” (Figure 2).

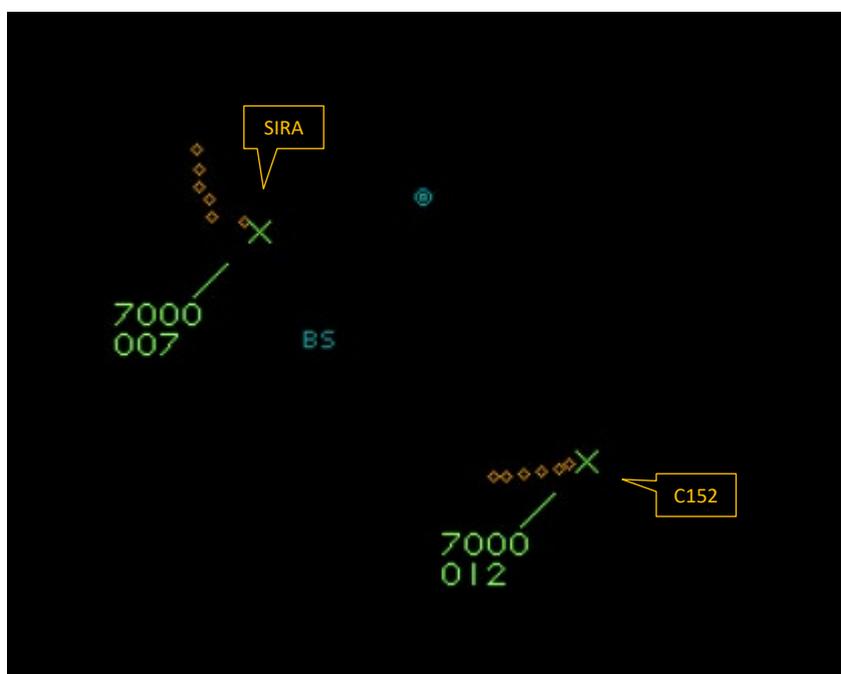
Figure 3 – 1222:50

The pilot of the C152 replied “we’re keeping a good lookout on left base. And er did that traffic, did they just say they were crosswind and then they’re now base is that correct?” which the AFISO confirmed. Immediately following this, at 1222:50, the pilot of the C42 reported “er the Tecnam is visual, he’s flying toward us” and the pilot of the SIRA replied “my apologies, misorientated – leaving the circuit to the south” (Figure 3).

The pilot of the SIRA admitted to having become disorientated and turning finals for RW08. They immediately spotted the C42 on the climb-out and turned away to the right.
