AIRPROX REPORT No 2021205

Date: 13 Sep 2021 Time: ~1300Z Position: 5057N 00052W Location: Harting Down

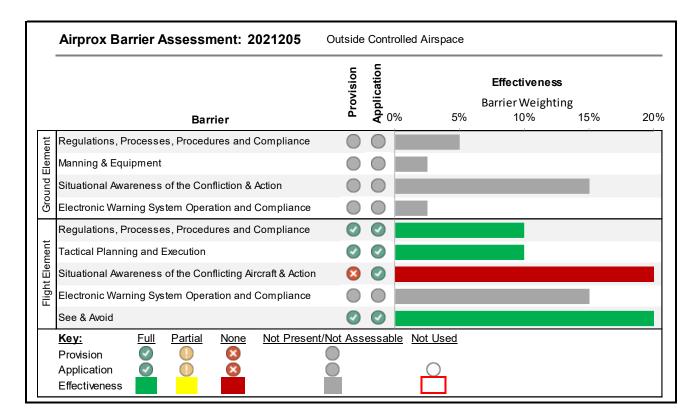
Safety Barrier Assessment³

Situational Awareness of the Conflicting Aircraft and Action were assessed as ineffective because neither the hang glider nor the model operator had any prior situational about the other until they became visual.
