AIRPROX REPORT No 2021208

Date: 10 Oct 2021 Time: 0842Z Position: 5249N 00144W Location: Tatenhill

PART A: SUMMARY OF INFORMATION REPORTED TO UKAB

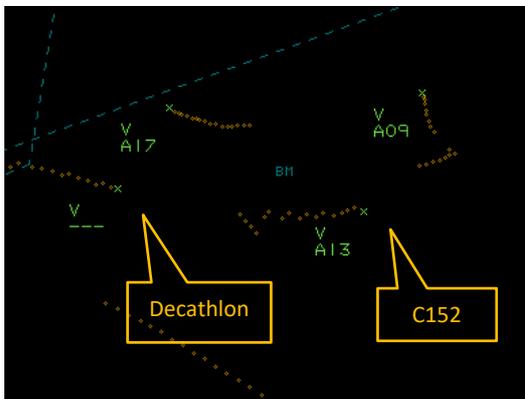
Figure 1 - 0839:19

Tatenhill does not record its RT and so a transcript was not available. Blithfield reservoir is situated 5NM west of Tatenhill; analysis of the NATS radars showed the Decathlon operating in the vicinity of the reservoir at 0838, squawking 7000 but with no Mode C. By 0839 the Decathlon had set course for returning to Tatenhill, the C152 was downwind at this point, with other circuit traffic ahead (Figure 1). By 0840:59 (Figure 2) the Decathlon was established downwind, although on a tighter circuit than the one flown by other circuit traffic and the C152 had turned onto a base leg.

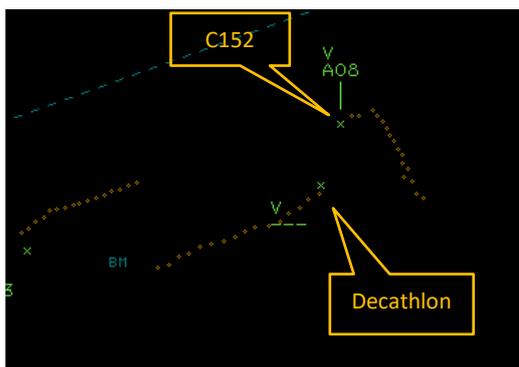
Figure 3 - 0842:00

At 0842:00 (Figure 3) the C152 was established on final and begun their decent, the Decathlon was late downwind. The radar was then subjected to some jitter and the Decathlon did not display on the radar until at 0842:15 (Figure 4) when it reappeared 0.1NM away from the C152, which was indicating 700ft.

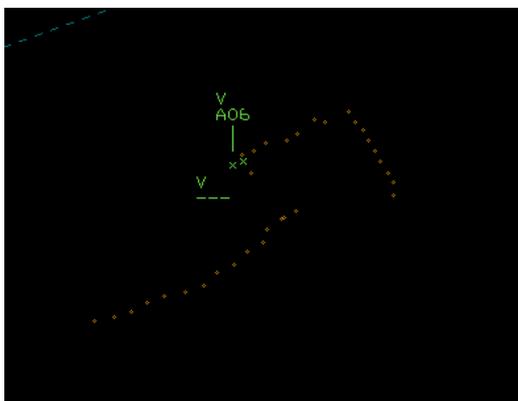
Figure 5 - 0842:19

The C152 crossed ahead of the Decathlon and both aircraft continued on finals in close proximity, although the radar returns again suffered from jitter (Figure 6) and the SSR labels appeared to switch positions, until the C152 could be seen going around (Figure 7).
