AIRPROX REPORT No 2021231

Date: 12 Nov 2021 Time: 1131Z Position: 5237N 00027W Location: Wittering ATZ

PART A: SUMMARY OF INFORMATION REPORTED TO UKAB

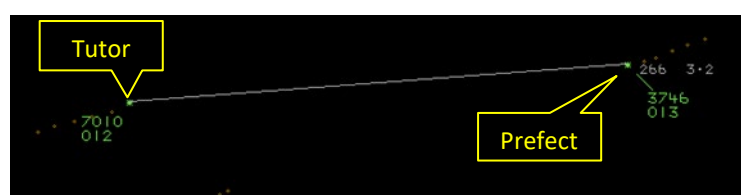
Figure 1 - 2NM broadcast to the visual circuit.

Four seconds after the Talkdown controller had passed the clearance to low approach to the Prefect pilot the Aerodrome controller broadcast on the Tower frequency that the Prefect was at 2NM and was cleared to low approach not below 200ft. Separation was measured as 3.2NM and 100ft.

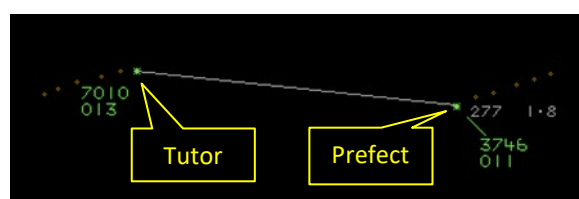
Figure 2 - Tutor pilot reports visual.

Nine seconds later the Tutor pilot reported visual with the Prefect and stated they would go-around at circuit height. The Tutor pilot had previously reported that they would go-around at circuit height but this was not acknowledged by the Aerodrome controller as they were passing the clearance to the Talkdown controller. Separation decreased to 2.8NM and 0ft.

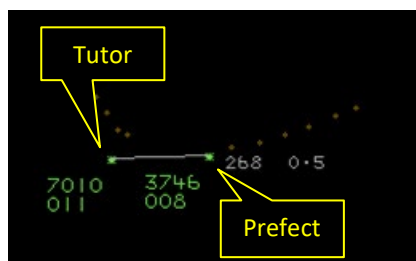
Figure 3 - Tutor pilot requests an updated position of the Prefect.

Fifty seconds later the Tutor pilot requested an update on the Prefect position and were advised that they were abeam the ramp going around. Separation was measured at 0.5NM and 300ft.

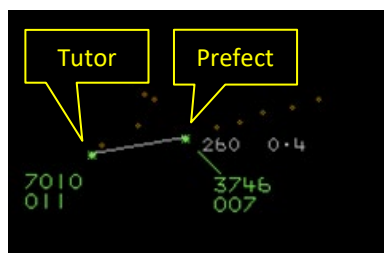
Figure 4 – CPA.

CPA was measured at 0.4NM and 400ft.
