**AIRPROX REPORT No 2021245**

Date: 15 Dec 2021 Time: 1336Z Position: 5340N 00032W Location: 6NM NE Scunthorpe

**PART A: SUMMARY OF INFORMATION REPORTED TO UKAB**

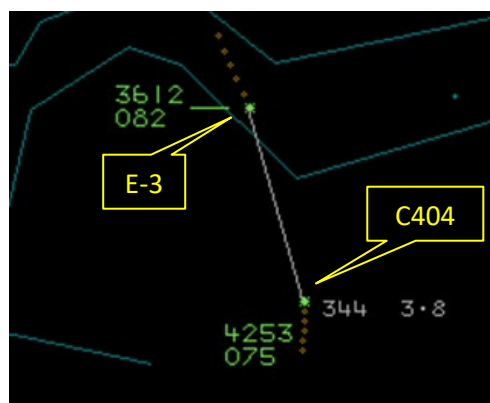
Figure 1 - C404 pilot believed to be visual with E-3.

On review of the Humberside controllers report, the C404 pilot reported visual with the E-3 at around 4NM lateral and 700ft vertical separation.

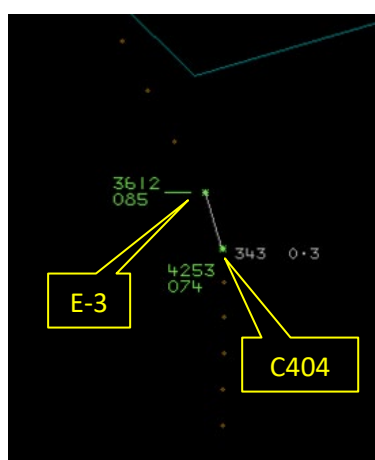
Figure 2 – Sweep prior to CPA.

Shortly after it was believed the C404 pilot reported visual with the E-3, the E-3 began to climb, levelling at FL85 which matches the pilot and controller reports. CPA occurred between radar sweeps with separation prior to the sweep measuring at 0.3NM and 1100ft.

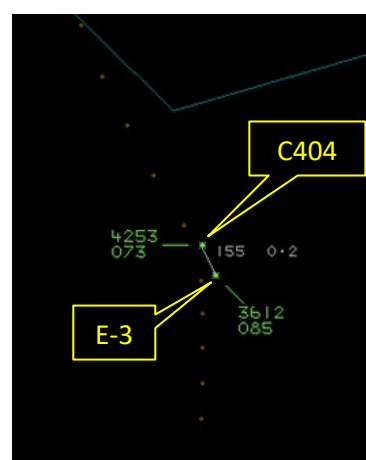
Figure 3 – Sweep after CPA.
