**AIRPROX REPORT No 2021018**

Date: 30 Mar 2021 Time: 1618Z Position: 5309N 00237W Location: 7NM NW of Crewe

**PART A: SUMMARY OF INFORMATION REPORTED TO UKAB**

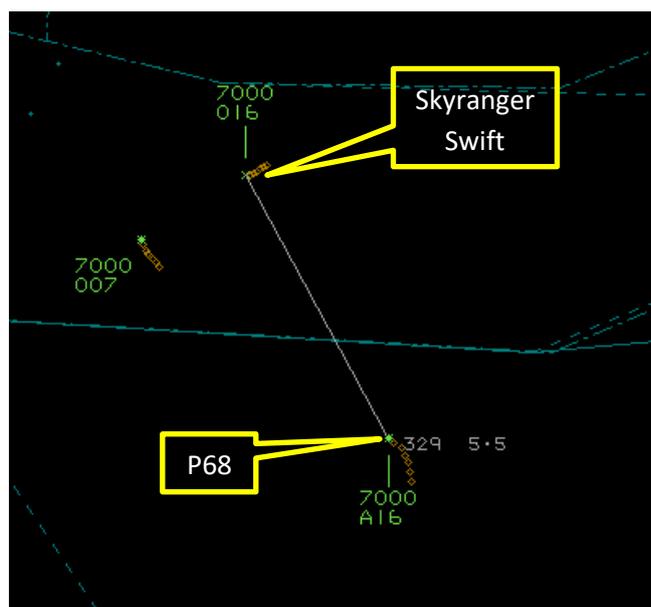
Figure 1 – 1615:18

Analysis of the NATS radar replay showed both aircraft squawking Mode A 7000 in the 3 minutes leading up to the Airprox. The P68 had previously been displaying a Mode A code allocated as 'Hawarden Airport Conspicuity Code', but this changed to Mode A 7000 at 1615:18 – some 3min 12sec before CPA – with the aircraft separated by 300ft vertically and 5.5NM laterally (see Figure 1 – note that the Skyranger's data is displayed as a flight level whilst the P68's data is displayed as an altitude. The local QNH was 1025, giving a height correction of ~300ft). Both aircraft maintained their respective tracks up until CPA; the P68 at an altitude of 1400ft until ~5sec prior to CPA when it descended to 1200ft and the Skyranger Swift in a continuous gentle descent from 2100ft to 1500ft at CPA (see Figure 2; aircraft data for both aircraft is displayed in flight levels).

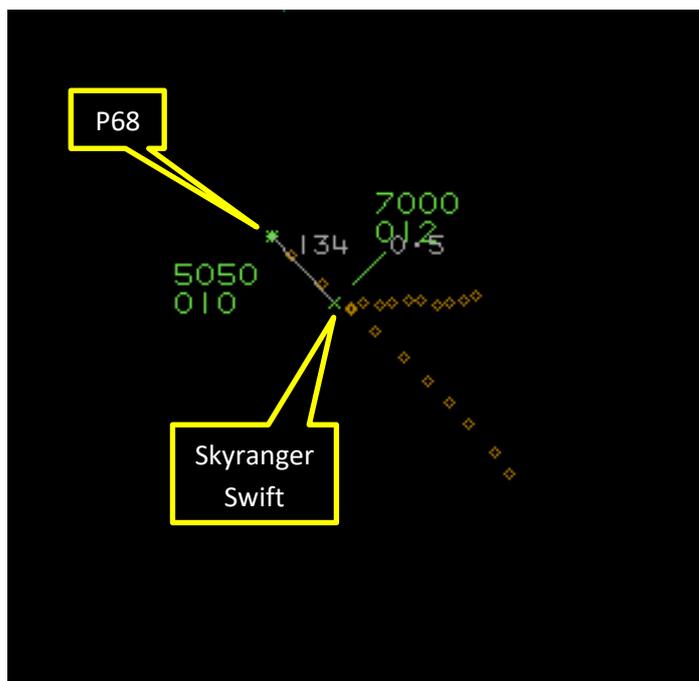
Figure 3 – 1618:38

After the aircraft had passed, the P68 climbed to an altitude of 1300ft and at 1618:38 (12sec/3 radar sweeps after CPA) the P68's Mode A code changed to 5050 (see Figure 3), which is allocated as a 'Liverpool Conspicuity' code. It is therefore likely that the P68 pilot was in the process of agreeing an Air Traffic Service with Liverpool as the Airprox occurred, though this could not be confirmed with Liverpool ATC due to delays encountered in obtaining the report from the P68 pilot.
