AIRPROX REPORT No 2021029

Date: 20 Apr 2021 Time: 1440Z Position: 5126N 00022E Location: Gravesend

PART A: SUMMARY OF INFORMATION REPORTED TO UKAB

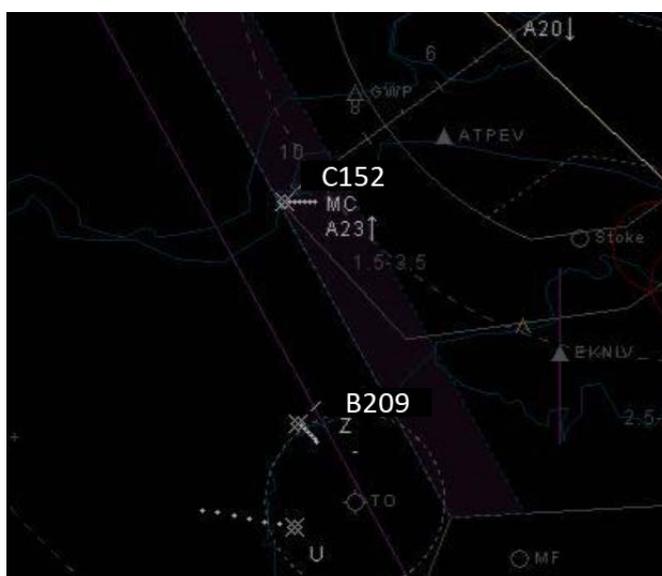
Figure 1

At 1436:38 the C152 left CAS indicating 2200ft, and was given a Basic Service, the B209 was 5NM south of their position, Figure 1. At this time the controller called the TWR controller with co-ordination for inbound traffic.

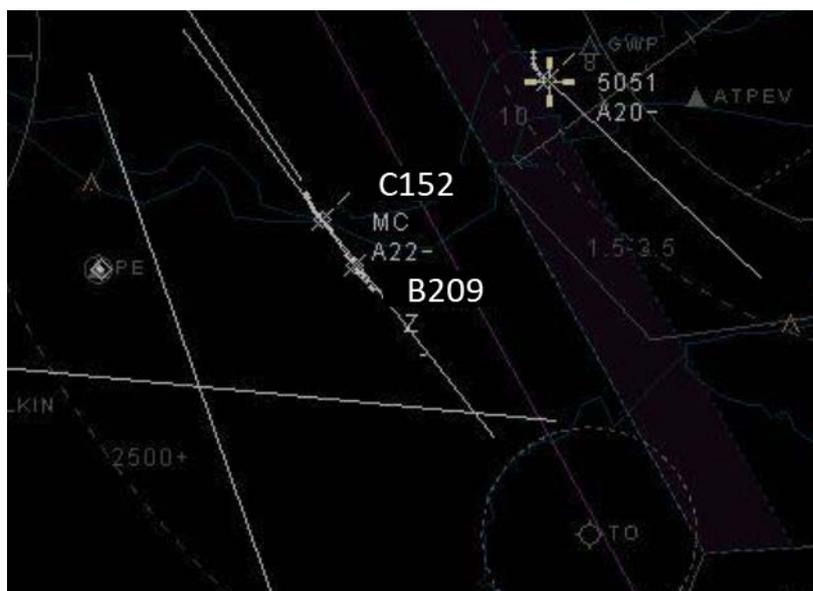
Figure 2

At 1439:45 the C152 turned at Tilbury onto a southeast heading, indicating 2300ft. The B209 was 0.5NM away, still with no height information, Figure 2.

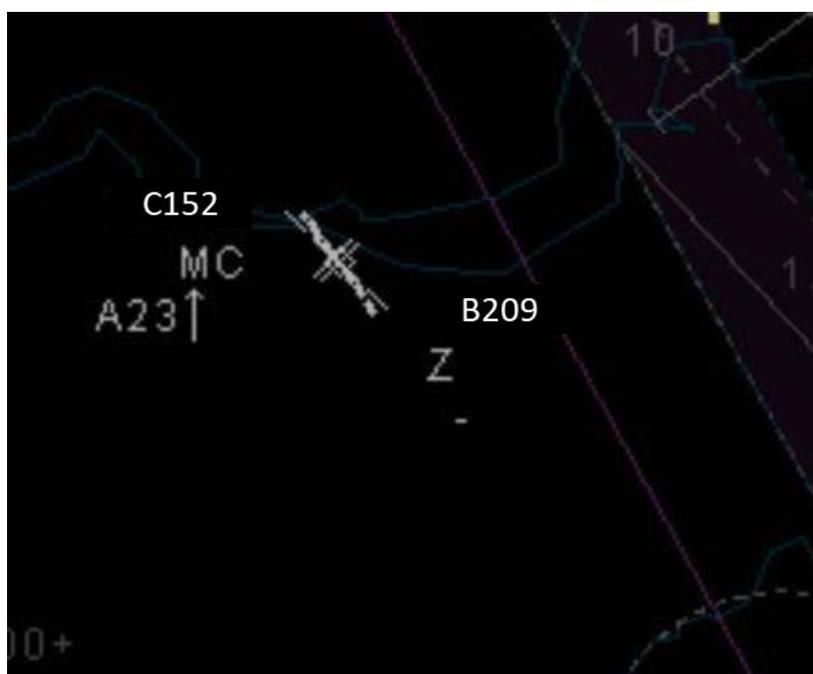
Figure 3

At 1439:58 the contacts merged, Figure 3. Another pilot called on the frequency, which was acknowledged by the DIR and at 1440:10 the C152 pilot reported the Airprox "And [C/S] we've just had a near miss with a north- bound head to head please, we're at two thousand three hundred feet travelling in the opposite direction probably about twenty foot away." This was acknowledged by the controller. At 1440.30 the C152 pilot continued: "Err I'm not sure if he's squawking anything but I think it's a Monsun, orange colour." The DIR replied "Roger, he's showing no height information."
