AIRPROX REPORT No 2021046

Date: 02 May 2021 Time: 1034Z Position: 5144N 00214W Location: 2 NM NE Nympsfield

PART A: SUMMARY OF INFORMATION REPORTED TO UKAB

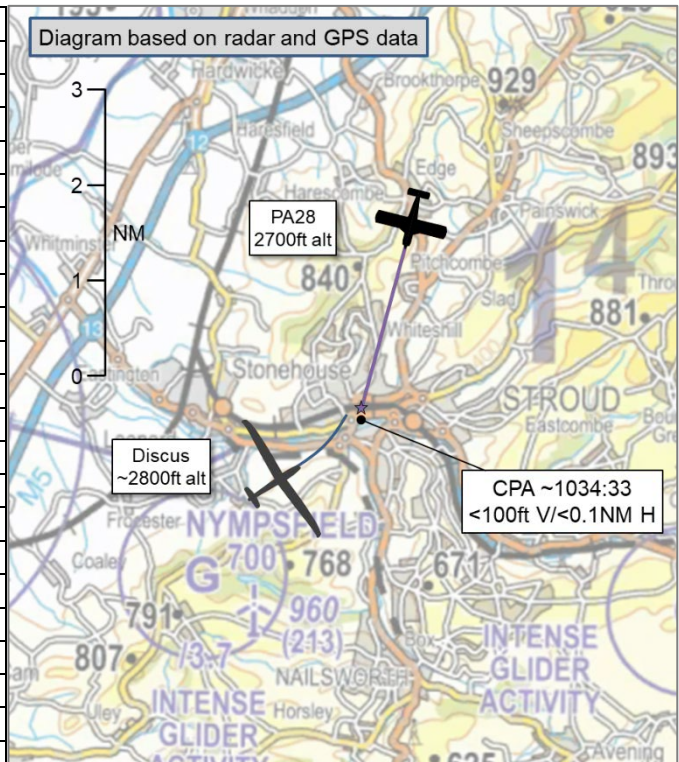
THE DISCUS PILOT reports that they were 1NM east of Nympsfield when they saw an aircraft at a similar level between 0.5-1NM away, on a constant heading generally towards their position. They observed the aircraft bank slightly left in an apparent adjustment to course to reduce collision risk. They believed the other pilot had seen their glider as the pilot seemed to look directly at them as they passed.

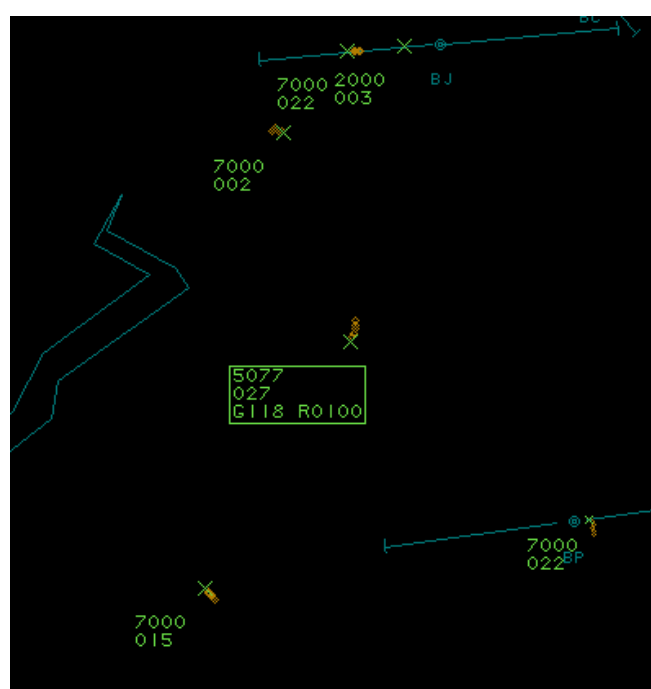
1034.35 (Range selected is 45NM)

The Airprox appears to have occurred during the frequency change from Gloucester to Bristol ATC, and there are no radar contacts within 8NM of the aircraft displaying on the area radar.
