**AIRPROX REPORT No 2021053**

Date: 11 May 2021 Time: 1348Z Position: 5113N 00005E Location: 4NM NE of Lingfield

**PART A: SUMMARY OF INFORMATION REPORTED TO UKAB**

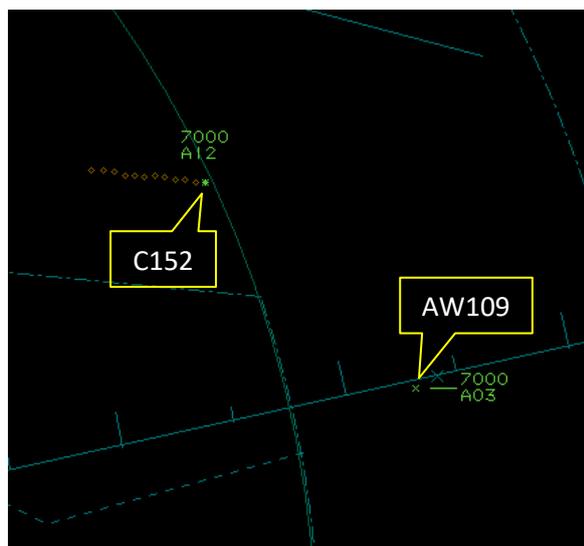
Figure 1 – 1336:44

An analysis of the NATS radar replay was undertaken, which showed the C152 tracking in an easterly direction at 1200ft ( $\pm$ 100ft). The first radar detection of the AW109 was at 1346:44 after the pilot had lifted from the landing site in the vicinity of Hever Castle (Figure 1). Both aircraft were tracked on primary and secondary radar. The AW109 could be seen to climb on a north-north-westerly track from 300ft (at initial radar detection) to 1300ft (at CPA).

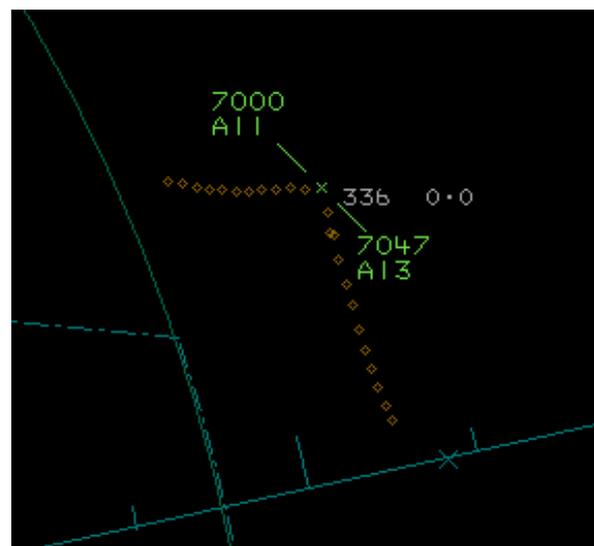
Figure 2 – 1347:48 – CPA

At 1347:44 the transponder code of the AW109 was seen to change from 7000 (General Conspicuity) to 7047 (TC Thames (Biggin Hill Airport Conspicuity)). CPA occurred one radar sweep later, at 1347:48 (Figure 2), and was measured at 200ft V and <0.1NM H.

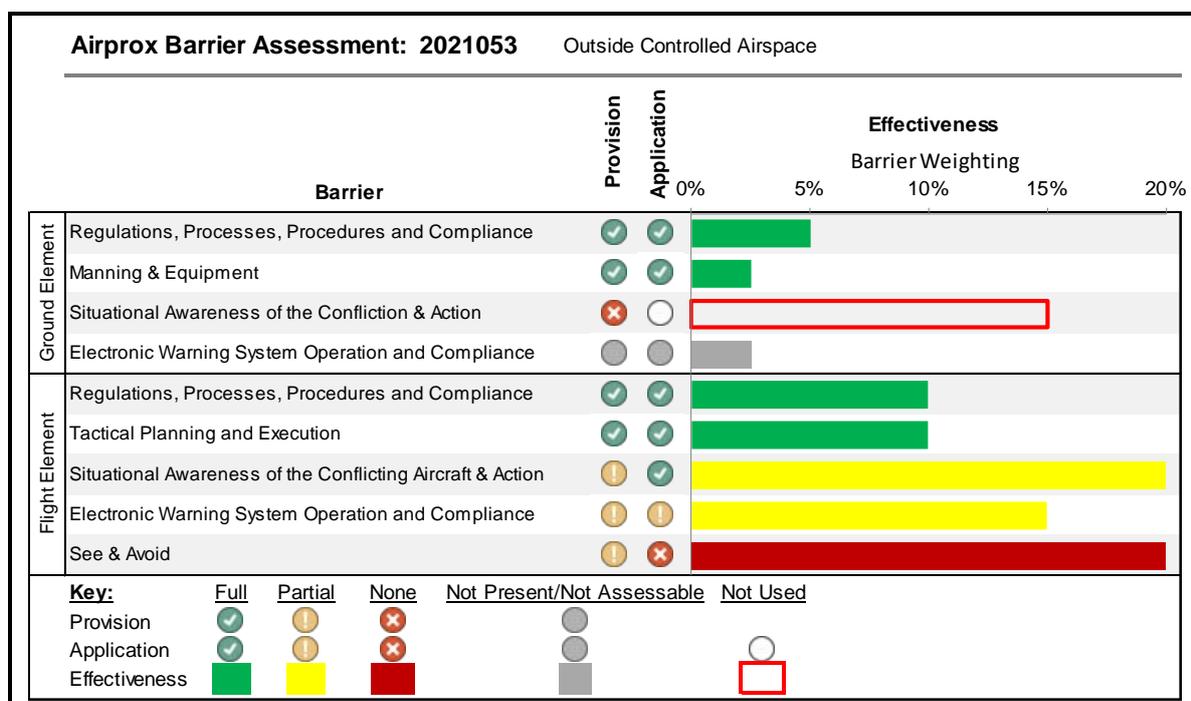
**Situational Awareness of the Confliction and Action** were assessed as **not used** because the Biggin Approach controller was not required to monitor the AW109 under the terms of a Basic Service.

**Situational Awareness of the Conflicting Aircraft and Action** were assessed as **partially effective** because the AW109 pilot had only generic situational awareness of the presence of the C152 (gained from their TAS equipment), and the C152 pilot had no situational awareness of the presence of the AW109.

**Electronic Warning System Operation and Compliance** were assessed as **partially effective** because the AW109 pilot utilised the TAS indications to cue their lookout without manoeuvring their aircraft to break the confliction.

**See and Avoid** were assessed as **ineffective** because the AW109 pilot sighted the C152 late and with insufficient time to take any avoiding action, and the C152 pilot most likely did not see the AW109.
