AIRPROX REPORT No 2021063

Date: 31 May 2021 Time: 1046Z Position: 5052N 00314W Location: Dunkeswell

An Airprox was reported when an RV7 and a C208 flew into proximity whilst on final for RW17 at Dunkeswell, at 1046Z on Monday 31st May 2021. Both pilots were operating under VFR in VMC and both were in receipt of a AGCS from Dunkeswell.

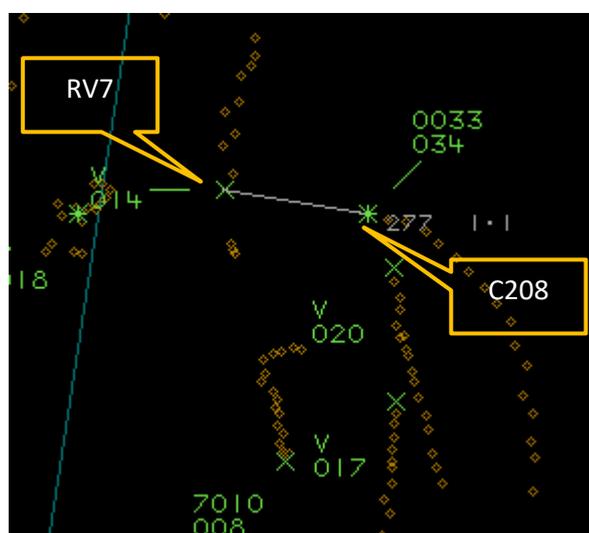
Figure 1:1045:39

Analysis of the NATS radar replay showed both aircraft in the Dunkeswell circuit, the radar screenshots show height in flight-level and the 7000 squawks of aircraft in the circuit are converted to 'V' (VFR). At 1045:39 (Figure 1) the RV7 was on a long straight-in approach at FL014. The C208, squawking 0033 (para-drop), had circled, descended from FL150, and by Figure 1 was passing through FL34.

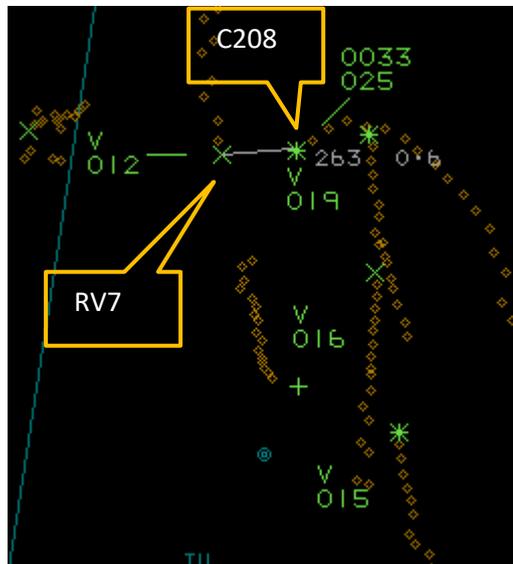
Figure 2: 10:45:51

At 1045:51 (Figure 2) the C208 was passing through FL025, 0.6NM from the RV7 which was at FL012. The C208 continued to turn onto a final position, still above the RV7, until by 1046:15 (Figure 4) it was ahead of the RV7 and 400ft above. The C152, who's instructor provided the witness statement, was on a base leg, also indicating FL015. The C208 continued to maintain 0.2NM ahead of the RV7, indicated 200ft above the RV7 the radar sweep before CPA, and had descended through the level of the RV7 at 1046:31 (Figure 5 - CPA) when the C208 indicated 100ft below the RV7 and the two aircraft were 0.2NM apart.

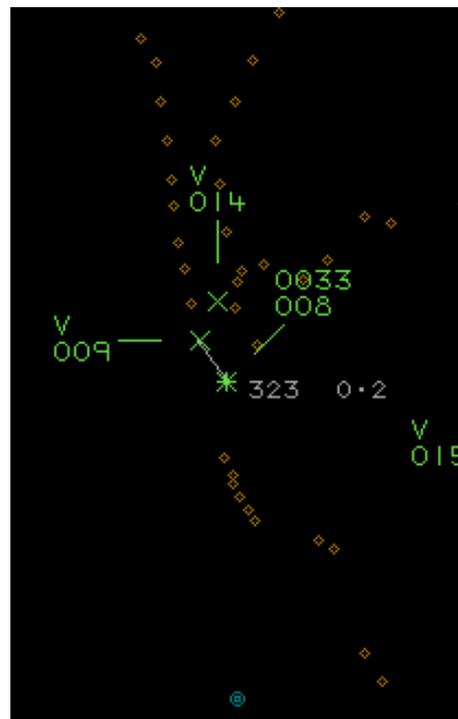
Figure 5: CPA, 10:46:31

they made an unexpected manoeuvre the outcome could have been different. In the end the latter view prevailed and the Board agreed that safety had not been assured, Risk Category B (CF8).
