AIRPROX REPORT No 2020006

Date: 21 Jan 2020 Time: 1412Z Position: 5051N 00009W Location: Brighton

PART A: SUMMARY OF INFORMATION REPORTED TO UKAB

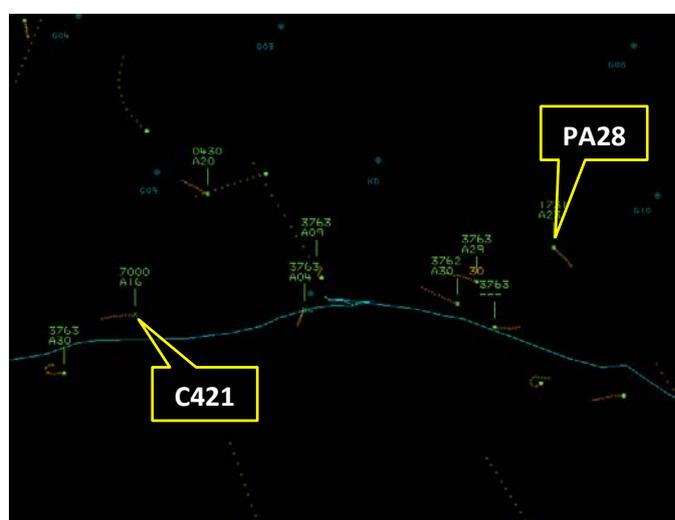
Figure 1 – 1406:10

At 1406:10, the C421 pilot contacted Shoreham Approach, advising that they were passing Littlehampton at 1500ft, requesting a transit of the Shoreham (airfield) overhead and a Basic Service (Figure 1). The Shoreham Approach controller agreed to a transit of the Shoreham ATZ at 1600ft, requesting that the C421 pilot report passing north of the Worthing Pier, but did not confirm the Basic Service. At this time the PA28 pilot was receiving a Basic Service from Farnborough LARS E in the vicinity of Lewes. At 1408:00, the C421 reported passing north of the Worthing pier (Figure 2). The controller acknowledged this and confirmed the ATZ transit approval at 1600ft, advising that the left-hand circuit was active at Shoreham at 1100ft, which was acknowledged by the C421 pilot.

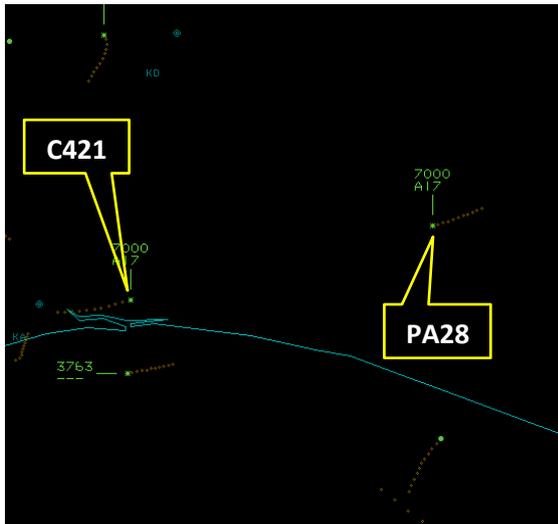
Figure 3 – 1410:35

“power station” at 1800ft, and requested a right-base join for RW02. The C421 was 6.2NM to the west-southwest of the PA28 at this time (Figure 3). The controller advised the PA28 pilot to expect a crosswind join for RW02 and to report approaching the power station, which was acknowledged by the pilot. Figures 4 illustrates the developing situation.

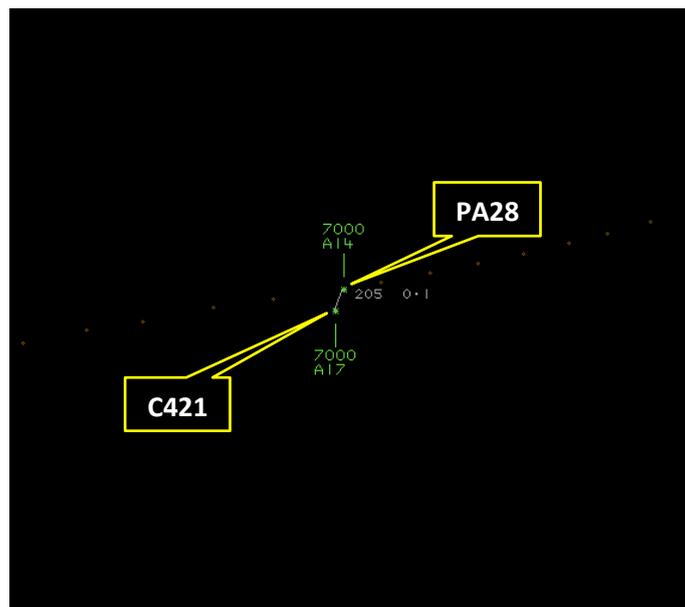
Figure 5 – 1412:07 - CPA

CPA occurred at 1412:07, with the C421 seen to already be in a turn to the right (Figure 5).

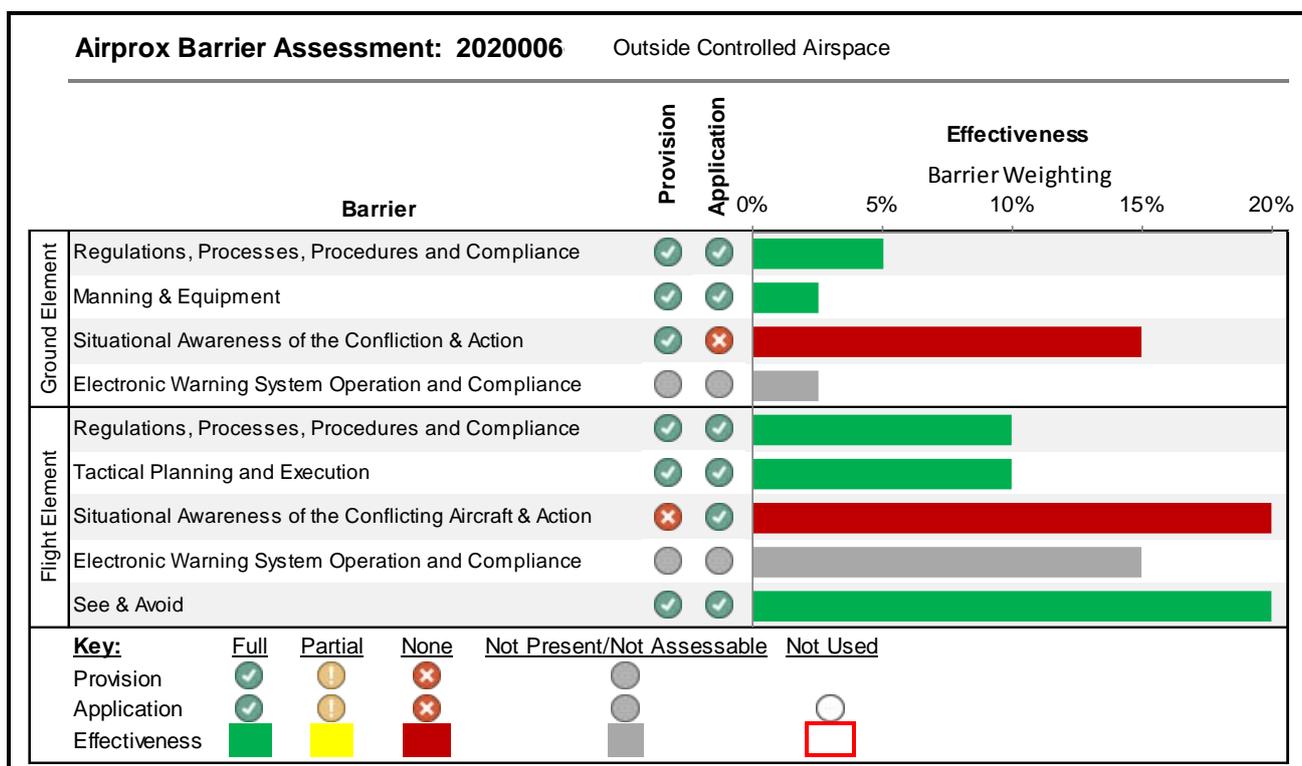
Situational Awareness of the Confliction and Action were assessed as **ineffective** because the Shoreham Tower controller had not assimilated that the 2 aircraft were in conflict until after CPA.

Situational Awareness of the Conflicting Aircraft and Action were assessed as **ineffective** because neither aircraft was equipped with an on-board collision warning system and neither pilot had been passed any information on the presence of the other aircraft.
