AIRPROX REPORT No 2020010

Date: 29 Jan 2020 Time: ~1245Z Position: 5056N 00149W Location: Abeam Fordingbridge

PART A: SUMMARY OF INFORMATION REPORTED TO UKAB

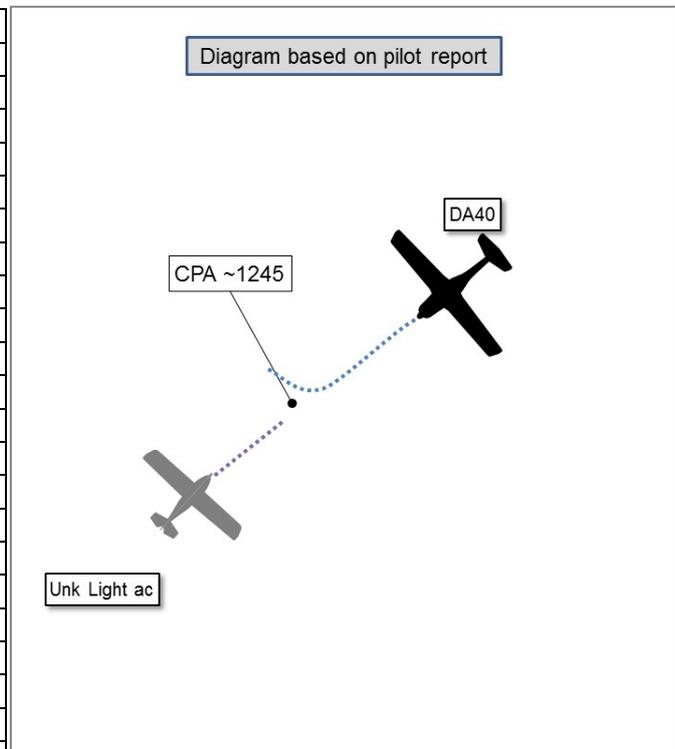
THE DA40 PILOT reports that she was carrying out a solo navigation flight as part of her flying training. The incident occurred on the leg between Redlynch and Dorchester. Her flight log showed that she turned at Redlynch at 12:42, at 12:45 she suddenly noticed another aircraft flying towards her head on and she immediately turned to the right to avoid the aircraft. She saw no corrective action from the other aircraft. At 12:46 she reported the incident to Bournemouth. She had no TAS indications and Bournemouth said they were not aware of any other aircraft in her vicinity. At the time she thought the other aircraft was a Cessna or Microlight, upon reflection she believed it was a Microlight.

The DA40 can be seen on the radar replay routing to Redlynch, unfortunately the radar contact fades from radar prior to the pilot commencing a turn towards Dorchester and does not reappear, therefore the second aircraft could not be traced, or the recorded separation determined.
