**AIRPROX REPORT No 2020022**

Date: 19 Feb 2020 Time: 1112Z Position: 5152N 00034W Location: 1NM W Dunstable Downs GS

**PART A: SUMMARY OF INFORMATION REPORTED TO UKAB**

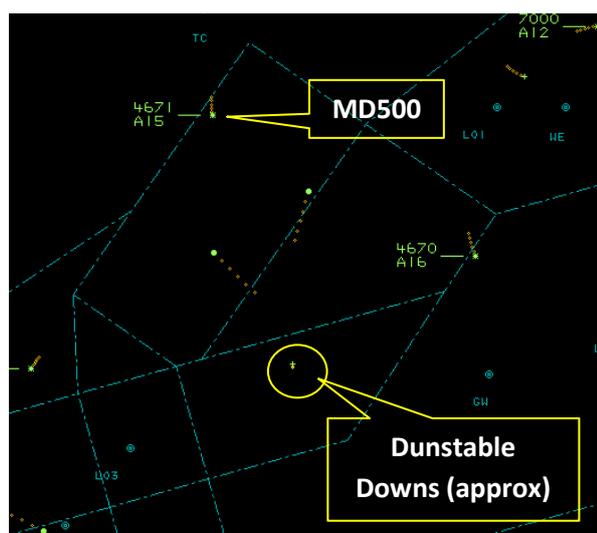
Figure 1 - 1106:44

According to a NATS investigation, at **1106:44**, having previously called the Luton radar controller, the MD500 was identified and a Basic Service agreed. The pilot requested a clearance to transit the Luton CTR, VFR, to the west of Dunstable Downs. The controller confirmed this clearance *“transit the Luton Control Zone, VFR, not above altitude two thousand feet routeing to the West of Dunstable Downs gliding site”*, which was correctly read back by the pilot. The controller went on to advise *“just caution, Dunstable Downs gliding site is active”*, which was acknowledged by the pilot (Figure 1). At **1110:12**, the controller advised the MD500 pilot, *“caution as you approach Dunstable, looks like there is a either transponding glider or possible a tug just airborne, about one mile to the west of the gliding site.”* The pilot responded *“Visual with that contact”* (Figure 2).

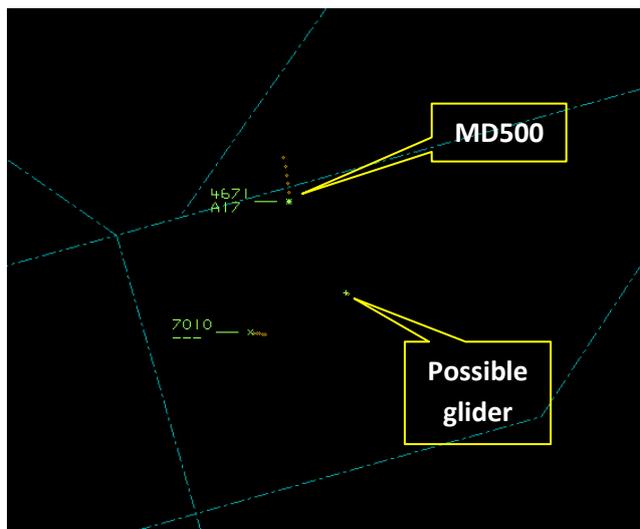
Figure 3 - 1111:04

At **1110:38**, the MD500 pilot, having entered the Luton CTR, was advised that it was a Radar Control Service. At **1111:01**, a primary contact, believed to be the glider, became visible on the radar replay in the vicinity of the Dunstable Downs gliding site. At **1111:04**, the controller passed Traffic

Information to the MD500 pilot: “possibly another contact lifting off there” to which the pilot responded “roger – looking” (Figure 3). The primary contact was last seen on the radar replay at 1111:11 before disappearing - possibly reappearing at 1111:27 (Figure 4).

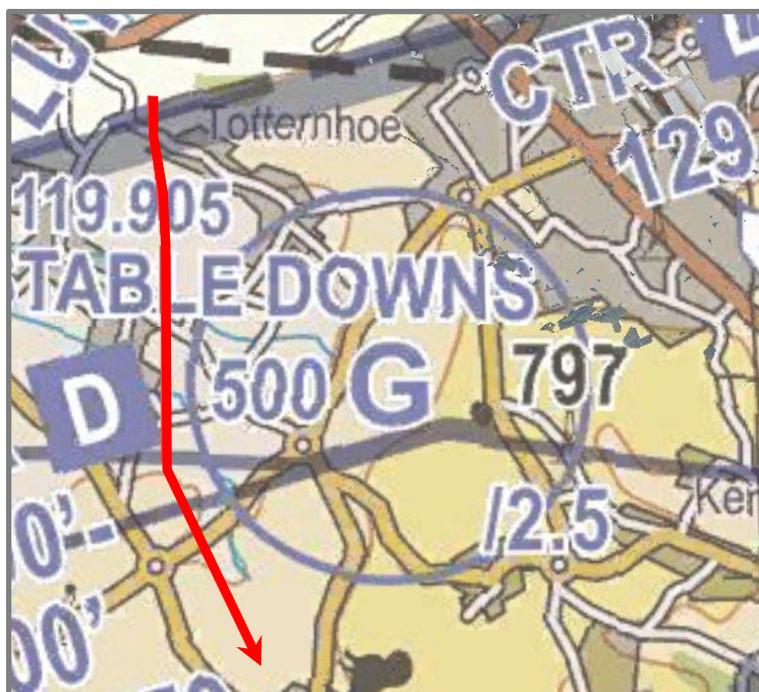
Figure 5 – Track of MD500

Dunstable Downs gliding site operates within part of the Luton CTR, but was not marked on the radar replay. However, CAA ATSI plotted the track of the MD500 in relation to the Dunstable Downs gliding site as published on aeronautical charts (Figure 5) to show that the MD500's track remained clear to the west of that site.

The controller passed timely Traffic Information both on the gliding site, and the two contacts visible to them on their radar display. It appeared that the MD500's proximity to the area was sufficient to cause concern to the pilot of the glider. No written report was received from the pilot of the MD500.
