AIRPROX REPORT No 2020040

Date: 20 May 2020 Time: 1230Z Position: 5145N 00110W Location: 1.5NM NE Oxford

PART A: SUMMARY OF INFORMATION REPORTED TO UKAB

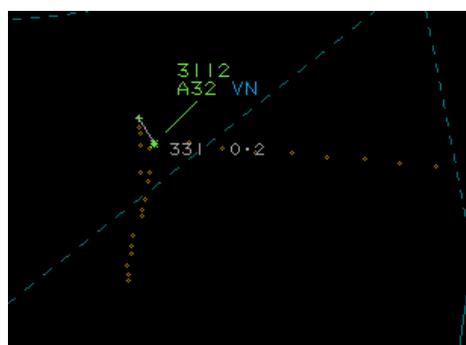
Figure 1: 1230:55 Voyager squawk 3112

Prior to CPA an unknown track can be seen on the area radar replay, it is not known if this is the unknown glider or not but is coincident with the time the Voyager pilot turns to avoid the glider. Separation between the Voyager and the unknown radar contact is 0.2NM horizontally.

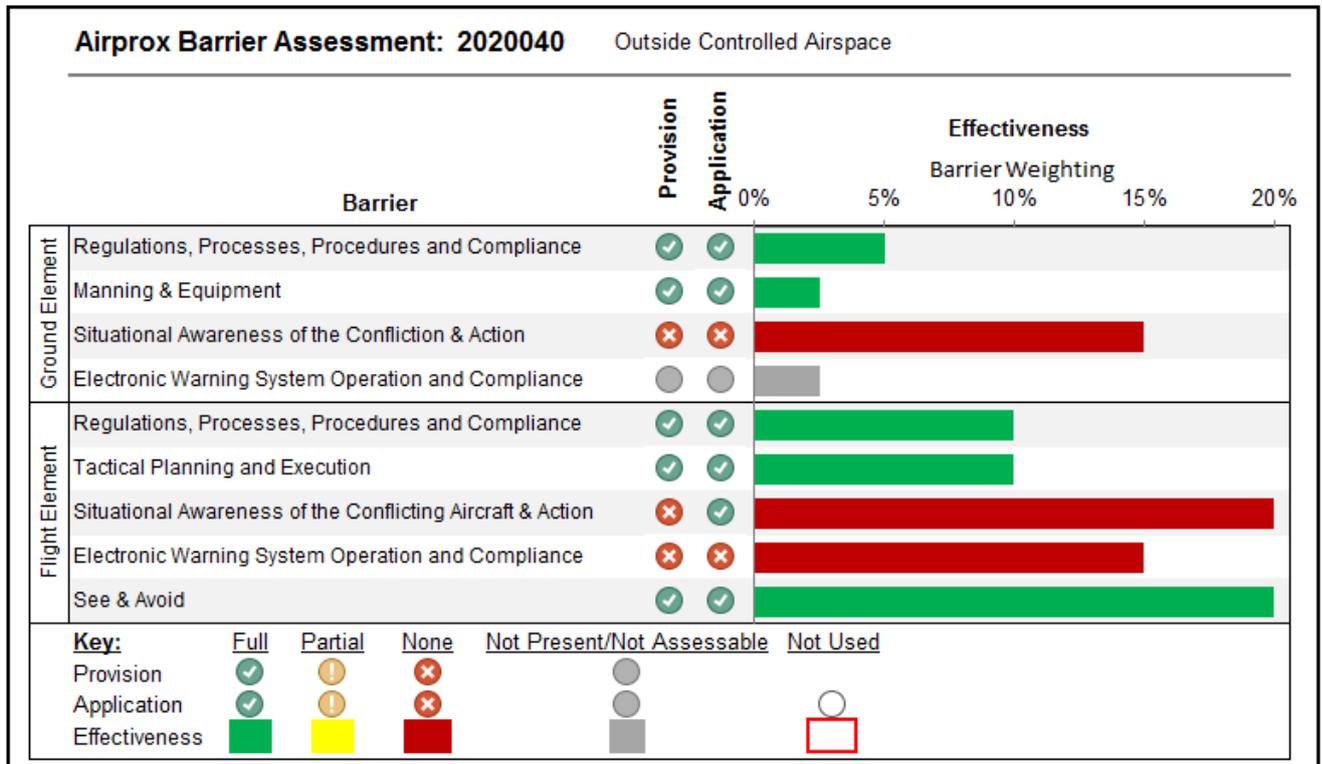
Situational Awareness of the Confliction and Action were assessed as **ineffective** because the glider was not visible on the Brize controllers radar screen.

Situational Awareness of the Conflicting Aircraft and Action were assessed as **ineffective** because neither pilot had any information on the other aircraft.

Electronic Warning System Operation and Compliance were assessed as **ineffective** because the Voyager’s TCAS could not detect the glider.
