**AIRPROX REPORT No 2020039**

Date: 19 May 2020 Time: ~1115Z Position: 5318N 00056W Location: Gamston ATZ

**PART A: SUMMARY OF INFORMATION REPORTED TO UKAB**

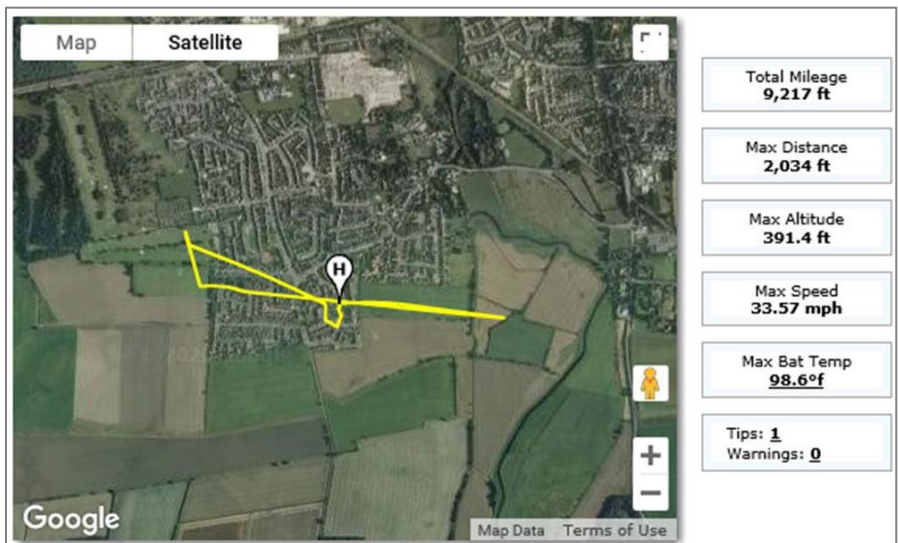
Figure 1: Drone Operating Area

an eye on the surrounding airspace. The Drone was taken to 607m away, with the RP utilising Emergency Service Exemptions following a dynamic risk assessment. The RP ensured that VLOS was continued throughout having walked towards the open field to increase his view. The flight was then continued to the West, with the drone travelling a further 622m. Having checked the areas, the Drone had continued back toward the TOLA. His attention was briefly drawn to two people walking towards him. As they were about to bring the drone back in, whilst at around 80m out from his TOLA, and at an altitude of 400ft, a Cessna type aircraft flew over his head and underneath the drone. The RP estimated that the aircraft was at an altitude of about 200ft, turning east towards south and appearing to make an approach at Gamston Airport. The RP saw that the aircraft was flying at a height between both him and his drone and was confident in having a gap in altitude so did nothing with the drone, leaving it at 400ft altitude. Once the aircraft was clear the RP began the descent again, bringing the drone to 200ft, as another aircraft making a similar approach but at a higher altitude flew above. The 2nd aircraft was apparently much higher than the first aircraft. The RP re-contacted Gamston Airport once the drone had landed to explain what had happened and the A/G operator stated that aircraft were in the circuit and wasn't overly concerned about what was reported to him. The drone Chief Pilot then contacted Gamston to discuss the incident, specifically with the Airport Manager. They were unaware of any issue in relation to a near miss but were aware that the RP had contacted them to report a low flying aeroplane. They had not received any reports from the pilots operating at Gamston and stated that it was unlikely that an aeroplane would have been at an altitude of 200ft over Ordsall. Aircraft preparing to land are usually at an altitude of 600ft at the village of Eaton, which is approximately 950m away from the drone's closest trajectory.

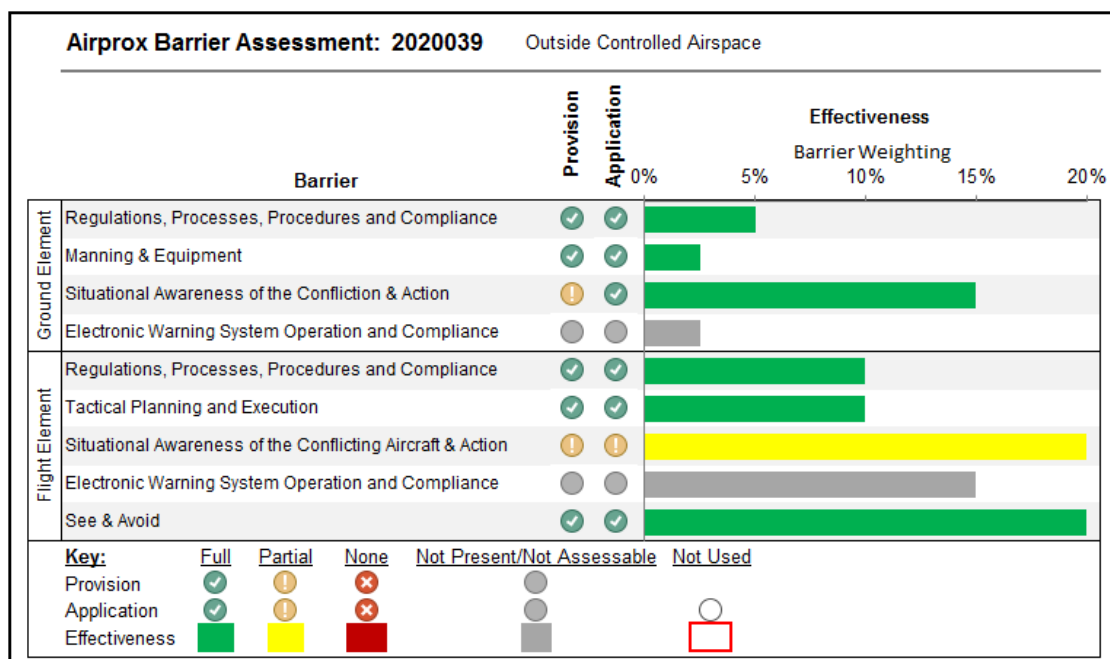
**Situational Awareness of the Conflicting Aircraft and Action** were assessed as **partially effective** because the C150 pilot had flawed SA on the drone’s location and conducted their flight based on that flawed SA.
