## AIRPROX REPORT No 2020051

Date: 08 Jun 2020 Time: 1036Z Position: 5112N 00100W Location: 1NM NE Lasham

### PART A: SUMMARY OF INFORMATION REPORTED TO UKAB

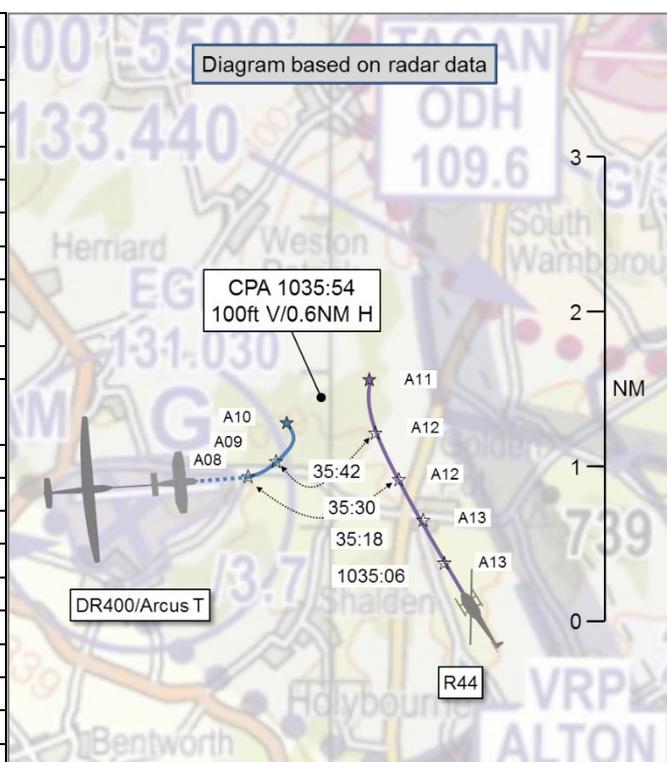
Recorded	Aircraft 1	Aircraft 2
Aircraft	DR400/Arcus T	R44
Operator	Civ FW	Civ Comm
Airspace	London FIR	London FIR
Class	G	G
Rules	VFR	VFR
Service	Listening Out	Basic
Provider	Lasham	Farnborough
Altitude/FL	1000ft	1100ft
Transponder	A, C, S	A, C, S
Reported		
Colours	Black, yellow	White, Hi vis blades
Lighting	NK	HISL
Conditions	VMC	VMC
Visibility	70km	>10km
Altitude/FL	200ft	1060ft
Altimeter	QFE (995hPa)	NK
Heading	080°	347°
Speed	75kt	99kt
ACAS/TAS	FLARM	TAS
Alert	None	None
Separation		
Reported	100ft V/600m H	200ft V/0.7NM H
Recorded	100ft V/0.6NM (~1100m) H

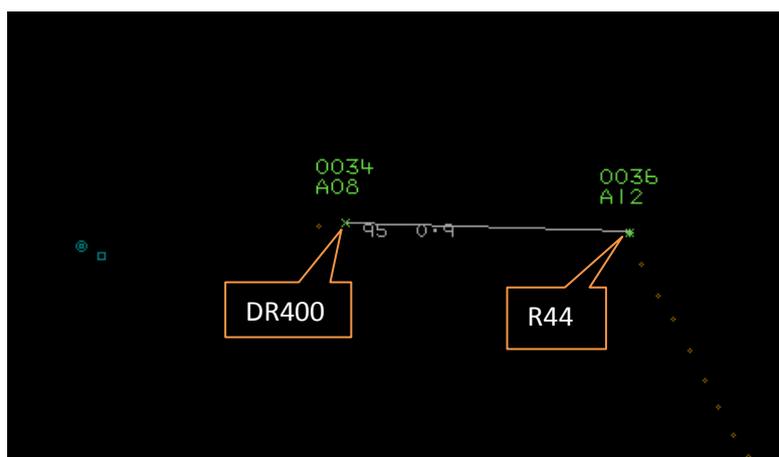
Figure 1 - 10:35:34

At 10:35.34 the DR400 first appeared on the Area Radar replay, 0.9NM west of the R44, indicating an altitude of 800ft (Figure 1).

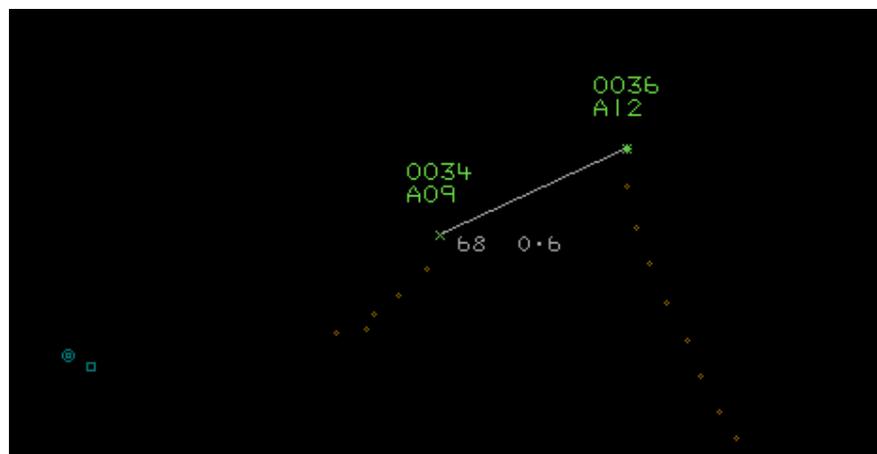
Figure 2 -10:35:50

CPA occurred at 10:35.50<sup>1</sup>, with the aircraft separated by 0.6NM laterally and 300ft vertically (Figure 2).

<sup>1</sup> UKAB Secretariat estimated that CPA occurred at 10:35:54, as depicted in the diagram on page 1.
