## AIRPROX REPORT No 2020058

Date: 28 Jun 2020 Time: 1426Z Position: 5128N 00028W Location: London Heathrow

### PART A: SUMMARY OF INFORMATION REPORTED TO UKAB

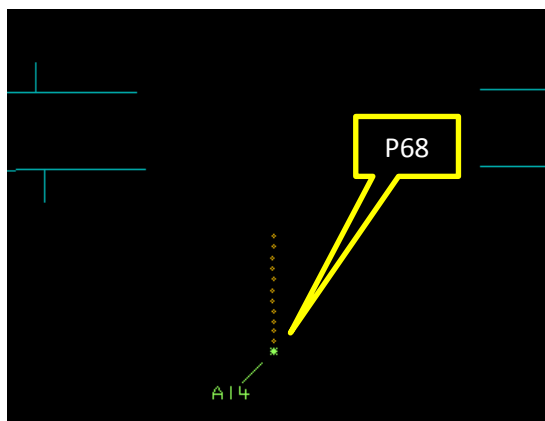
Figure 1 – 1424:06

At **1424:06**, and having just completed a north-to-south pass, the P68 pilot advised the controller "[P68 C/S], line is completed" the controller instructed the pilot "[P68 C/S] proceed northbound"

(Figure 1). At **1425:11**, the A320 pilot was issued with their take-off clearance and the P68 had just completed a 360° left turn (Figure 2).

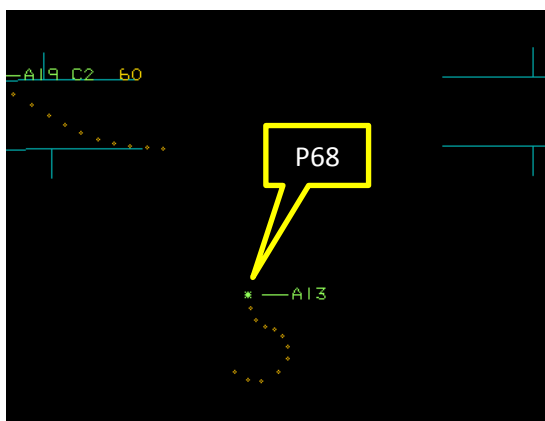
Figure 3 – 1425:23

At **1425:23**, the controller passed Traffic Information to the P68 pilot “[P68 C/S] traffic information, a three twenty just commencing their departure roll runway two seven left”. The pilot responded, “copy that, we have the traffic in sight, [P68 C/S]” (Figure 3). At **1425:41**, the controller passed Traffic Information to the A320 pilot “callsign, traffic information, light fixed wing transiting south-to-north, fifteen hundred feet”. The A320 pilot had commenced their take-off roll and did not respond (Figure 4).

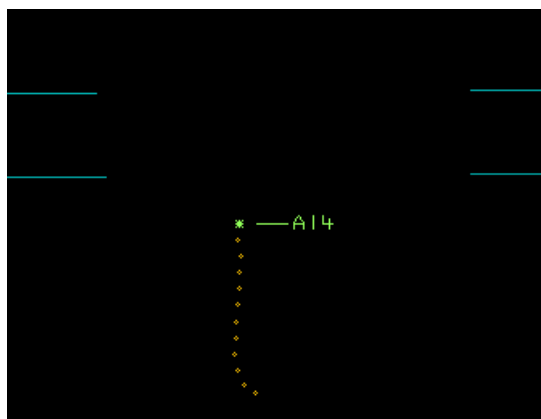
Figure 5 – 1425:54

At **1425:54**, the P68 was at the southern aerodrome boundary, tracking north and indicating altitude 1400ft (Figure 5).

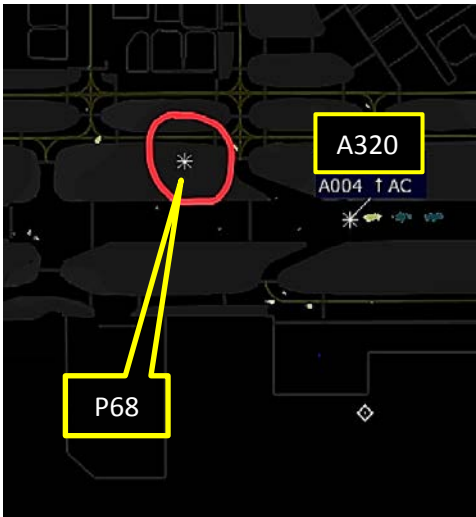
Figure 7 – 1426:06 (surface radar)

At **1426:06**, CPA had occurred and the P68 could be seen on the surface movement radar as being to the north of RW27L; the A320 was airborne, displaying an indicated altitude of 400ft, climbing (Figures 7 and 8).

The A320 did not display on the Heathrow 10 radar replay until **1426:18** (Figure 9). The P68 had been indicating altitude 1400ft as it crossed above the runway. The trajectory below, and Figures 7 and 8 above, indicate that the P68 passed ahead of, and 1000ft or more above, the A320.
