**AIRPROX REPORT No 2020076**

Date: 22 Jul 2020 Time: 1447Z Position: 5104N 00230W Location: 6NM NE Yeovilton

**PART A: SUMMARY OF INFORMATION REPORTED TO UKAB**

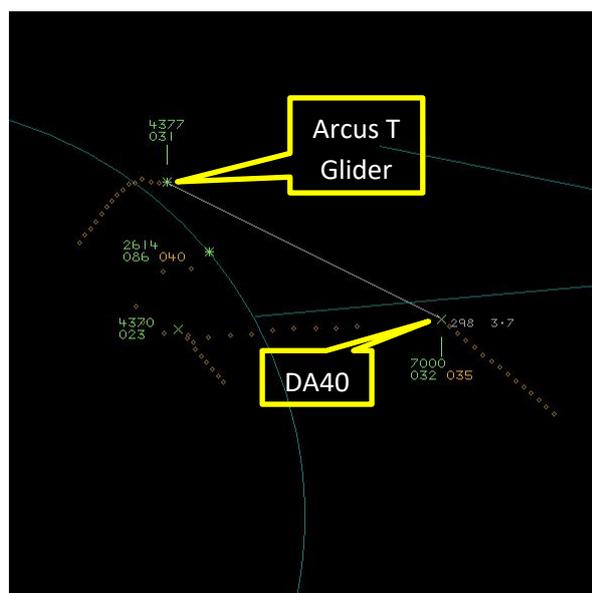
Figure 1 – 1445:50

The Arcus glider pilot had agreed a Basic Service with the Yeovilton Radar controller and had been on the frequency during their entire overflight of the Yeovilton MATZ. Analysis of the NATS radar replay revealed that, on reaching the lateral MATZ boundary (the Mode C indicated that they were above the MATZ), the Arcus pilot turned onto an east-south-easterly heading and towards the DA40 (see Figure 1). Coincident with the glider pilot's turn, the DA40 pilot called Yeovilton Radar and requested a Basic Service, which was agreed and a squawk issued by the Yeovilton controller. The DA40's squawk was seen to change to that issued by the controller at 1445:30 (Figure 2); the aircraft are separated by 1.5NM and 300ft at this time.

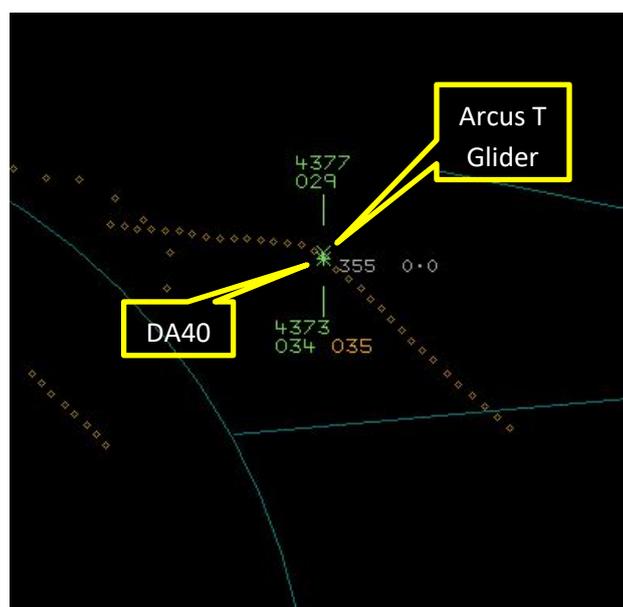
Figure 3 - 1446:58 - CPA

Analysis of the tape transcript shows that, after this exchange with the DA40 pilot, the Yeovilton controller was busy with a number of other aircraft; it is likely that this high workload led to the controller not noticing the proximity of the 2 Airprox aircraft, albeit both pilots were under a Basic Service. CPA occurred at 1446:58 and was measured at <0.1NM lateral and 500ft vertical separation (see Figure 3).
