AIRPROX REPORT No 2020083

Date: 29 Jul 2020 Time: 1044Z Position: 5143N 00214W Location: 2NM E Nympsfield

PART A: SUMMARY OF INFORMATION REPORTED TO UKAB

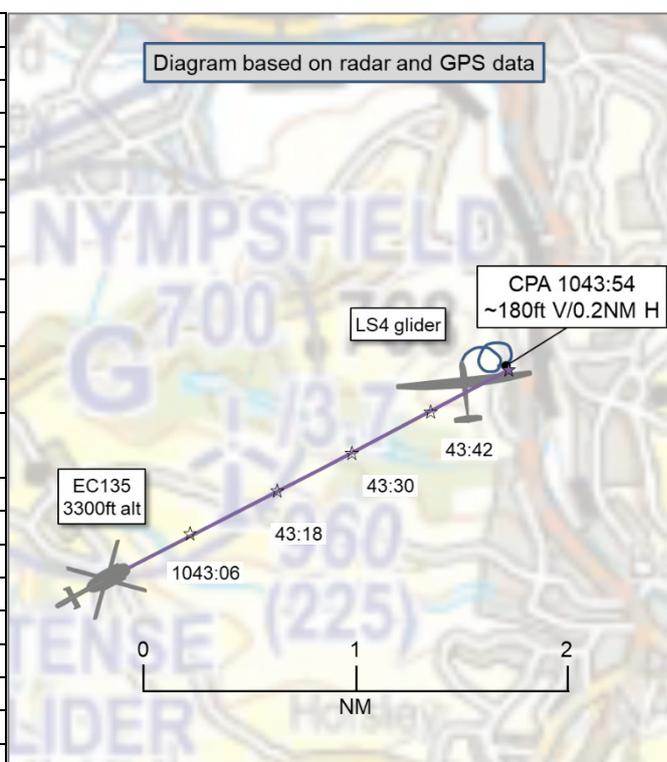
Recorded	Aircraft 1	Aircraft 2
Aircraft	EC135	LS4
Operator	Civ Helo	Civ Gld
Airspace	London FIR	London FIR
Class	G	G
Rules	IFR	IFR ¹
Service	Basic	Listening Out
Provider	Gloucester	BGGC ²
Altitude/FL	3300ft	~3110ft
Transponder	A, C, S	Not fitted
Reported		
Colours	Red	White, red
Lighting	Nav, strobe, landing	Not fitted
Conditions	IMC	IMC ¹
Visibility	30NM	50km
Altitude/FL	FL030	2949ft
Altimeter	SPS	QFE
Heading	045°	210°
Speed	120kt	50kt
ACAS/TAS	Not fitted	FLARM
Alert	N/A	None
Separation		
Reported	200ft V/0.25NM H	150ft V/500m H
Recorded	~180ft V/0.2NM (370m) H

THE EC135 INSTRUCTOR reports conducting IF training, IFR in IMC but 200ft clear of cloud, in the transit towards REKLO, the IAF for the RNP 27 approach at Gloucester. The Training Flight was being flown by the P2 as the handling pilot in the LHS with the Instructor in the RHS and autopilot upper level modes engaged [examples of which are heading and altitude hold]. The Instructor had briefed the presence of Nympsfield glider site and the hazard of a transit to the IAF at the minimum altitude within the TAA, as the track would pass close to the site and its associated winch launch. The decision was made to transit to the south of the glider site and maintain VCF³ below cloud at a level/altitude that would be above the maximum winch launch altitude of the site. Nearing the glider site, a glider was sighted ahead and slightly right by the Instructor, who called "glider" and made a cyclic control input to turn left away from the glider. The glider pilot made a similar avoiding turn to the left and rocked wings to acknowledge. Approximately 3 minutes later, at 1045 UTC, a further glider was sighted by the Instructor, about ½NM ahead and slightly right. He made a cyclic input to the left to avoid and the glider in conflict also turned left and descended below.

THE LS4 PILOT reports climbing in a right hand thermalling turn when a red helicopter was seen heading straight towards the glider in level flight. The LS4 pilot promptly turned hard right and dived, whilst maintaining visual contact with the helicopter to confirm separation. A couple of seconds after initiating the right turn the LS4 pilot saw the helicopter initiate a right turn also, presumably because the helicopter pilot had seen the glider.

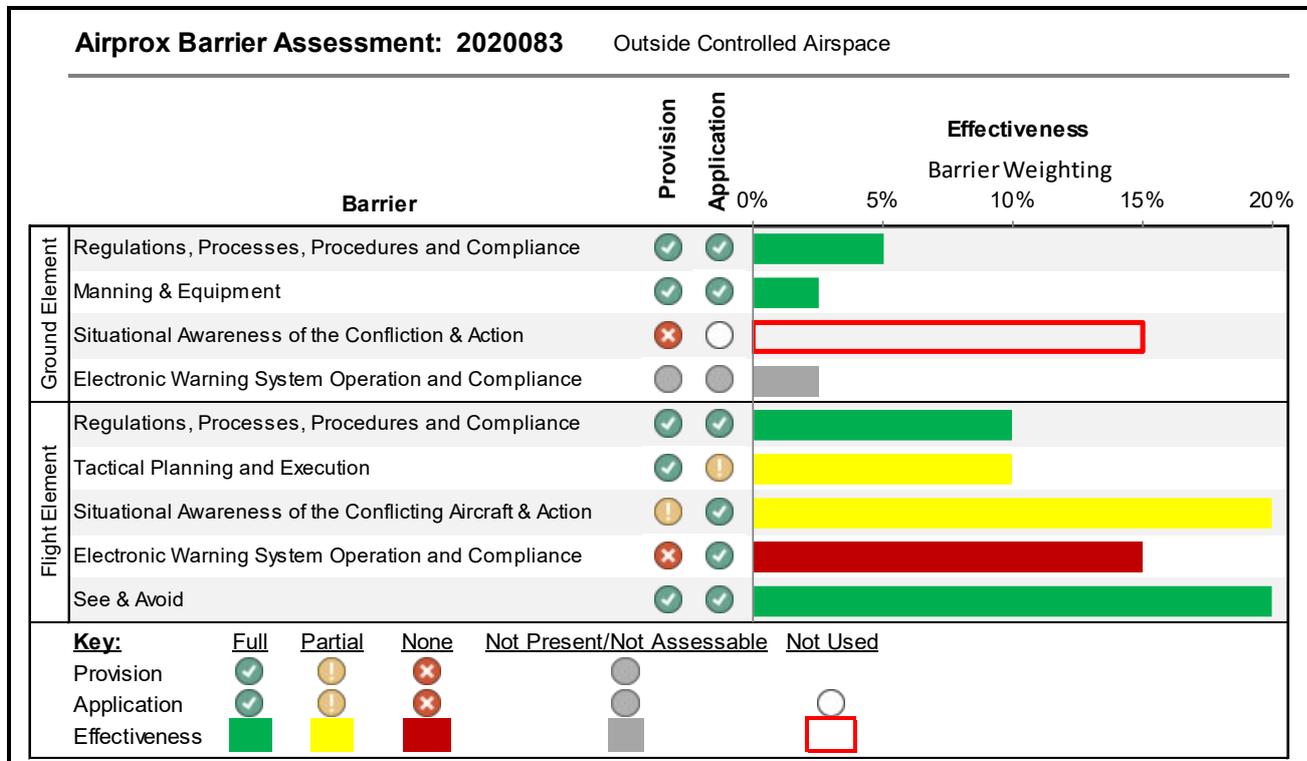
Safety Barrier Assessment⁶

Situational Awareness of the Confliction and Action were assessed as **not used** because the controller was not required to monitor the EC135 position or potential conflicting traffic.

Tactical Planning and Execution were assessed as **partially effective** because further mitigations were available to the EC135 crew to avoid the locality of likely levels of high gliding activity.

Situational Awareness of the Conflicting Aircraft and Action were assessed as **partially effective** because only generic SA was available to the EC135 crew in the proximity of Nympsfield gliding site.

Electronic Warning System Operation and Compliance were assessed as **ineffective** because the EC135 was not compatible with the LS4 FLARM.

Recommendation: The CAA include Glider Site ICFs, as supplied by the BGA, in the UK AIP ENR 5.5.
