AIRPROX REPORT No 2020096

Date: 11 Aug 2020 Time: ~1501Z Position: 5223N 00007E Location: Sutton

PART A: SUMMARY OF INFORMATION REPORTED TO UKAB

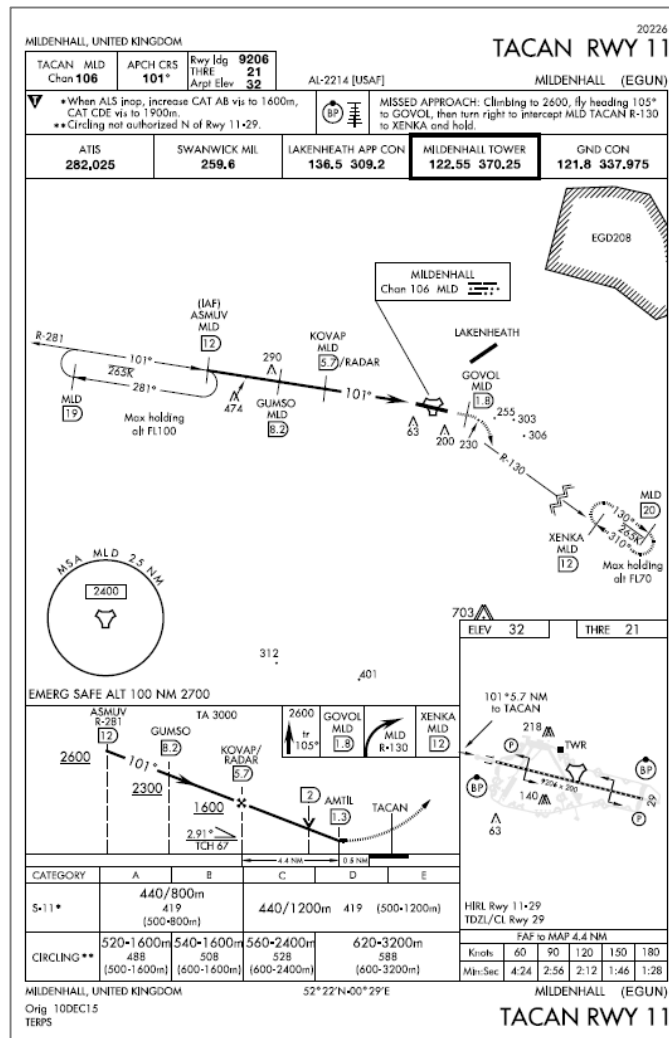
Figure 1: Mildenhall IAP TACAN RW11

This event occurred during a busy period for RAF Lakenheath ATC (RAPCON), who were controlling a mix of VFR/IFR approaches and departures for Lakenheath and Mildenhall (MLD); there was also VHF traffic, including the non-Airprox glider on a listening watch. The formation of F15s were carrying out a TACAN approach to MLD and were routing via ASMUJ (the initial approach fix (IAF) for MLD's RW11 TACAN App). This route brings aircraft very close to Sutton Meadows Airfield –
