## AIRPROX REPORT No 2020109

Date: 05 Sep 2020 Time: 1224Z Position: 5208N 00027E Location: 3NM N of Haverhill

### PART A: SUMMARY OF INFORMATION REPORTED TO UKAB

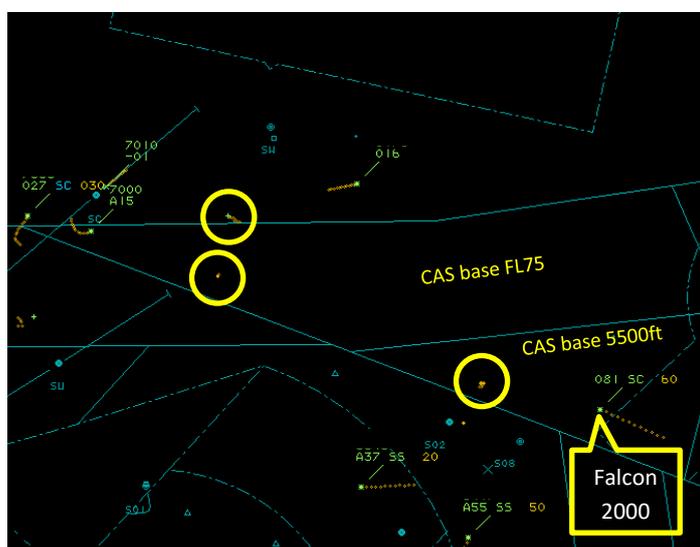
Figure 1 – 1220:58 – possible glider activity circled

An Airprox was reported by the pilot of a Falcon 2000 against a glider whilst inbound to Cambridge. The Falcon 2000 had previously been under a Radar Control Service with London Control. According to the NATS investigation report, at **1220:58** whilst passing FL80 in the descent, the pilot was given further descent to an altitude of 4000ft and advised the service would change to a Traffic Service on passing 5500ft. A number of primary-only contacts were visible on the radar replay, none of which corresponded to the glider involved in the Airprox, the radar contact for which did not appear until after CPA (Figure 1).

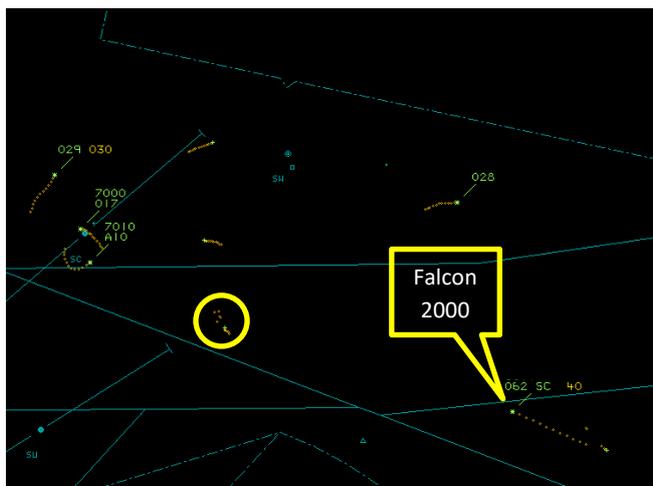
Figure 2 – 1222:34

At **1222:34**, the Falcon 2000 was still passing 6000ft and approaching the edge of controlled airspace. The London controller terminated the radar service, advising the pilot that they were about to leave controlled airspace and that *"I have nothing seen or known to affect, so my radar service terminates"*. They instructed the pilot to contact Cambridge. The nearest visible contact according to the radar replay snapshots in the NATS investigation report and confirmed by ATSI, was still over 10.5NM away (circled on Figure 2). The Falcon 2000 pilot established contact with the Cambridge Approach controller at **1222:50**. The controller confirmed the descent clearance to 4000ft and a routing direct towards the Cambridge NDB. The Falcon 2000 pilot asked *"can we expect a full approach?"*, to which the controller replied, *"affirm, expect a no delay approach for an ILS approach Runway Two Three"*. At **1223:25** the controller asked the Falcon 2000 pilot if they wished to self-position, to which the pilot replied *"standby, we're still coming through the cloud sir, we'll let you know in just a little bit"*. At **1223:50** the Cambridge controller contacted one of two gliders which were on the Cambridge Approach frequency and requested they report their position. The glider pilot reported their position as just north of Six Mile Bottom at 3000ft (Figure 3).

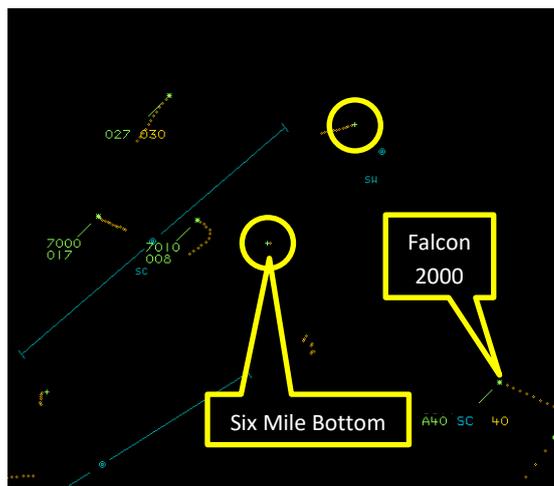
Figure 3 – 1223:50  
Circled are the two gliders believed to be in contact with Cambridge

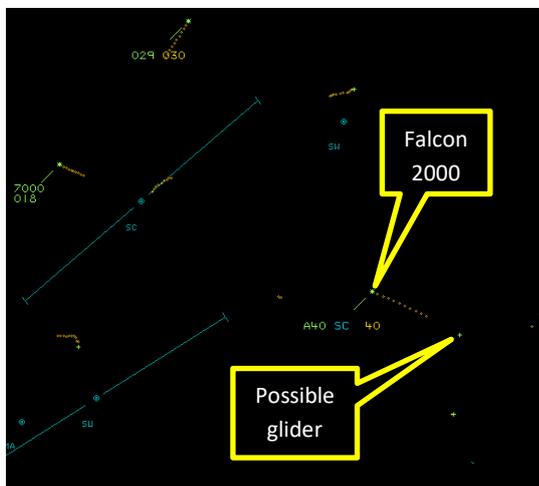
Figure 4 – 1224:47

The controller acknowledged this and, at **1224:00**, passed Traffic Information *"traffic is a Falcon 2000 routing towards the Cambridge overhead descending initially to four thousand feet"*. Before the glider pilot was able to acknowledge this, the pilot of the Falcon 2000 replied *"yep we've just passed him and we're reporting an Airprox"*. CPA could not be determined as the glider involved in the Airprox was not visible on the radar replay. A contact believed to be that aircraft subsequently appeared at 1224:47 (Figures 4 and 5).
