AIRPROX REPORT No 2020115

Date: 10 Sep 2020 Time: 1309Z Position: 5043N 00213W Location: Eyres Field glider site

PART A: SUMMARY OF INFORMATION REPORTED TO UKAB

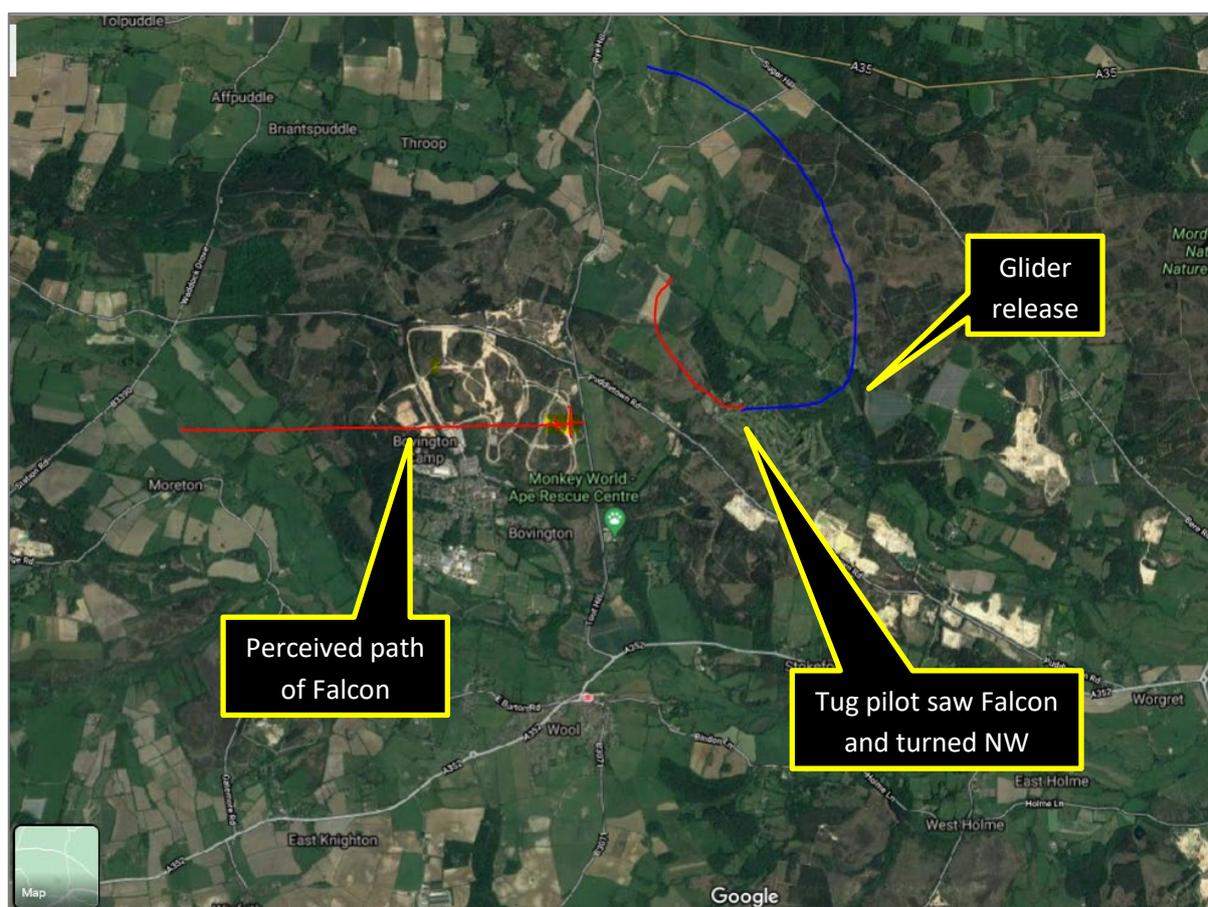
DORSET GLIDING CLUB reports the event was witnessed by two people on the ground and the tug pilot in the air. They collectively observed a Falcon at an estimated height of between 1500ft and 2000ft above ground level (the tug pilot confirmed the height as 3200ft). The lower of the two Falcons was observed above the middle of the airstrip. The second Falcon, which passed over 1½ to 2 minutes later, could not be seen from the ground as it was above cloud. The ground observers concluded it was a Falcon from the sound being similar to the first. An estimation of relative ground tracks is at Figure 1 below.

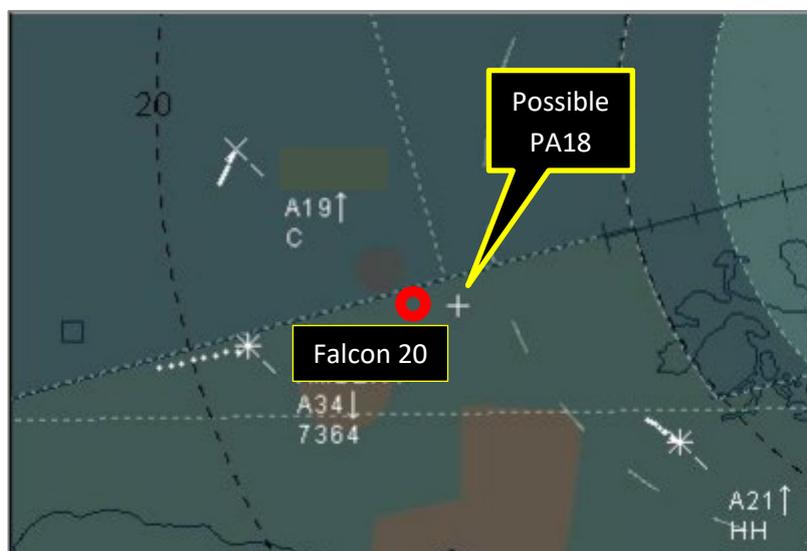
Figure 2 – 1308:08

The narrative outlined in the APS controllers MOR describes an accurate account of the incident. [The Falcon 20] was 30NM west of the airfield in Class G airspace and had self-positioned on the extended centreline for RW08 when the crew contacted the Bournemouth radar frequency. They were given clearance to join for a straight-in approach, VFR. As the aircraft approached 23NM from touchdown, the APS controller advised that Eyres Field gliding site was notified as active. At that time the aircraft was approximately 8NM from the site and would overfly on their elected routing. As [the Falcon 20] reached 4NM from Eyres Field, a PSR-only contact popped up in that vicinity within 0.5NM of the site. The controller passed the Traffic Information to the crew who acknowledged it and advised that they were looking. The screen shot captured at this moment and depicted at Figure 2 shows the PSR contact as a '+' ahead of [the Falcon 20]. A red circle has been added to the screenshot to indicate the position of the gliding site.

As of July 2020, as a result of a review of procedures following a previous Airprox involving an FA20 and glider [UKAB note: Airprox 2020044], it was recommended that Eyres Field should be marked on the radar display when notification had been received that it was active. This serves as an aide memoire to the controller enabling them to pass generic Traffic Information as the radar struggles to capture and/or retain returns for such aircraft. In this instance it had not been selected, however it was noted in the remarks on the MET screen which reflects information which is being broadcast on the ATIS.

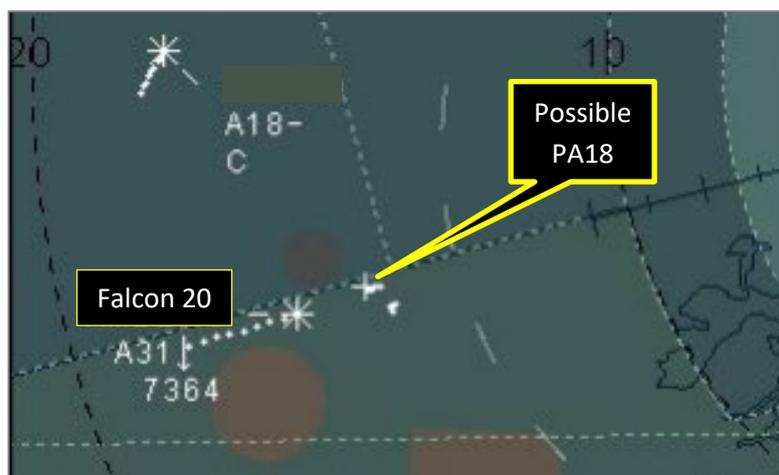
Figure 3 – 1308:51

The aircraft continued inbound towards the airfield without deviation from track. The PSR contact continued to paint on the radar display; however, the accuracy of the plot is questionable as the radar struggled to retain the return. The screenshot depicted at Figure 3 is believed to be the last accurate capture prior to the Airprox.

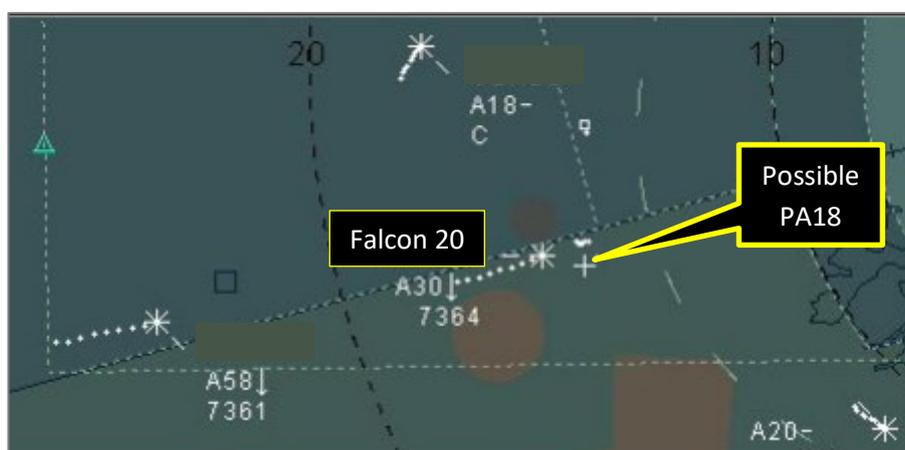
Figure 4

Following this, the contact coasted as the radar attempted to predict the direction of the aircraft (Figure 4). At this point the pilot reported passing within half a mile of another aircraft and that it was overhead Eyres Field. They also reported being visual with a glider at about 4000ft in the same vicinity. The altitude of the FA20 at the time of the report was 3000ft.

The glider tug was not fitted with a transponder and was slow moving and, as such, the radar struggled to retain the return.

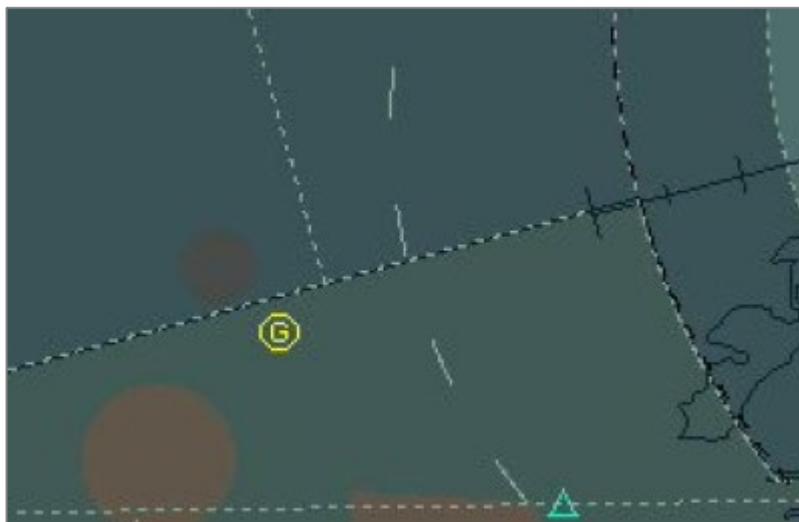
It is unknown why the selectable symbol representing the gliding site was not depicted on the screen as seen in Figure 5 below. The controller reported post-incident that, had it been on the screen, they may have been able to let the crew know sooner. The pilot was, however, informed of the activity status of the gliding site when the aircraft was still some 8NM miles from it and subsequently Traffic Information 4NM miles ahead. The radar replay shows no deviation by the aircraft from its track and the pilot responded to the traffic report "*Copied looking [Falcon 20 C/S]*".
