AIRPROX REPORT No 2020126

Date: 18 Sep 2020 Time: 1123Z Position: 5144N 00010E Location: North Weald – elev 321ft

PART A: SUMMARY OF INFORMATION REPORTED TO UKAB

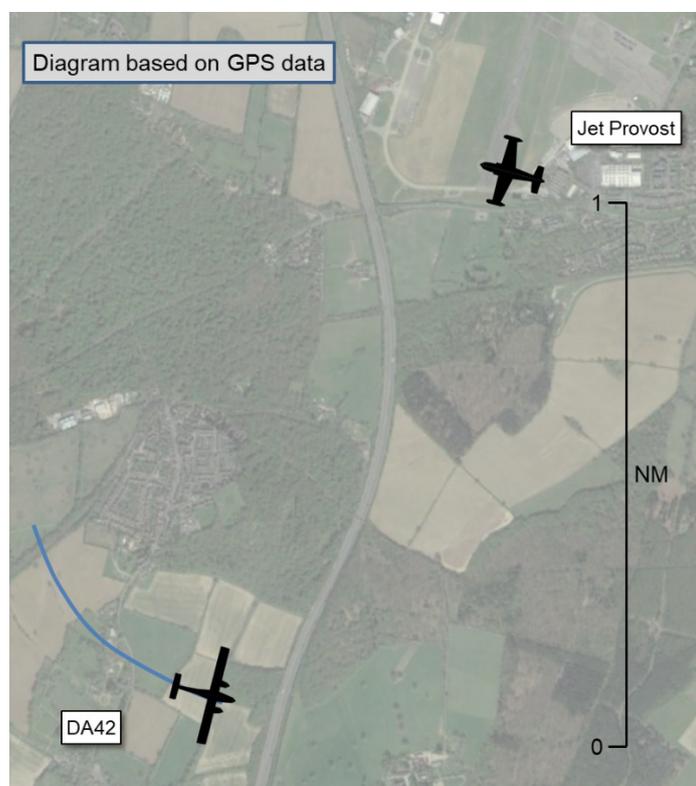
Figure 1: 1122Z – JP enters runway to line-up
