AIRPROX REPORT No 2020134

Date: 28 Sep 2020 Time: 1216Z Position: 5048N 00112W Location: Lee-on-Solent

PART A: SUMMARY OF INFORMATION REPORTED TO UKAB

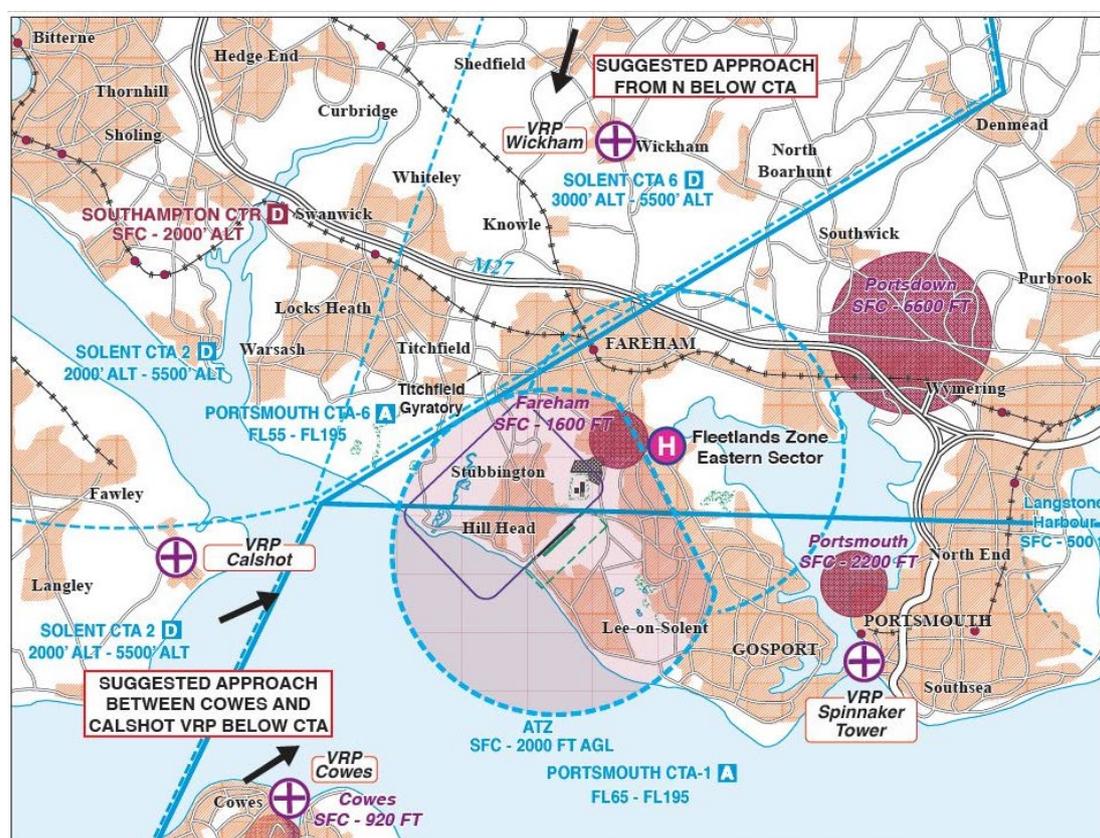
The Solent Airport website details joining information for pilots and states that standard joins from the south, west and east are downwind for RW23. See Figure 1.

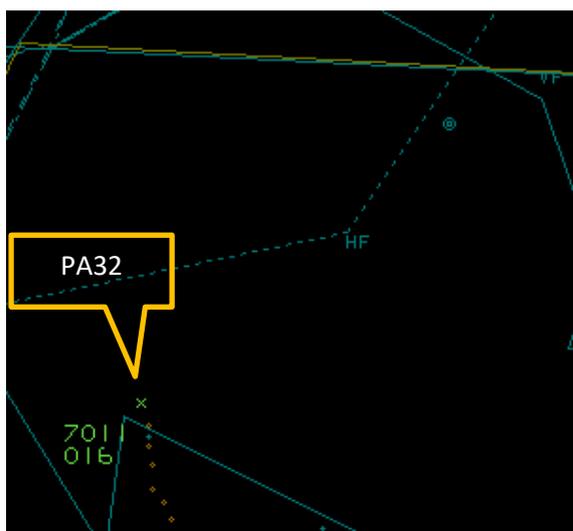
Figure 1

At 1215:49 the PA32 had turned in the vicinity of Cowes at FL016, Figure 1. By 1216:16 they were 2.5NM SW of Lee-on-Solent, had crossed through the climb-out lane of RW23 and had descended to FL013 (Figure 2).

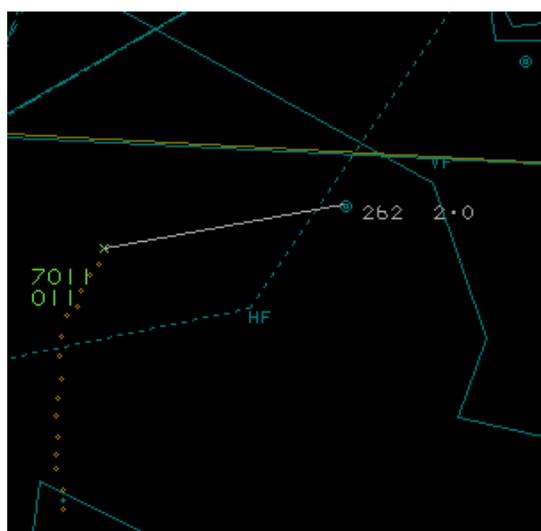
Figure 3

The PA32 entered the ATZ at 1216:42, at FL011, and had started the turn to position downwind (Figure 3). From there the PA32 continued downwind (Figure 4). Without the PA28 being visible on the radar it is not possible to say exactly where the Airprox took place.
