## AIRPROX REPORT No 2020139

Date: 29 Sep 2020 Time: 1409Z Position: 5053N 00137W Location: 2NM SE Stoney Cross VRP

### PART A: SUMMARY OF INFORMATION REPORTED TO UKAB

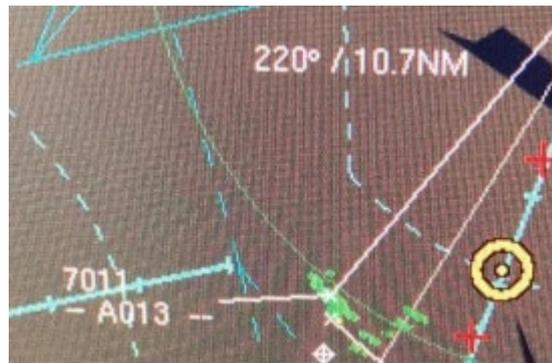
Figure 1

No radar contact on [Fournier RF3 C/S] was observed during this conversation, however an intermittent primary contact painted on radar at 1403:01, 1NM West of Beaulieu river (200° at 9.9NM from SAM). This contact faded in and out of coverage for 3.8NM, at which point it faded from coverage completely (222° at 10.3NM from SAM). There was a Solent monitor 7011 squawk (Mode S [CZA SportCruiser C/S]) in the vicinity of the primary contact indicating A013 and bearing 220° at 10.7NM from SAM (Figure 1).

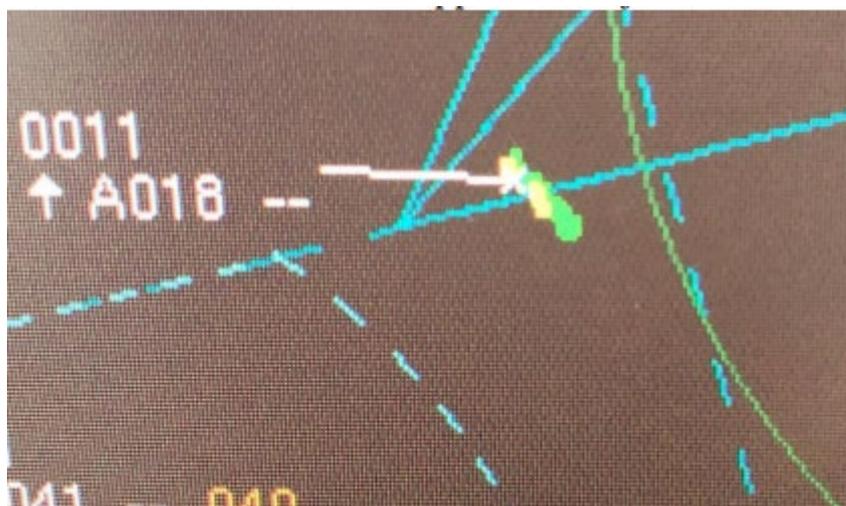
Figure 2

1410:12 the [CZA SportCruiser C/S] changed to the Bournemouth monitor squawk 0011. At 1410:31 a very intermittent primary contact started to paint on radar bearing 254° at 11.7NM from SAM and approximately 792m behind the [SportCruiser C/S].

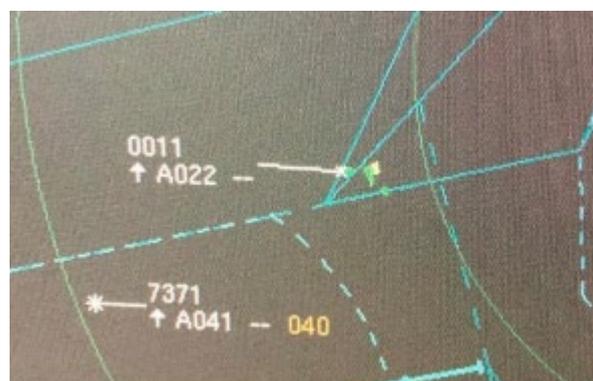
Figure 3

At 1410:54 [Fournier RF3 C/S] reported at Stoney Cross, '*Solent [Fournier RF3 C/S] Stoney Cross ah turning North ah North East direct to [destination] at ah two thousand feet*'. The ATCO asked them to report leaving the frequency and the pilot replied that they would do. At this time the SportCruiser was also at Stoney Cross, indicating A021 climbing, in a left turn to the west, however, the primary contact had faded from radar coverage again by this time.

1411:04 A primary contact again painted on radar in the right turn tracking northeast bound, the SportCruiser was now 0.9NM west of the primary contact and tracking west, passing A022.
