AIRPROX REPORT No 2020153

Date: 15 Oct 2020 Time: 1137Z Position: 5344N 00105W Location: Burn gliding site

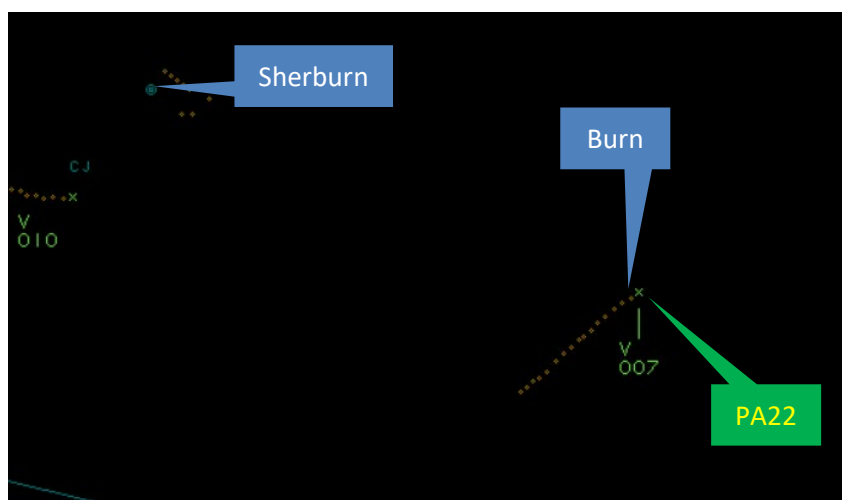
Figure 1: Radar replay – 1137:03

The Board then turned to the actions of the PA22 pilot. They had planned to land at Sherburn but, because of the weather, decided to divert. The radar replay showed the PA22 turning towards the town of Selby when they were approximately 5NM from Sherburn, this change in track put them on a direct course over Burn gliding site. The GA Board member said that the workload when initiating a diversion can increase significantly and is best mitigated with pre-flight planning, where it is easier to identify hazards which may affect a flight if there is a need to deviate from the planned route (CF2). Regardless, when diverting careful examination of onboard planning equipment (either paper maps or electronic devices) is very important, especially when flying in unfamiliar areas. The GA member said that there are several electronic aids which can be very helpful in these situations; dependent on specification, they have the ability to warn the pilot when they are approaching an area that should be avoided, e.g. glider sites, NOTAMs etc. In this case the radar replay clearly shows the PA22 routing towards Sherburn and then changing course to head towards the SWE corner of Selby, which was the stated navigation feature used for a reference point on their way to the diversion airfield. Unfortunately this change in course resulted in them flying overhead Burn gliding site; The maximum winch launch altitude of Burn gliding site is published on the chart as being at 3100ft altitude, the reported and recorded altimeter readings confirm that the PA28 was well below this, indicating that they flew through the area of a notified and active glider winch launch site (CF1&3).

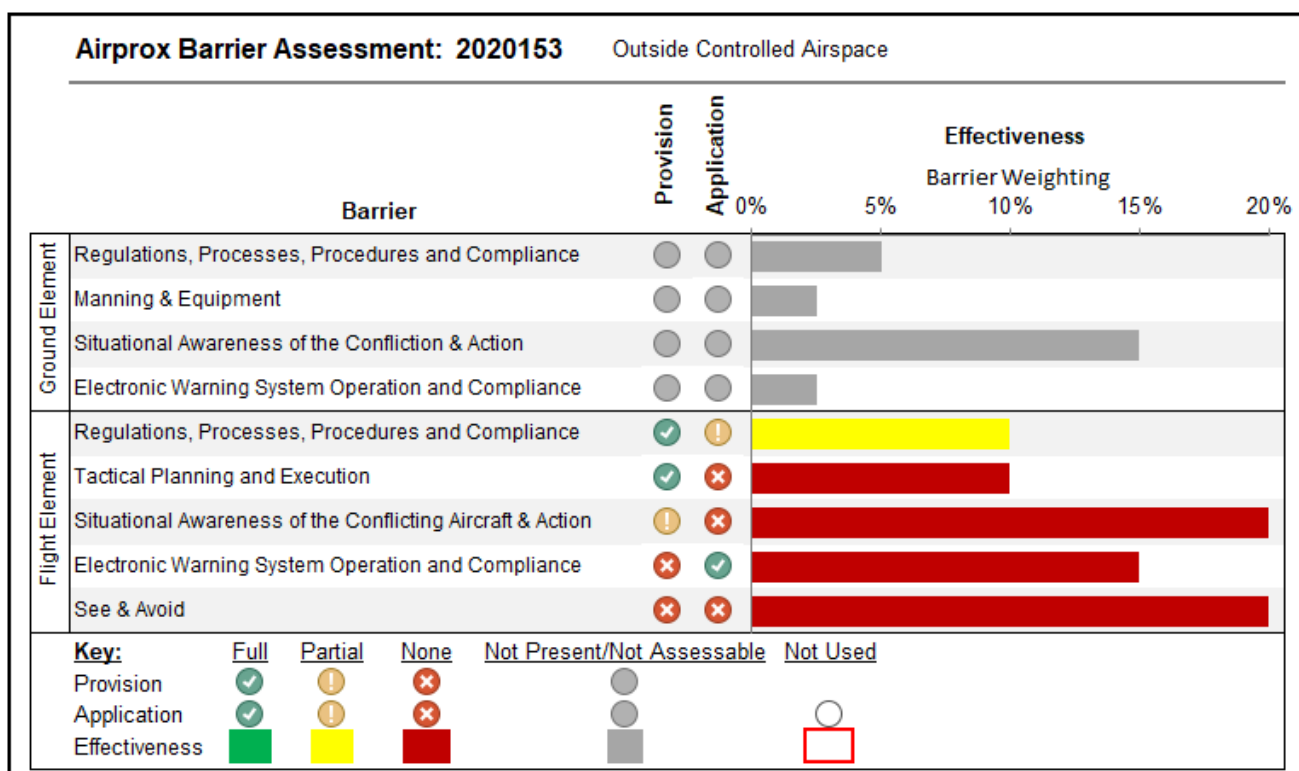
In assessing the effectiveness of the safety barriers associated with this incident, the Board concluded that the key factors had been that:

Regulations, Processes, Procedures and Compliance were assessed as **partially effective** because the PA22 pilot flew through an active and notified gliding site.

Tactical Planning and Execution was assessed as **ineffective** because the PA22 pilot’s diversion did not allow for Burn gliding site on their route.

Situational Awareness of the Conflicting Aircraft and Action were assessed as **ineffective** because the ASK13 pilot had no information about the PA22. The PA22 pilot had generic information about the glider site but did not act on the available information.

Electronic Warning System Operation and Compliance were assessed as **ineffective** because both aircraft were fitted with an electronic warning system, but they were incompatible with each other.

See and Avoid were assessed as **ineffective** because neither pilot saw the other aircraft.
