**AIRPROX REPORT No 2020163**

Date: 12 Nov 2020 Time: 1500Z Position: 5713N 00207W Location: Aberdeen

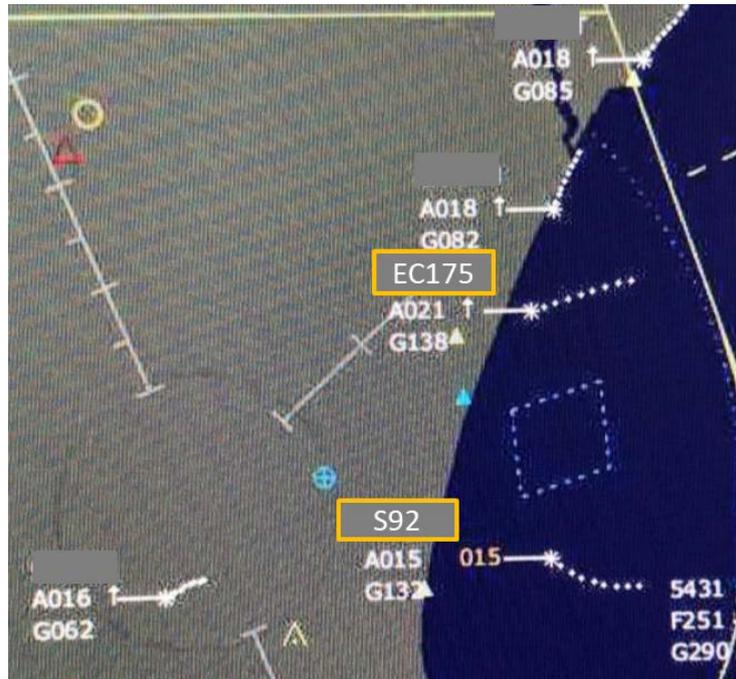
Figure 1

At 1458:57 the ADC advised the crew of [S92 C/S] that traffic north of them was an EC175 and that it was No2 to them. The pilot acknowledged this and reported they were “looking” for the traffic. At 1459:05 the aircraft were 4.56NM apart and converging with [S92 C/S] at 1500ft and groundspeed of 132kts and [EC175 C/S] indicating 2100ft at 138kts (Figure 1).

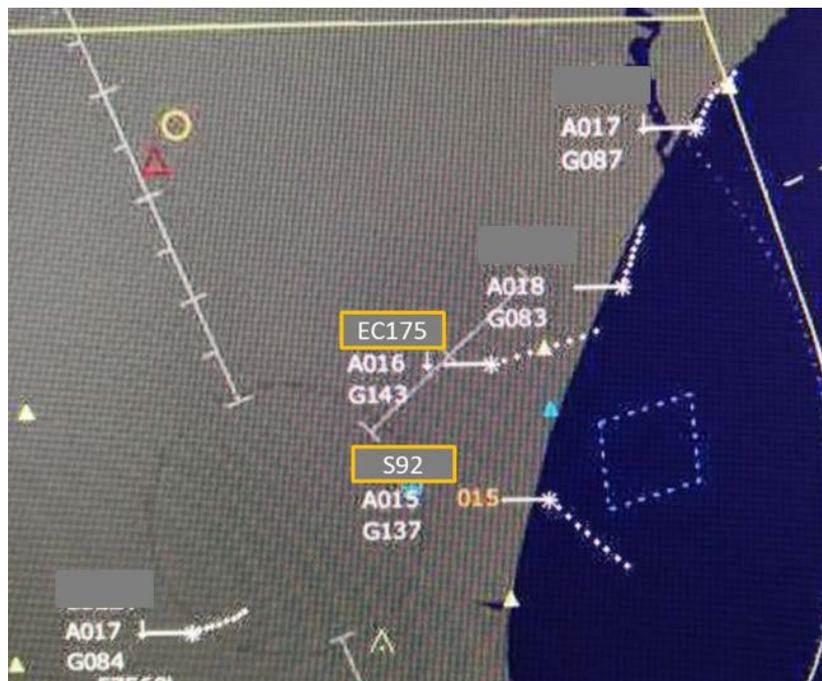
Figure 2

At 1459:24 the [EC175 C/S] commenced descent with a slight increase in groundspeed to ~145kts. At 1500:05 the distance between the aircraft was now 2.7NM and 150ft. The pilot of [EC175 C/S] asked ADC to confirm that they were No2 to traffic in their 8 o'clock, adding that they were ahead of them. ADC responded that was the intention but to standby (Figure 2).

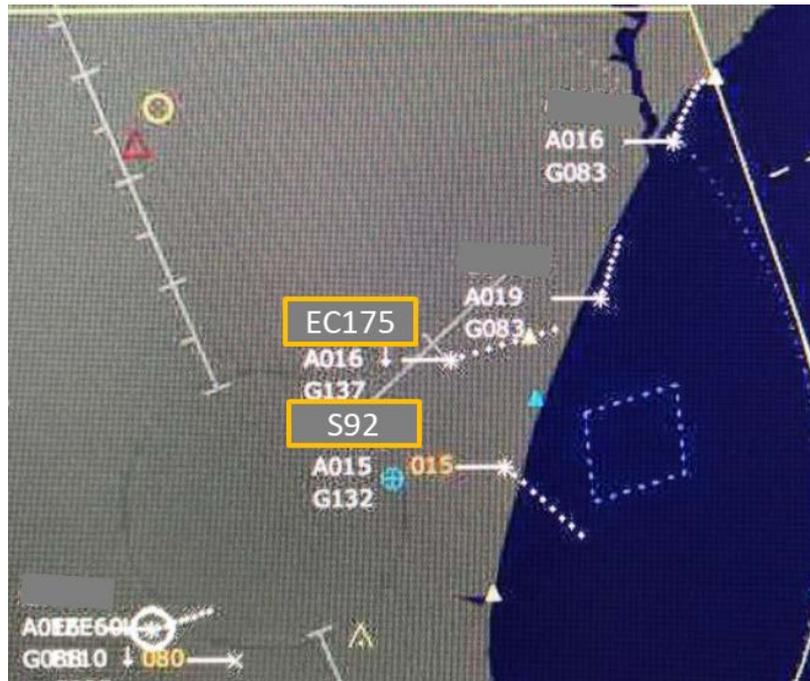
Figure 3

At 1500:18 the ADC asked the pilot of [S92 C/S] if they were happy for [EC175 C/S] to go ahead of them. The pilot of [S92 C/S] responded they were and stated they were slowing down. The aircraft were now 2.15NM/75ft apart. ADC issued a wake turbulence warning to [S92 C/S] (Figure 3).

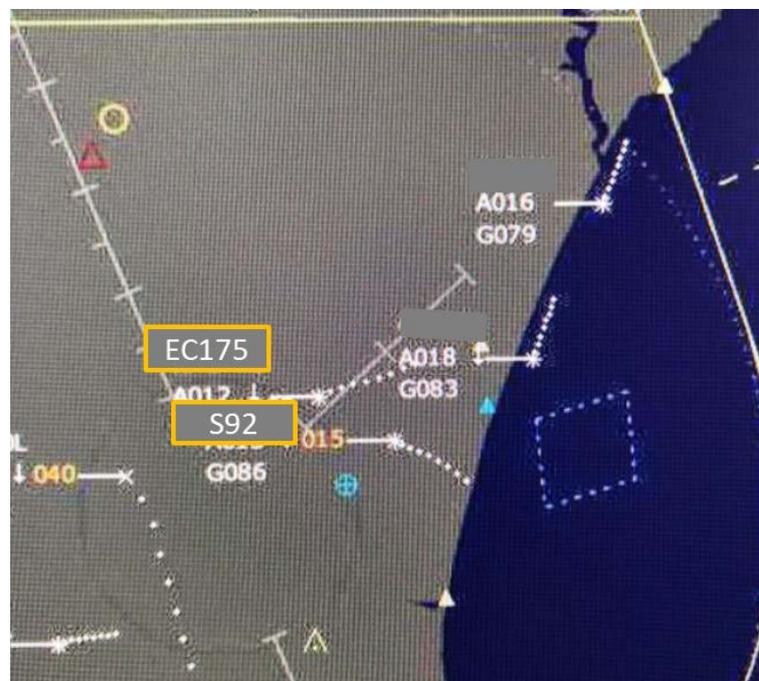
Figure 4

At 1500:28 the ADC advised the crew of [EC175 C/S] that they were now number one and to continue to final. Both aircraft subsequently landed safely. At 1501:00 the groundspeed of [S92 C/S] had reduced to 80-90kts with the closest point of approach recorded at 1.61NM and 75ft. At this time [EC175 C/S] was tracking 255° at 130kts groundspeed and [S92 C/S] tracking 300° at 86kts. [S92 C/S] was in [EC175 C/S]'s 7 o'clock position (Figure 4).
