## **AIRPROX REPORT No 2019108**

Date: 16 May 2019 Time: 1540Z Position: 5201N 0019W Location: Henlow

An Airprox was reported when a DH82 and a AS355 flew into proximity in the Henlow visual circuit at 1540hrs on Thursday 16<sup>th</sup> May 2019. Both pilots were operating under VFR in VMC, the DH82 pilot in receipt of a AGCS from Henlow and the AS355 pilot was in receipt of a Basic Service from Luton.

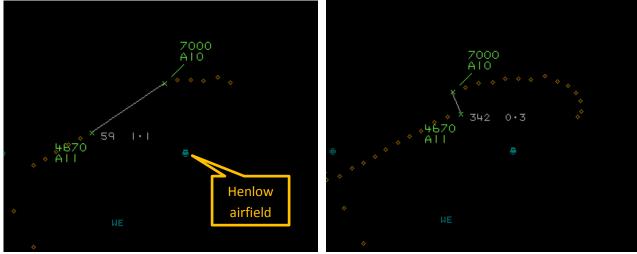
Figure 1:1540:32

Figures 1 and 2 were taken from the NATS area radars and show the AS355 (squawking 4670) at 1100ft, to the north-west of Henlow and the DH82 (squawking 7000) at 1000ft in the visual circuit. CPA was at Figure 2 when the two aircraft were 0.3nm apart.
