AIRPROX REPORT No 2019116

Date: 23 May 2019 Time: 1208Z Position: 5237N 00041E Location: 5nm E Marham

PART A: SUMMARY OF INFORMATION REPORTED TO UKAB

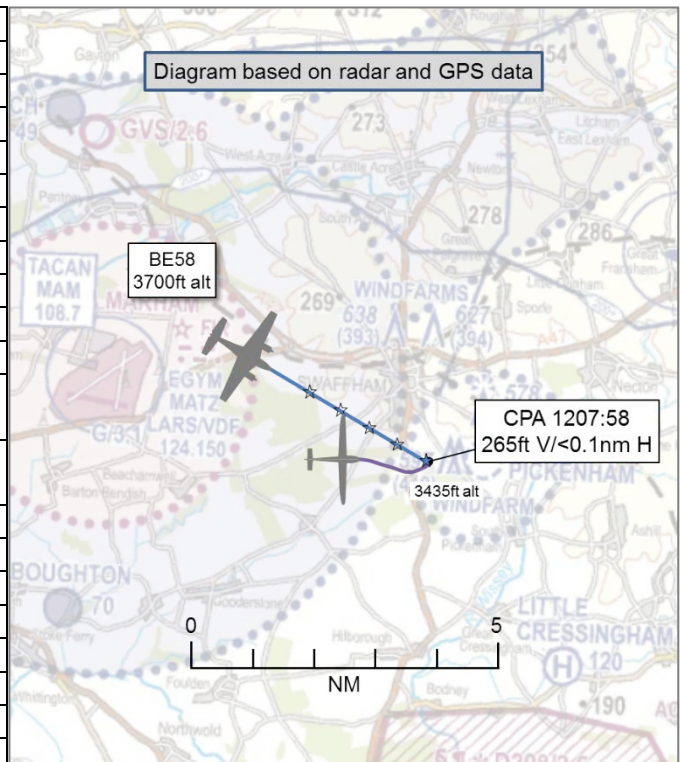
Recorded	Aircraft 1	Aircraft 2
Aircraft	Beech 58	Ventus glider
Operator	Civ FW	Civ Gld
Airspace	London FIR	London FIR
Class	G	G
Rules	VFR	VFR
Service	Traffic	None
Provider	Marham	(Marham ¹)
Altitude/FL	3700ft	3435ft
Transponder	A, C, S	Not fitted
Reported		
Colours	White, black, gold, grey	White
Lighting	Strobe, beacon, nav, landing	Not fitted
Conditions	VMC	VMC
Visibility	>20km	>15km
Altitude/FL	3500ft	3700ft
Altimeter	NK (1011hPa)	NK (NK hPa)
Heading	124°	100° - 70°
Speed	160kt	70kt
ACAS/TAS	TAS	FLARM
Alert	None	None
Separation		
Reported	50ft V/300m H	100ft V/0m H
Recorded	265ft V/<0.1nm H

As the BE58 approached an area of windfarm radar clutter, the Marham Zone Controller passed traffic information on an unknown contact (the Ventus) and the BE58 reported descending to his destination. 19secs after the traffic information was passed the BE58 reported that it had just manoeuvred to avoid a glider and, on hearing this RT exchange, the Ventus reported that it had just had 'a close call' with a twin-engine aircraft.

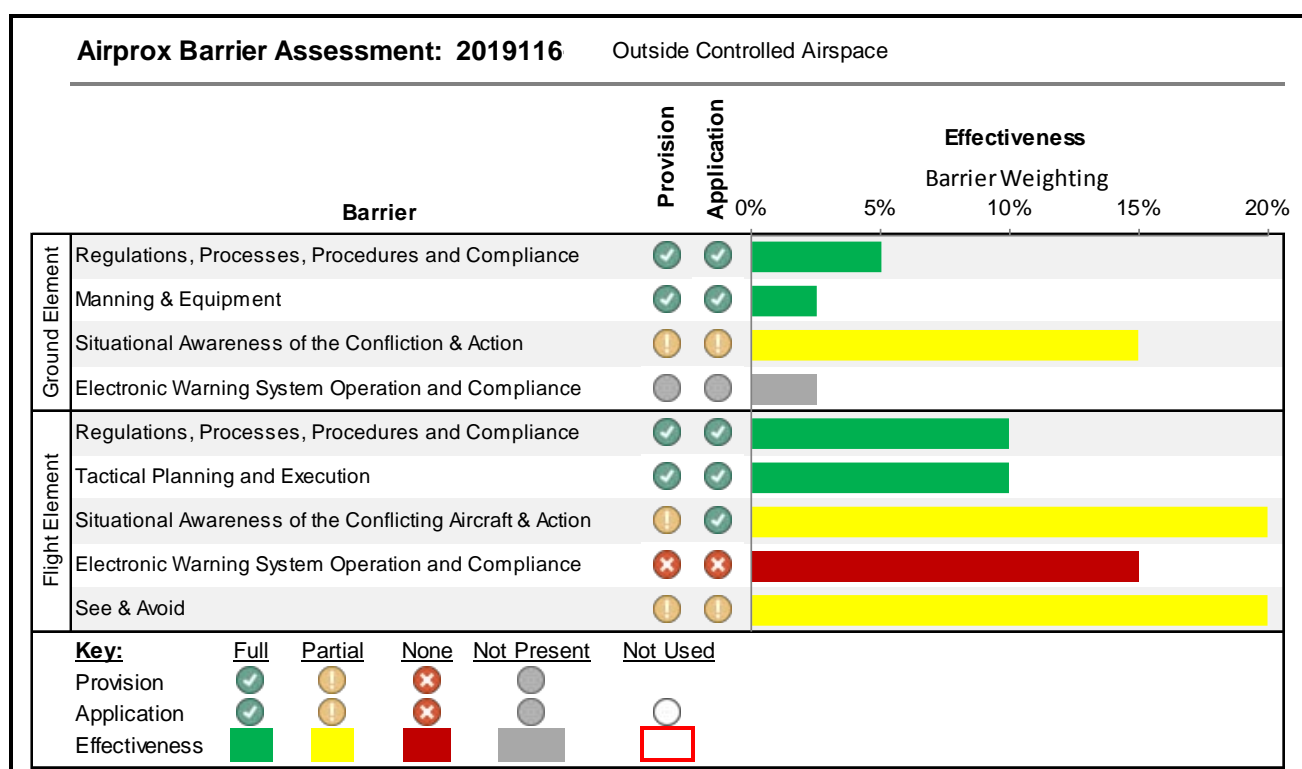
Safety Barrier Assessment⁵

Situational Awareness of the Confliction and Action were assessed as **partially effective** because conditions were such that the Marham controller could not detect the confliction until at a late stage.

Situational Awareness of the Conflicting Aircraft and Action were assessed as **partially effective** because although they had generic information about activity in the area, neither pilot was specifically aware of the other aircraft until at a late stage.

Electronic Warning System Operation and Compliance were assessed as **ineffective** because neither aircraft's TAS was compatible with the other aircraft.

See and Avoid were assessed as **partially effective** because each pilot saw the other aircraft at a late stage and were only able to increase separation at CPA by a correspondingly small amount.
