AIRPROX REPORT No 2019180

Date: 07 Jul 2019 Time: 1428Z Position: 5143N 00009E Location: North Weald

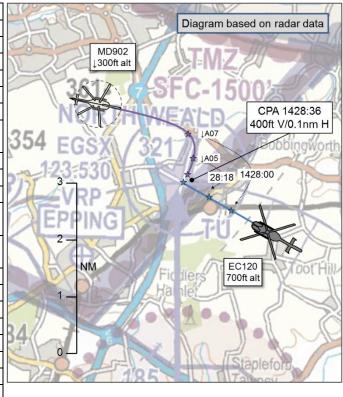
Recorded	Aircraft 1	Aircraft 2	
Aircraft	MD902	EC120	
Operator	HEMS	Civ FW	
Airspace	London FIR	London FIR	
Class	G	G	
Rules	VFR	VFR	
Service	AGCS	Listening Out	
Provider	North Weald	North Weald/Essex	
		Radar	
Altitude/FL	300ft	700ft	
Transponder	A, C, S	A, C, S	
Reported			
Colours	Air Ambulance	Grey, Orange	
	colours		
Lighting	Strobes, HISL, NAV,	Anti-Cols, strobes,	
	Landing	landing	
Conditions	VMC	VMC	
Visibility	>10km	'Very good'	
Altitude/FL	150ft agl	~700ft	
Altimeter	Rad Alt	QNH	
Heading	200°	315°	
Speed	50kt	115kt	
ACAS/TAS	TAS	Not fitted	
Alert	TA	N/A	
	Separation		
Reported	100ft V/200m H	700ft V	
Recorded	400ft V/0.1nm H

THE MD902 PILOT reports that he was on short final to land at North Weald. He was in RT contact with North Weald Radio and other aircraft in the circuit when an EC120 was seen in the 10 o'clock position moving from left to right. It was slightly above his level, but sufficiently low (estimated 200ft agl) that he assumed it had just lifted from adjacent to the control tower. Upon initial sighting it appeared as though the aircraft would pass ahead and above them. They were nearing their landing decision point and continuing the approach created the largest possible separation both laterally and vertically. Had they attempted a go-around there would have been a high risk of collision. At first sighting they reported 'visual with the crossing helicopter' (post-flight, the A/G operator said that their RT transmission was the first they knew of the other helicopter). Whilst on short final he had heard several TAS warnings and multiple contacts were shown on the TAS screen. There were 3 other aircraft in the circuit and two were holding on the ground at the time of the incident. He believed one of the TAS TA warnings was generated by the Airprox helicopter but he could not be certain it was not from another of the aircraft holding on the ground.
