AIRPROX REPORT No 2019274

Date: 14 Sep 2019 Time: 1407Z Position: 5334N 00056W Location: 6NM NE Doncaster Airport

PART A: SUMMARY OF INFORMATION REPORTED TO UKAB

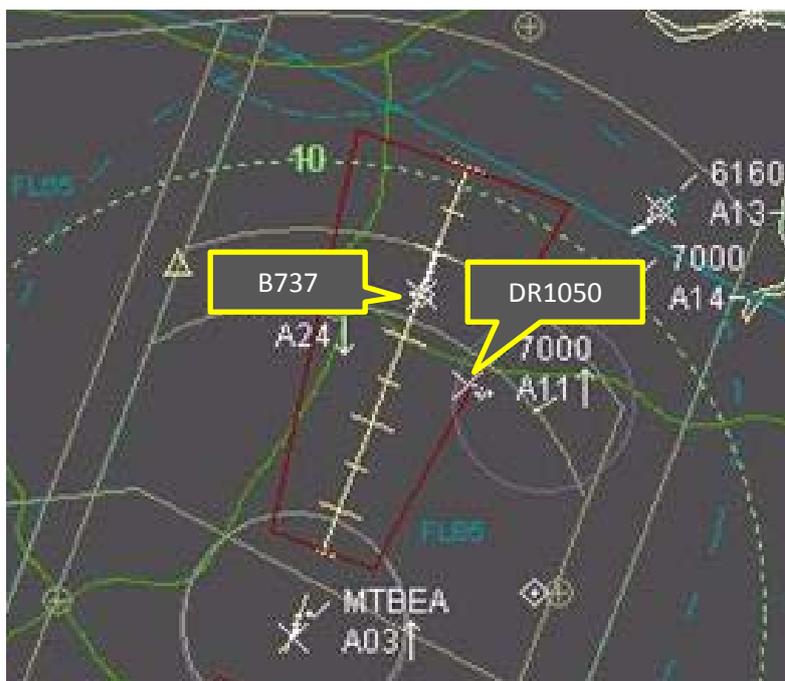
[B737 C/S] was being vectored for an ILS approach to Rwy 20 at Doncaster Sheffield. When, on 7nm final [B737 C/S] was issued avoiding action by the Radar Controller due to an unknown a/c, squawking 7000 tracking westbound, which was entering the CTR, 2nm SSE of [B737 C/S].

Figure 1 14:06:47 - #7000 unknown entering CTR

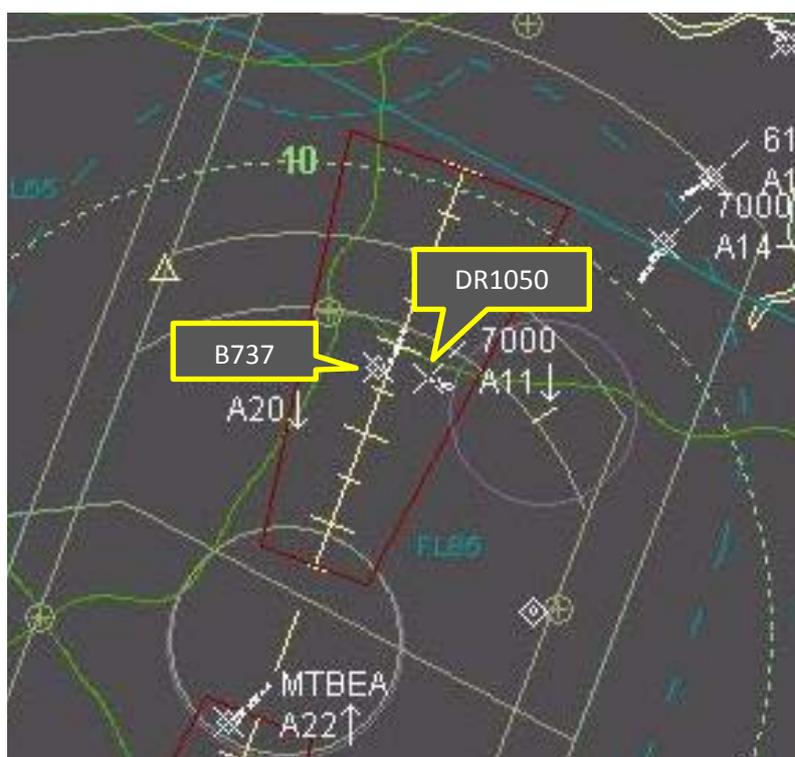
Figure 2 14:07:28 – Shows the point of least proximity between [B737 C/S] & Unknown
