AIRPROX REPORT No 2018008

Date: 16 Jan 2018 Time: 1227Z Position: 5128N 00025W Location: Heathrow airport

PART A: SUMMARY OF INFORMATION REPORTED TO UKAB

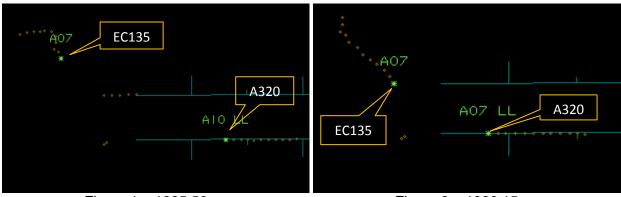
Figure 1 – 1225:50.

At 1225:50 the EC135 pilot made contact with the Air South controller, who responded with:

"Hello (EC135 C/S) you can cross runway two seven left now and er s- remain south of two seven left after crossing".

The pilot readback the instruction and the controller then turned his attention to a previous landing aircraft and issued taxi instructions (Figure 1).

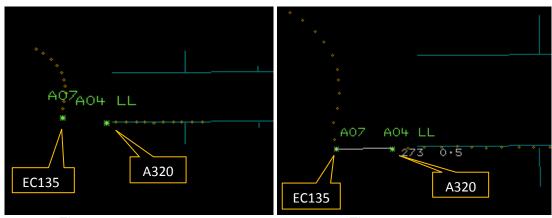
Figure 3 – 1226:40.

At 1226:40 (Figure 3) the controller called the EC135 pilot using the wrong callsign and said:

"And (wrong C/S) I see you've cleared the runway, the surface wind is two six zero degrees one six knots".

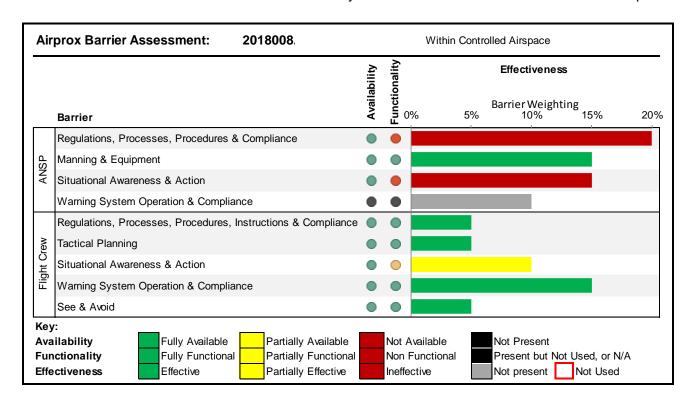
In assessing the effectiveness of the safety barriers associated with this incident, the Board concluded that the key factors had been that:

Regulations, Processes, Procedures and Compliance were assessed as ineffective because the Air South Arrivals controller's clearance for the EC135 to cross ahead of the A320 had resulted in less than ideal separation between the 2 aircraft.

Situational Awareness and Action were assessed as ineffective because the Air South Arrivals controller misjudged the distance between the two aircraft when clearing the EC135 pilot to cross the approach path ahead of the A320.

Situational Awareness and Action were assessed as partially effective because, although being cleared to cross, with hindsight it would have been preferable for the EC135 pilot to have held and crossed behind the A320 in order to remove any concern about the situation from the A320 pilot.
