AIRPROX REPORT No 2018021

Date: 12 Feb 2018 Time: ~1515Z Position: 5049N 00112W Location: Lee-on-Solent

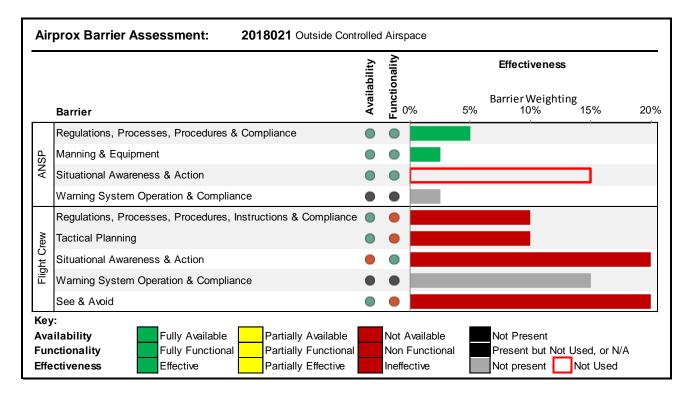
Safety Barrier Assessment³

In assessing the effectiveness of the safety barriers associated with this incident, the Board concluded that the key factors had been that:

Situational Awareness and Action were assessed as **not used** because although the AGO was aware of the aircrafts' positions, he was not required to take action.

Regulations, Processes, Procedures, Instructions and Compliance were assessed as **ineffective** because the unknown pilot pilot did not integrate with the pattern of traffic in the Leeon-Solent visual circuit.

Tactical Planning was assessed as **ineffective** because the unknown pilot did not maintain appropriate spacing on the C150.

Situational Awareness and Action were assessed as **ineffective** because neither pilot was aware of the proximity of the other until close to or at CPA.

See and Avoid were assessed as **ineffective** because the unknown pilot evidently did not see the C150 and the C150 pilot only saw the other aircraft at about CPA.
