AIRPROX REPORT No 2018027

Date: 23 Feb 2018 Time: 1227Z Position: 5126N 00106W Location: 6nm SE CPT

PART A: SUMMARY OF INFORMATION REPORTED TO UKAB

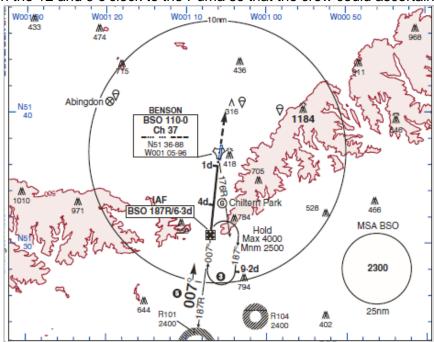
Figure 1: RAF Benson COPTER TAC 01

THE PUMA PILOT reports that he was entering the holding pattern for the COPTER TAC 01 procedure at RAF Benson when an aerobatic aircraft (CAP231) was seen to the south, which was suspected to be close enough to the hold to conflict with the procedure. He broke off the procedure with a turn to the west and informed ATC. The decision was made to use an alternate joining procedure for the hold that would put the CAP231 between the 12 and 9 o'clock to the Puma so that the crew could ascertain

if the CAP231 would affect the hold. The CAP231 then became visual to the crew approximately 1min prior to hold entry, was observed throughout the turn, and was assessed by the crew as being far enough from the hold that it would not affect the procedure (approximately 2-3nm from the hold turn). The HP was also monitoring the trainee and the crewman was monitoring an additional light-aircraft that had passed approximately 3nm down the left side of the Puma. completing a further hold, the HP was looking for the CAP231 and saw it as they were approximately 2/3 around the inbound turn, just as the TAS assessed it as within 1nm. When seen, the CAP231

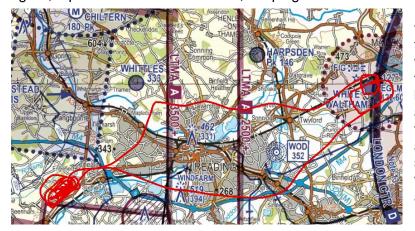
Figure 2: CAP 231 pilot gpx file track log

THE CAP231 PILOT reports that he was practicing a competition aerobatic sequence at one of his regular practice spots, just to the south of the Benson MATZ. He was flying a warm-up figure and in a vertical climb when he first saw a helicopter transiting east-to-west abeam and south [he recalled] of his practice site. He deemed the other aircraft to be no conflict and so completed the top part of his figure, a push-over to vertical down, keeping the other aircraft in sight. He then pulled to level flight at

roughly the same height as the transiting helicopter and decided to turn towards but behind it. The helicopter was now ahead of him, and to keep it in view he flew a climbing turn (partial barrel-roll) keeping the Puma in view at all times. This turn, although initially towards the conflicting aircraft, took him above and behind the Puma with it in sight throughout the manoeuvre until he was well behind it and had turned onto a reciprocal heading.

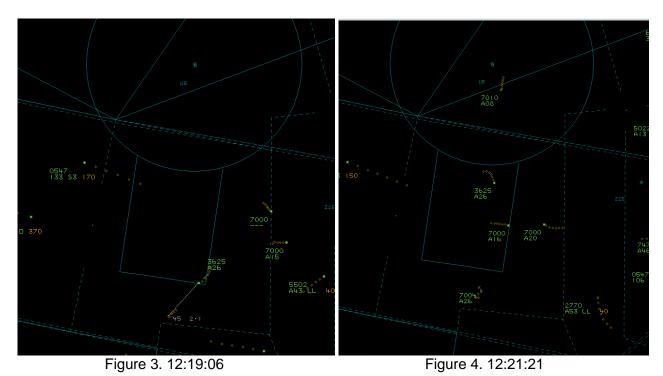
Figure 3 shows the Puma (3625) and the CAP231 (7004). Traffic Information is passed on the CAP231 as well as the 7000/A16 and 7000/A20 tracks.

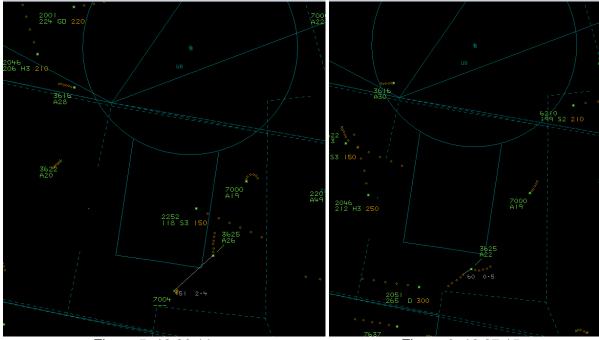
Figure 5. 12:26:11

Having completed a hold (Figure 5), the Puma was cleared for the procedure. At this time, the CAP231 was manoeuvring 2.4nm away from the Puma. The Mode C of the CAP231 was lost due to the rapid change in altitude. No Traffic Information was passed.
