AIRPROX REPORT No 2018060

Date: 22 Apr 2018 Time: 1314Z Position: 5108N 00214W Location: Park Gliding Site

PART A: SUMMARY OF INFORMATION REPORTED TO UKAB

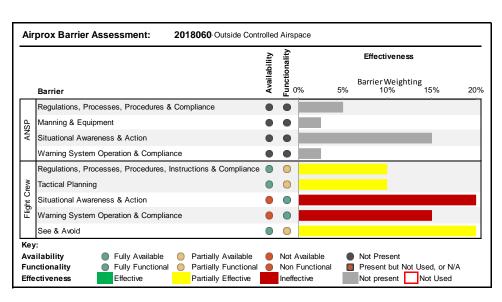
In assessing the effectiveness of the safety barriers associated with this incident, the Board concluded that the key factors had been that:

Regulations, Processes, Procedures, Instructions and Compliance were assessed as partially effective because the PA28 pilot flew through an active and promulgated gliding site below the maximum winch launch altitude.

Tactical Planning was assessed as **partially effective** because the PA28 pilot did not assimilate that he would track through the gliding site whilst assessing the deteriorating weather and planning his diversion to Compton Abbas.

Situational Awareness and Action were assessed as **ineffective** because neither pilot was aware of their converging tracks or the proximity of the other aircraft prior to visual detection.

Warning System Operation and Compliance were assessed as **ineffective** because the PA28 was not equipped with a compatible TAS and the glider FLARM was not compatible with the PA28 SSR transponder emissions.

See and Avoid were assessed as partially effective because, by the nature of a winch launch, the glider pilot saw the PA28 at a fairly late stage.
