AIRPROX REPORT No 2018108

Date: 11 May 2018 Time: 1456Z Position: 5352N 00137W Location: Leeds/Bradford airport

PART A: SUMMARY OF INFORMATION REPORTED TO UKAB

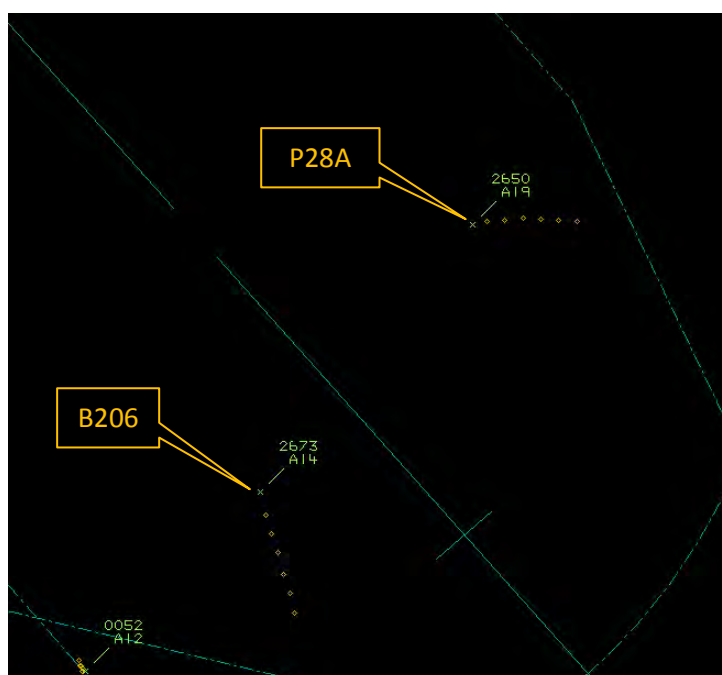
Figure 1 – 1454:33 (PA28 3.7nm E).

At the same time, (1454:33), the Leeds Aerodrome controller, who had been updating the pilot of the B737 on the position of a Bell 206 helicopter previously notified to them as tracking northbound through the ATZ, cleared the B737 pilot for take-off (Figure 1).

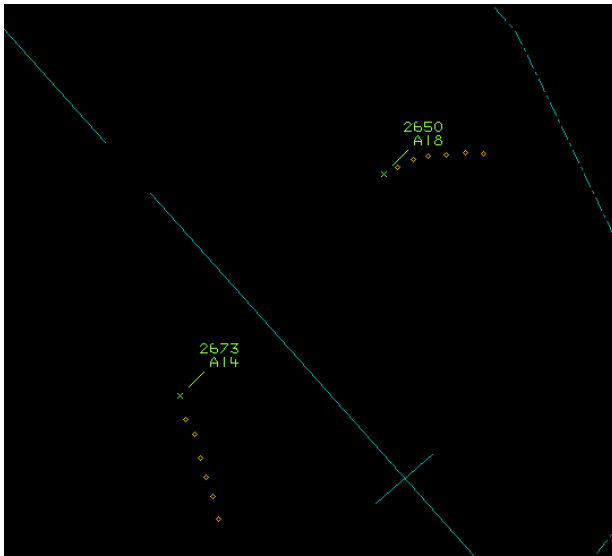
Figure 2 – 1454:50.

At 1454:50 the pilot of the PA28 contacted Leeds Tower, advising that he was “*routing er downwind er Left er to Runway One Four*” (Figure 2).

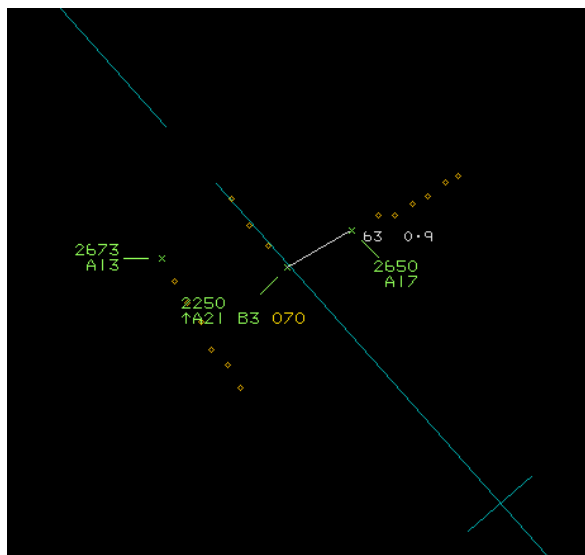
Figure 4 - 1455:45.

The Aerodrome controller replied, “[C/S] roger – report downwind left Runway One Four. The QFE is 987hPa”. The pilot asked for a repeat of the QFE, which was given, but subsequently not read back correctly by the pilot, nor corrected by the controller. The pilot’s readback did however, include the joining instructions for the left-hand downwind join to RW14. At 1455:33, the pilot of the B206 asked to fly through the climb-out, advising that they thought they would be clear of any wake turbulence (from the departing B737). The controller instructed the B206 pilot to hold to wait for further landing traffic (Figure 3). The Aerodrome controller then issued a landing clearance to the pilot of the aircraft on final approach (Figure 4).

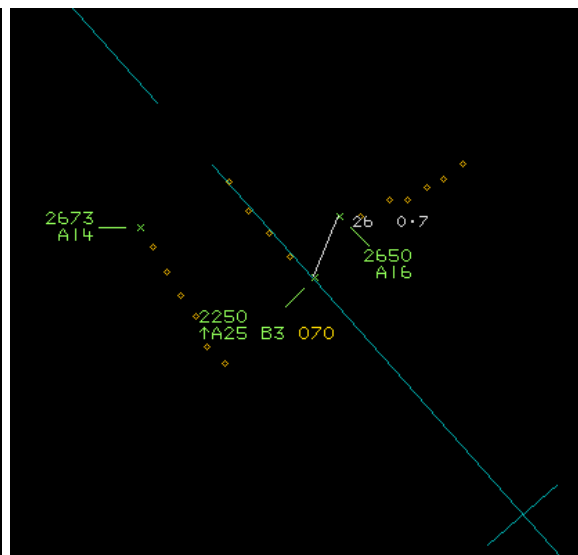
Figure 5 - 1455:51.

CPA was at 1455:51 with the aircraft separated by 0.7nm laterally and 900ft vertically (Figure 5).

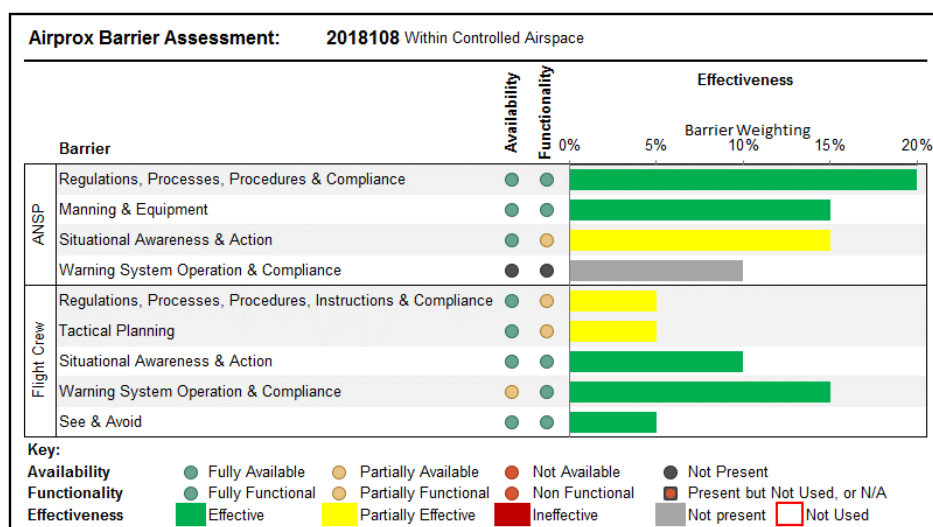
Situational Awareness and Action were assessed as **partially effective** because the controller did not notice early enough that the PA28 pilot was routeing to the incorrect downwind leg.

Regulations, Processes, Procedures, Instructions and Compliance were assessed as **partially effective** because the PA28 pilot joined downwind right-hand rather than left-hand.

Tactical Planning was assessed as **partially effective** because the PA28 pilot, although reading back the ATC instruction to join downwind left-hand, routed towards right-hand downwind.

Warning System Operation and Compliance were assessed as **partially available** because only one aircraft was equipped with an electronic warning system.
