AIRPROX REPORT No 2018189

Date: 24 Jul 2018 Time: 1709Z Position: 5128N 00120W Location: ivo Firs Farm airfield

PART A: SUMMARY OF INFORMATION REPORTED TO UKAB

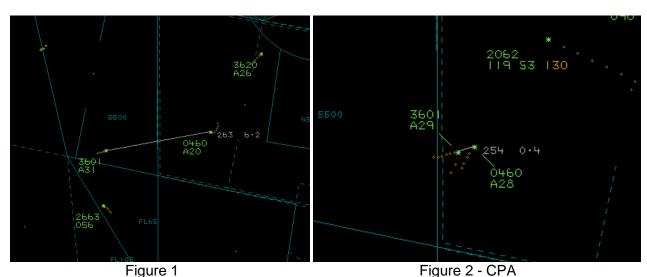
Figures 1 and 2 show the positions of the PA28 and CJ6 in the lead-up to and during the Airprox. The screen shots are taken from a replay using Swanwick radars, which are not utilised by Benson Zone and therefore do not necessarily depict the picture available to the controller.

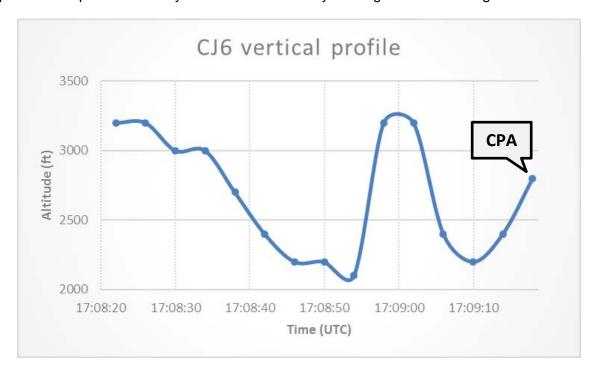
In the 20sec before CPA, the CJ6 is seen manoeuvring at about 2200ft, prior to a rapid climb (c4500ft/min). CPA occurred at 1709:18 and was measured at 0.4nm lateral and 100ft vertical separation. Given the rapid manoeuvring of the CJ6 it is not known if the primary and secondary return were consistently painting on the Benson Zone controller's radar screen. At the point Traffic Information was passed, the Benson Zone controller reported the conflicting traffic as 'pop-up'. Workload for the controller was low, there were only two aircraft on frequency (including the PA28) and there were no transmissions to the other aircraft in the minutes leading up to the Airprox.
