## AIRPROX REPORT No 2018191

Date: 24 Jul 2018 Time: 1424Z Position: 5122N 00114W Location: 2nm WSW Brimpton

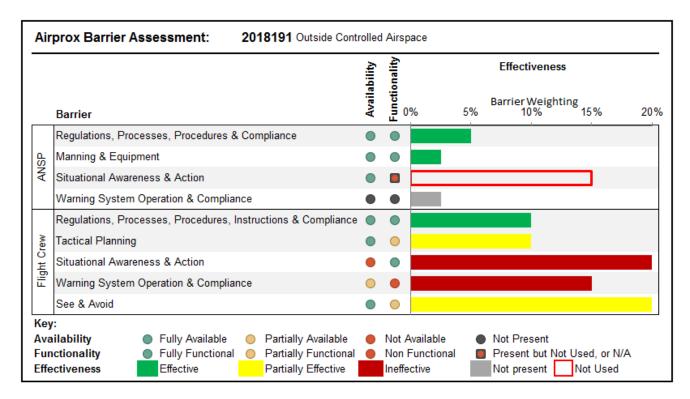
#### Safety Barrier Assessment<sup>4</sup>

**Tactical Planning** was assessed as **partially effective** because the R66 pilot would have been better served communicating with Brimpton as he transited past, and Farnborough LARS beforehand, to increase his SA.

**Situational Awareness and Action** were assessed as **ineffective** because the pilots were on different frequencies and therefore neither pilot had SA on the other aircraft.

**Warning System Operation and Compliance** were assessed as **ineffective** because the Tecnam had PilotAware but this was not configured for audio alerts and he was looking for geographical features prior to re-joining and not at the display.

**See and Avoid** were assessed as **partially effective** because the R66 pilot did not see the Tecnam, and the Tecnam pilot saw the R66 later than desirable.
