# **AIRPROX REPORT No 2018206**

Date: 03 Aug 2018 Time: 1005Z Position: 5134N 00017E Location: 2nm south Brentwood

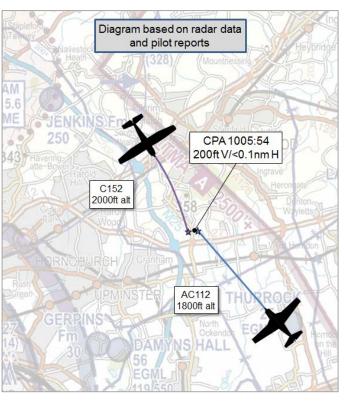
Recorded	Aircraft 1	Aircraft 2
Aircraft	AC112	C152
Operator	Civ FW	Civ FW
Airspace	London FIR	London FIR
Class	G	G
Rules	VFR	VFR
Service	Listening Out <sup>1</sup>	Basic
Provider	Farnborough	Southend
Altitude/FL	1800ft	2000ft
Transponder	A, C, S	A, C, S
Reported		
Colours	Red, White	White, Red
Lighting	Beacon, Strobe	Nav
Conditions	VMC	VMC
Visibility	>20km	>10km
Altitude/FL	1900ft	2000ft
Altimeter	QNH (1023hPa)	NK
Heading	295°	160°
Speed	124kt	93kt
ACAS/TAS	Not fitted	Not fitted
Separation		
Reported	50ft V/100m H	Not reported
Recorded	200ft V/<0.1nm H

THE AC112 PILOT reports that he was at the top of the initial climb, approaching 1900ft, and had begun to reduce power to cruise. He had already changed to Farnborough North when he left the circuit at Thurrock but, probably because it was a sunny day, the frequency was busy and he couldn't find a gap to make the initial call. He had selected a cruise altitude of 2000ft because his intention was to transit Heathrow airspace after passing Denham inbound to Waltham. He scanned the area in front of the aircraft, and to both sides, before looking at the Tacho and Manifold Pressure, then looked back out, then back in to the EGT, and then leaned the mixture. While doing this he picked up the C152 in his peripheral vision moving from right to left. By the time he reacted it was in his 12 o'clock, slightly above. He perceived that the pilot of the C152 reacted at the same time, and both aircraft turned right. His aircraft passed behind the C152 in a right turn. He lost sight of the C152 at that point because it was behind him and so he resumed his original course. He assumed that the C152 was positioned such that its position was obscured by either the right-side windscreen frame and door pillar or it was in a position slightly above his aircraft and obscured by the roof. Had neither pilot reacted he would have passed behind the C152 but considerably closer than they did by turning right. Since this incident he has ordered a PilotAware collision warning system.

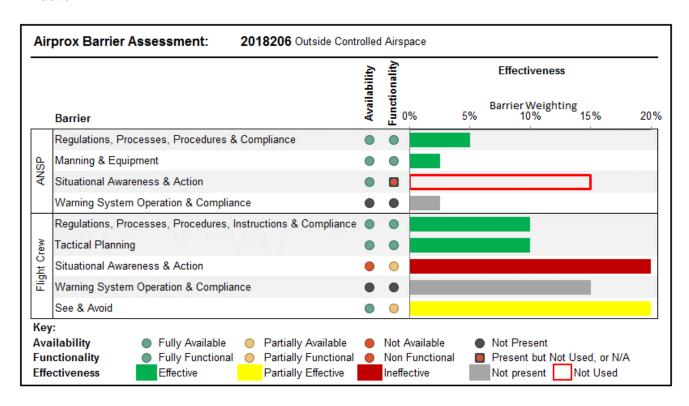
**Situational Awareness and Action** were assessed as **ineffective** because neither pilot had any SA on the other aircraft.

**See and Avoid** were assessed as **partially effective** because the C152 pilot did not see the AC112 until CPA, whilst the AC112 pilot only saw the C152 late and had to carry out emergency avoiding action.
