## **AIRPROX REPORT No 2018216**

Date: 13 Aug 2018 Time: ~1830Z Position: 5443N 00545W Location: 7nm NE Belfast City Airport

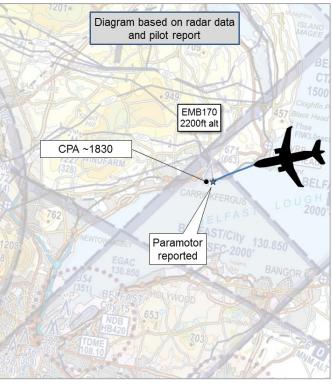
Recorded	Aircraft 1	Aircraft 2	
Aircraft	EMB170	Paramotor	and the
Operator	CAT	Civ Hang	
Airspace	Belfast City CTR	Belfast City CTR	
Class	D	D	BAN
Rules	IFR	VFR	
Service	Radar Control	None	SIN
Provider	Belfast		
Altitude/FL			
Transponder	A, C, S	None	RM 9
Reported		NK	72
Colours	Company		
Lighting	Nav, Strobe,		
	Landing		
Conditions	VMC		1208
Visibility	10km		8
Altitude/FL	2000ft		
Altimeter	QNH		
Heading	220°		7.2
Speed	170kt		Carried A
ACAS/TAS	TCAS II		10 38
Alert	None		358 (309
	Sepa	ration	No.
Reported	100-200ft V/0nm	NK	
	Н		
Recorded	NK

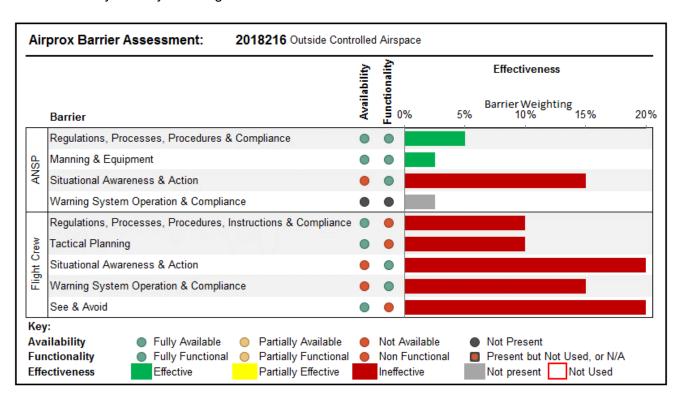
**Situational Awareness and Action** were assessed as **ineffective** because the paramotor did not display on the Belfast City Controller's radar, therefore the controller could not provide any information to the EMB170.

**Regulations, Processes, Procedures, Instructions and Compliance** were assessed as **ineffective** because the Paramotor pilot infringed Class D airspace without communicating with the controlling authority.

**Tactical Planning** was assessed as **ineffective** because the paramotor pilot had evidently not taken account of the Belfast Class D airspace during his planning or execution of his flight.

**Situational Awareness and Action** were assessed as **ineffective** because the EMB170 pilot had no knowledge of the paramotor and could therefore not act prior to visually acquiring it.

**Warning System Operation and Compliance** were assessed as **ineffective** because the EMB170's TCAS II could not alert on the presence of the paramotor because the paramotor was not transponding.

**See and Avoid** were assessed as **ineffective** because the EMB170 pilot saw the paramotor too late to carry out any avoiding action.
