AIRPROX REPORT No 2018230

Date: 23 Aug 2018 Time: 1537Z Position: 5202N 00015E Location: Little Walden

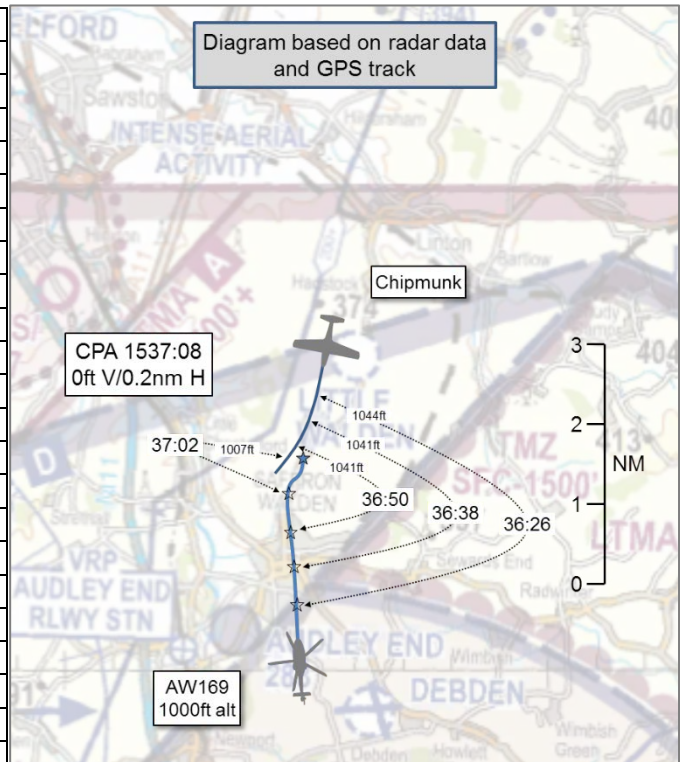
STANSTED ATSU reports that there were no logged events for Stansted Tower at the date and time of the Airprox. Having reviewed the recording it appeared that the AW169 routed northbound VFR not above altitude 2000ft. It was transferred to Radar when clear of Stansted traffic at about 2.5nm north. There was a primary-only contact, opposite direction, no Mode A or C information but there was a definite 'jink' in the AW169 track when the two got close. The primary contact then appeared to route inbound to the [destination airfield] overhead.

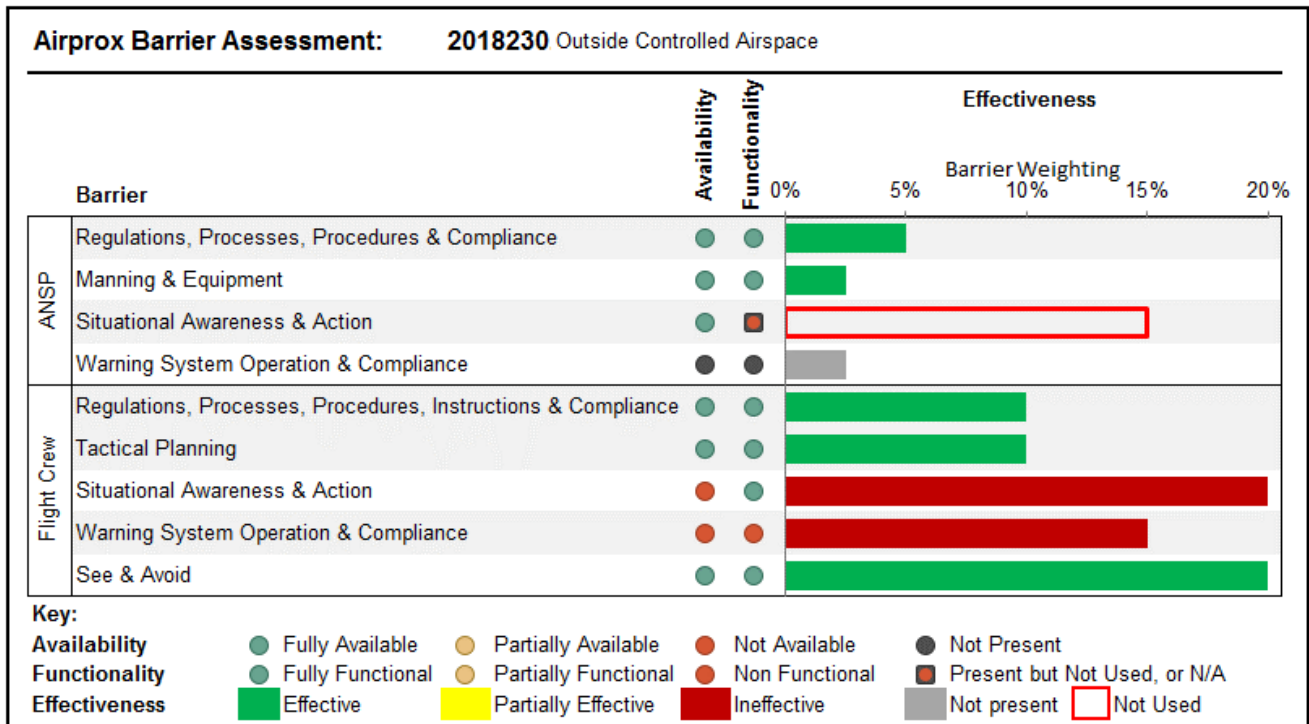
In assessing the effectiveness of the safety barriers associated with this incident, the Board concluded that the key factors had been that:

Situational Awareness and Action were assessed as **ineffective** because neither pilot had SA on the other aircraft.

Warning System Operation and Compliance were assessed as **ineffective** because the AW169's TCAS II could not detect the Chipmunk due to the Chipmunk's electrical failure.
