AIRPROX REPORT No 2018232

Date: 23 Aug 2018 Time: 1333Z Position: 5112N 00139W Location: 5nm NE Boscombe Down

PART A: SUMMARY OF INFORMATION REPORTED TO UKAB

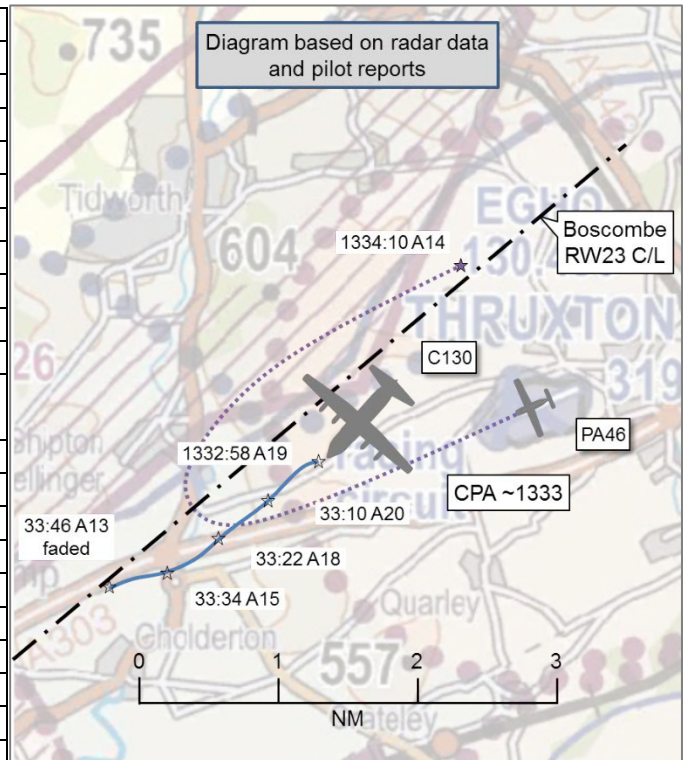
Unfortunately, the PA46's departure routeing was not shown on the radar recording because it was below radar coverage until clear of the area. Notwithstanding, by using the R/T recordings, the Board were able to deduce the PA46's likely track and members held a lengthy discussion about whether the PA46 had left the Thrupton ATZ heading SW before turning to the northeast. After much consideration and measuring of the C130's range from Boscombe when its pilot was informed of the PA46 being 1nm ahead (about 4 to 4.5nm on the PAR), it was decided that the PA46 had travelled outside the Thrupton

ATZ as indicated by its notional track on the diagram on the front page. If this was the case, then the Board thought it would have been preferable for the PA46 pilot to have contacted Boscombe prior to Farnborough. The Board then turned its attention to what the AIP entry actually said in this respect and concluded that, its wording for 'Departing to north/east/south-east' was ambiguous because there was no mention that a departing aircraft had to remain within the Thruxton ATZ or else contact Boscombe; the only stipulation was to maintain an altitude of 1200ft until either contacting Boscombe or being clear of the CMATZ. In other words, as long as the PA46 pilot remained at 1200ft, he was free to route wherever he wished within the CMATZ. The Board then considered whether the PA46 pilot had remained at 1200ft, and concluded that he probably had because when the PA46 subsequently appeared on the radar display sometime after departure it was northwest of Thruxton and then only climbing through 1400ft. Agreeing that it was undesirable that there was such a degree of ambiguity about the operation of aircraft departing from Thruxton, the Board resolved to make a recommendation that Boscombe Down and Thruxton review their LoA.

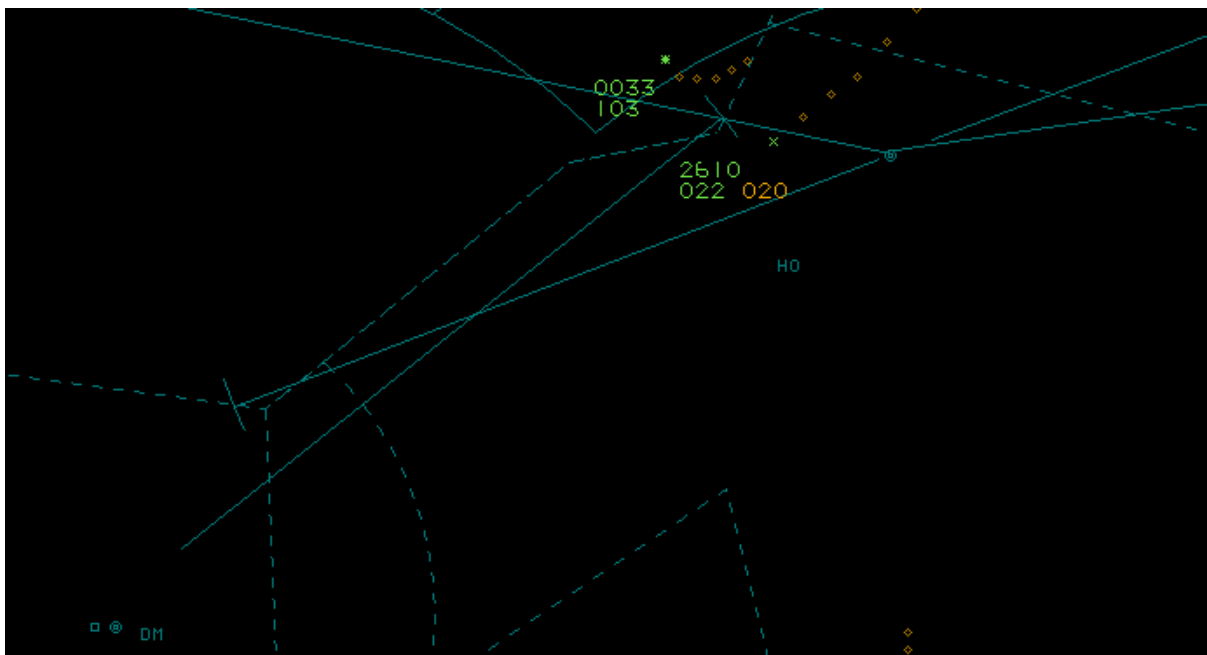
Figure 1 1332:39. C130 squawk 2610.

Traffic Information was issued to the C130 pilot at 1332:39 (Figure1). The PA46 is not visible on the radar replay, and was only portrayed on the PAR controller's screen, which is not recorded.
