**AIRPROX REPORT No 2018286**

Date: 23 Oct 2018 Time: 1557Z Position: 5129N 00009W Location: 12nm E Heathrow

**PART A: SUMMARY OF INFORMATION REPORTED TO UKAB**

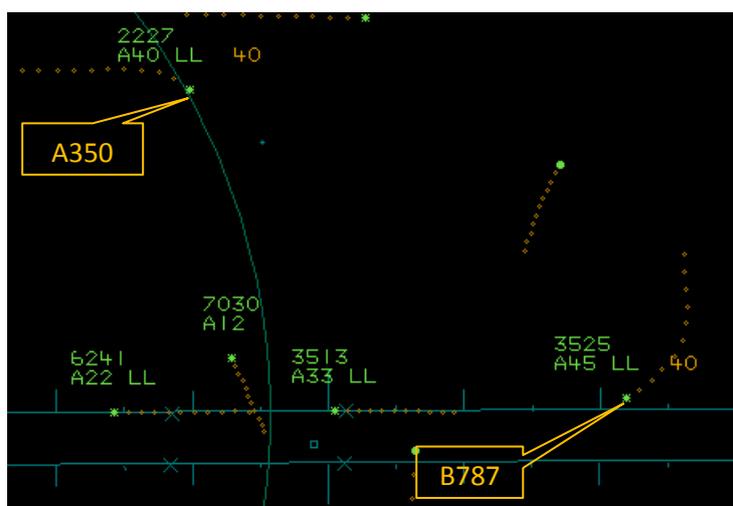
Figure 1 – 1556:20.

At 1556:20 (Figure 1), the A350 could be seen turning south. The controller advised the A350 pilot that the heading was 095° and instructed them to turn left immediately heading 080°. The pilot readback *“heading 095 degrees”*. The controller responded by reiterating the instruction to turn left immediately heading 080°. Having received no readback the controller then repeated the instruction again, to turn left immediately heading 080°.

**Note:** The pilot can be heard faintly in the background transmitting at the same time as the controller, however, the content of their transmissions could not be determined, and the pilot report does not mention heading 080° at any point.

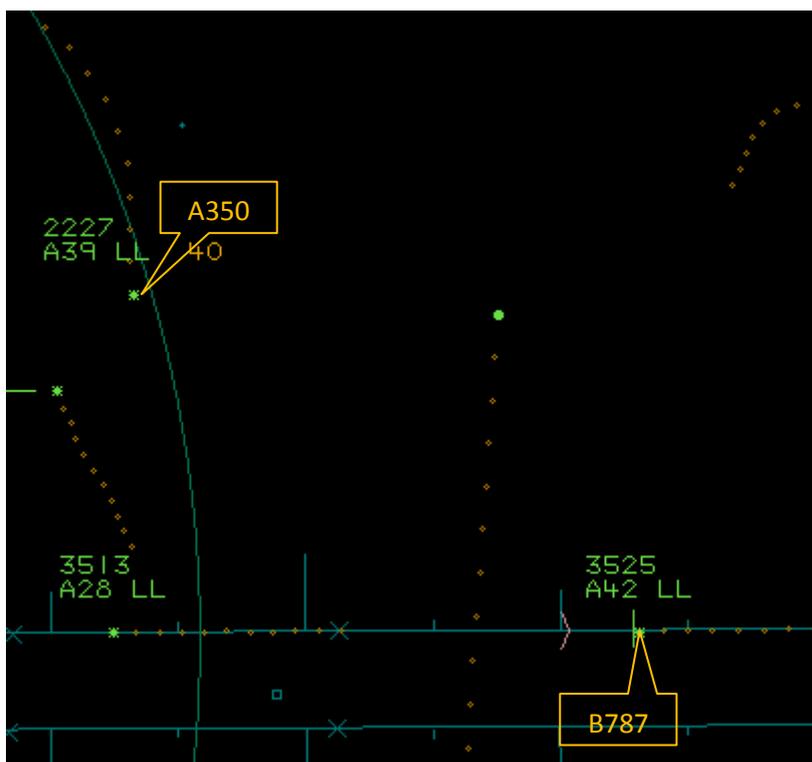
Figure 2 – 1556:42.

At 1556:42 (Figure 2), the controller instructed the B787 pilot *“avoiding action turn left immediately heading 180 degrees”*. The pilot readback *“left immediately”*. The controller reiterated that the heading was south. The pilot responded with *“heading south”*.

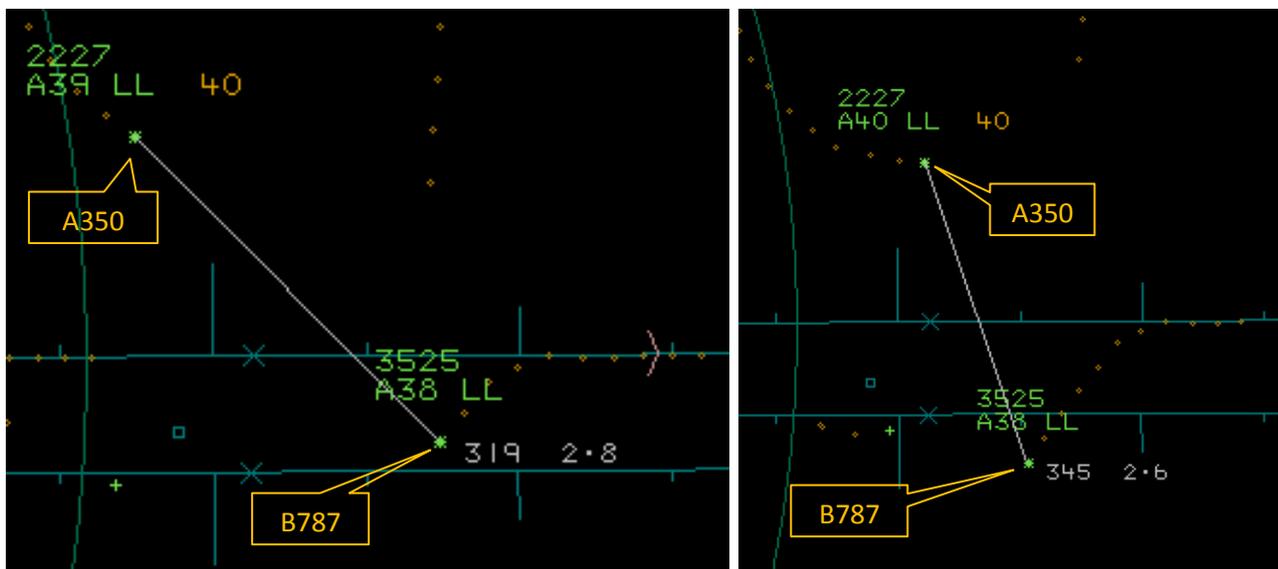
Figure 3 – 1557:20. Figure 4 - 1557:40.

At 1557:20 (Figure 3), the controller advised the B787 pilot “traffic just going behind you now 4000 feet”. The pilot reported visual with the traffic.

CPA occurred at 1557:40 (Figure 4), with the aircraft separated by 2.6nm laterally and 200ft vertically. [Another radar recording, timed at 1557:25, shows the two aircraft separated vertically by 100ft, at the same horizontal distance.]

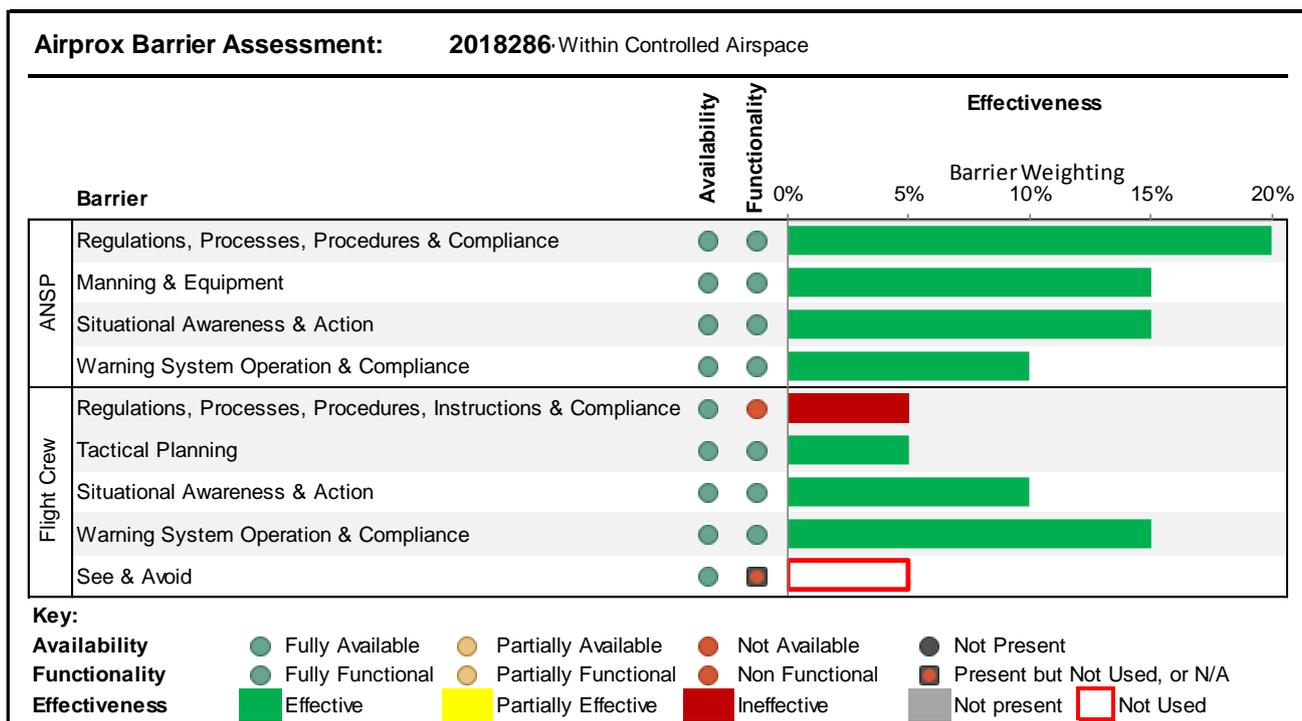
In assessing the effectiveness of the safety barriers associated with this incident, the Board concluded that the key factors had been that:

**Flight Crew:**

**Regulations, Processes, Procedures, Instructions and Compliance** were assessed as **ineffective** because the A350 pilot did not comply with his ATC clearance.

**See and Avoid** was assessed as **not used** because the situation was resolved at sufficient range without the need for the pilots to visually avoid each other (accepting that the B787 pilot was visual with the A350 in the latter stages of the incident and could conceivably have employed this barrier if it had been required).
