AIRPROX REPORT No 2017020

Date: 19 Feb 2017 Time: 1614Z Position: 5143N 00008E Location: North Weald

PART A: SUMMARY OF INFORMATION REPORTED TO UKAB

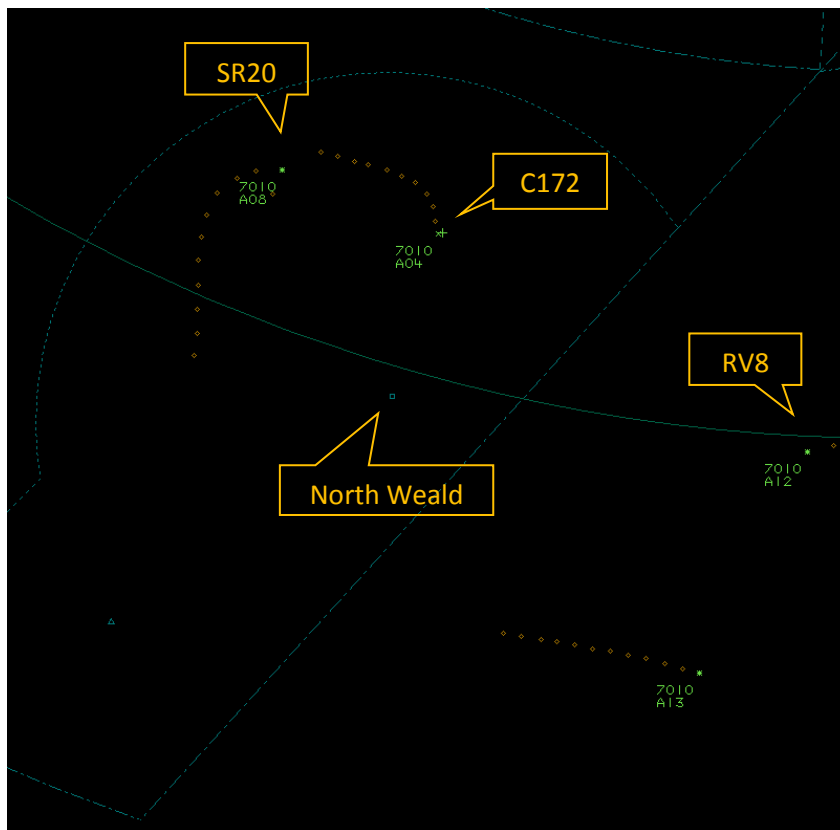
Figure 1 – 1613:01

At 1613:01, the C172 pilot reported on final. The A/G operator advised the pilot that there was nothing to affect them and passed the surface wind (Figure 1).

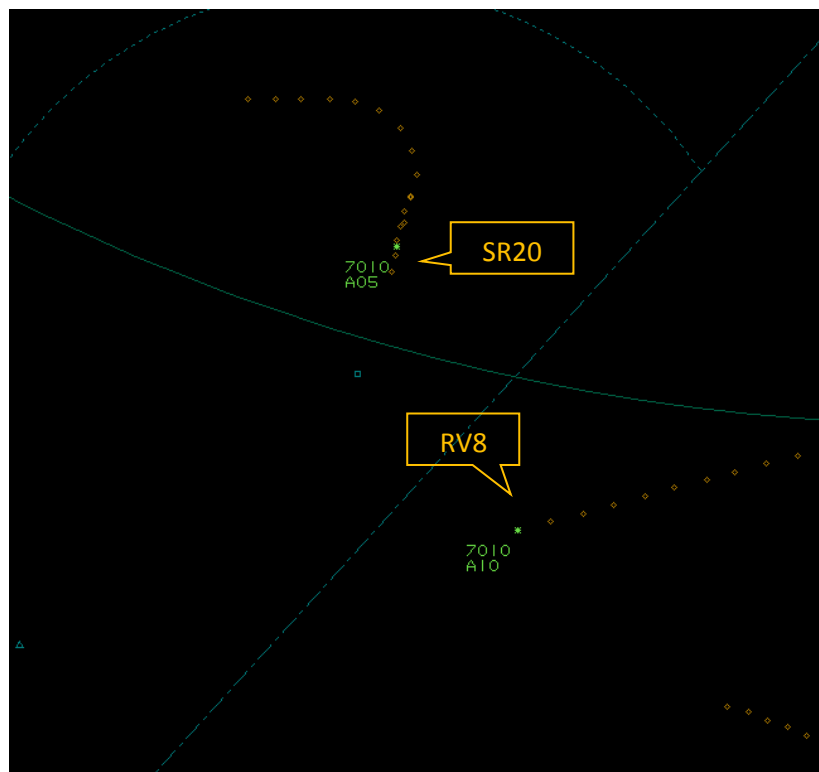
Figure 2 – 1613:45

At 1613:45 the RV8 pilot reported approaching the cross-wind position and was advised by the A/G operator that there was a Cirrus and a C172 in the circuit. (Figure 2 – note C172 below radar cover whilst completing a touch and go).

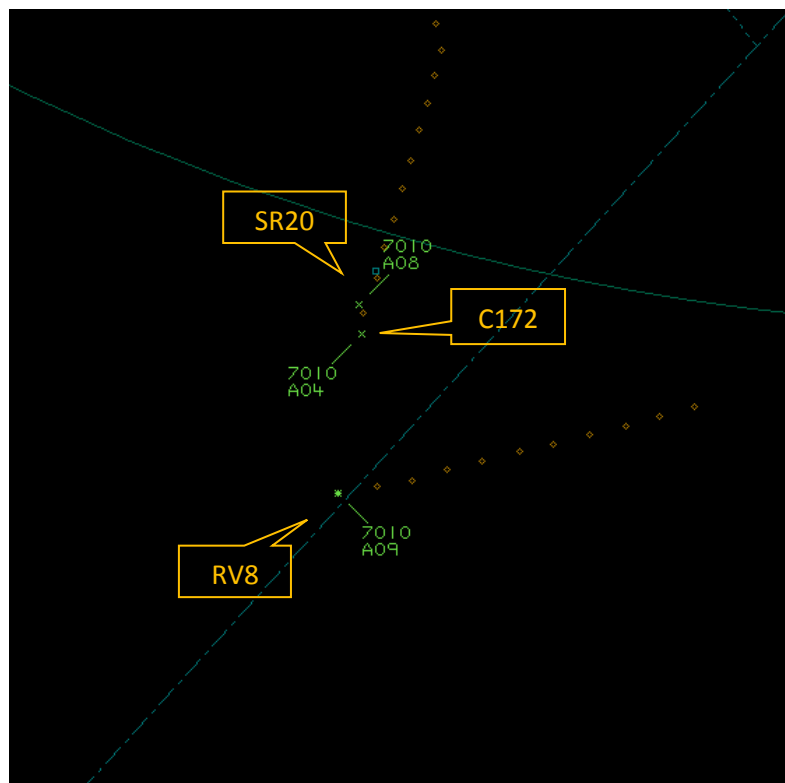
Figure 4 – 1614:10

Immediately afterwards, at 1614:10, the A/G operator asked the RV8 pilot for his range from the airfield. The RV8 pilot reported crossing over the RW02 threshold. (Figure 4 – *note reappearance of C172*).

The traffic situation at 1614:10 (Figure 4) was discussed, and it was the expectation of the A/G operator that with the RV8 pilot having reported crosswind with the C172 on a touch and go, and with the SR20 going around behind the C172, that the RV8 was No 1, the C172 No 2 and the SR20 No 3 in the next circuit. On the NATS radar the RV8 subsequently reappeared inside of the SR20 at the end of the downwind leg, with the SR20 pilot commencing a left-hand orbit to position behind the RV8, and the C172 crosswind, yet to turn downwind.

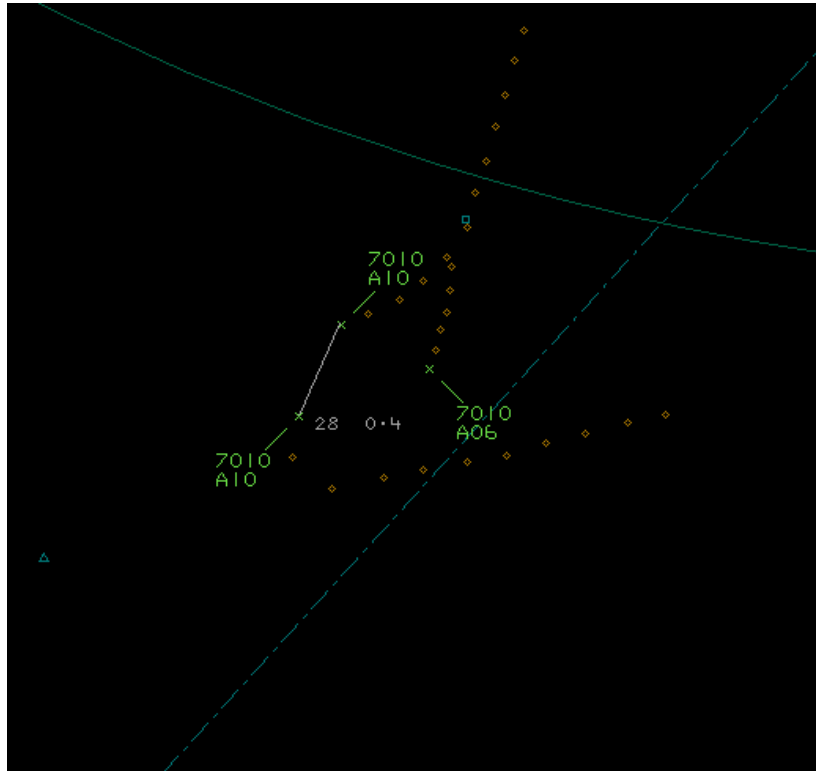
Figure 5 – 1614:26

CPA was estimated to take place shortly after 1614:26 (Figure 5), the radar contact from the RV8 having subsequently disappeared.

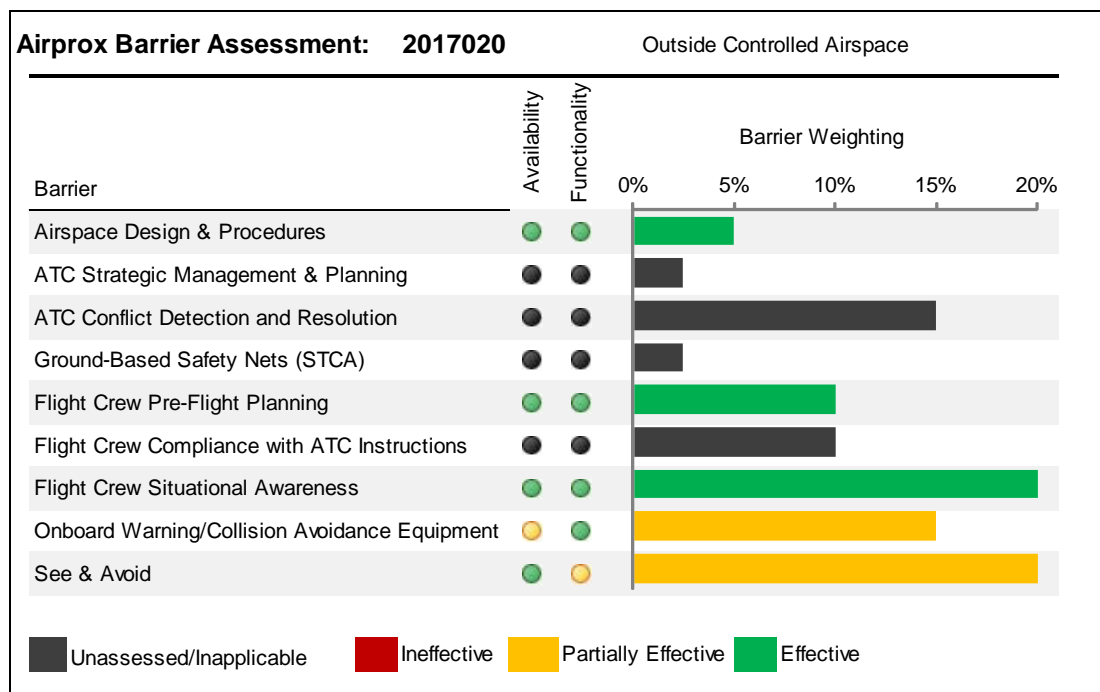
Onboard Warning Collision Avoidance Equipment was **partially effective** because although the SR20 had TCAS and received some indications, the RV8 did not have one fitted.

See and Avoid was **partially effective** because the RV8 pilot was visual with the SR20 as it turned downwind and, although the SR20 pilot saw the RV8 pilot only once he was downwind, he made his turn with awareness of the RV8’s location and was able to avoid it by making a subsequent orbit.
