AIRPROX REPORT No 2017064

Date: 12 Apr 2017 Time: 1732Z Position: 5123N 00028W Location: Heli-route 3

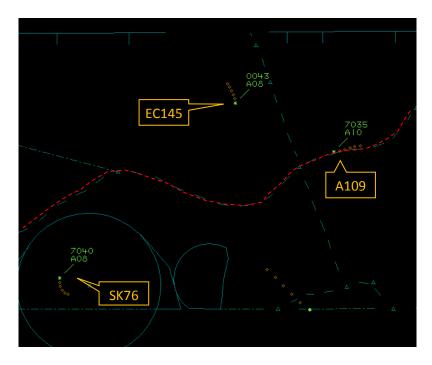
Figure 2 – 1730:35 (H3 outlined in red)

At 1730:35 the controller passed Traffic Information to the AW109, (transponding code 7035) on an EC145 helicopter (code 0043) approaching from their right, but this was not acknowledged by the pilot (Figure 2).

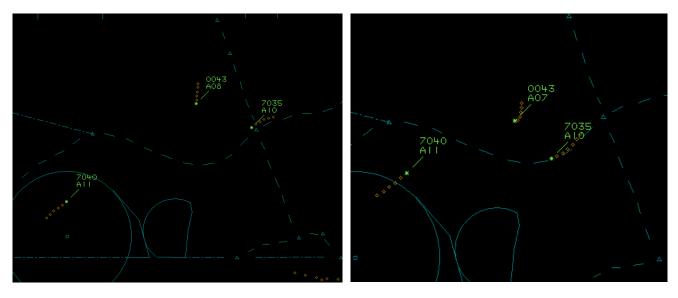
Figure 3 – 1731:07

The controller made two further attempts to contact the AW109 pilot without success. Then, at 1731:07 the controller called the SK76, (transponder code 7040), to check their radio, and subsequently, passed Traffic Information on both the AW109 and the EC145 (Figure 3).

At 1731:26 the controller re-established two-way communications with the AW109, and passed Traffic Information on both the EC145 and the SK76. At 1731:45 the AW109 pilot reported being visual with the SK76 (Figure 4). Shortly afterwards the EC145 pilot also reported being visual with the AW109 (although referred-to as an "*EC55*"), which was acknowledged by the controller who then went on to pass Traffic Information to the EC145 pilot on the SK76.

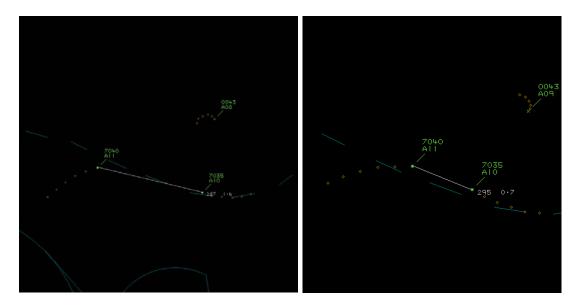
Figure 5 – 1732:12 Figure 6 – 1732:24

At 1732:12 the SK76 pilot reported visual with "the, er, one coming down" (Figure 5).

At 1732:24 (Figure 6), one of the pilots transmitted: "try the right-hand rule..." CPA took place at 1732:30 with the aircraft separated by less than 0.1nm laterally and less than 100ft vertically (Figure 7).

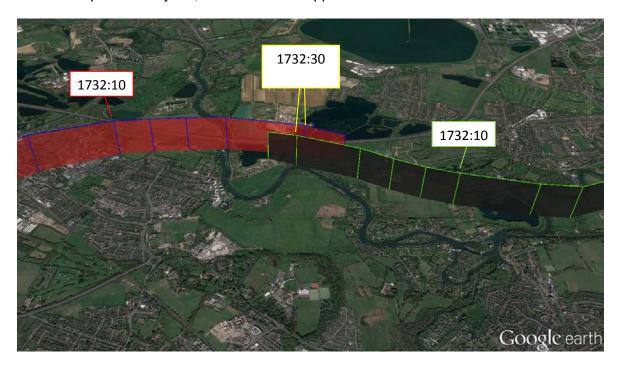
Figure 8 – Plotted tracks on Google Earth

In his written report, the pilot of the SK76 stated that after having become visual with the AW109, "I felt the safest course of action was to not cut across his track but rather stand on and prepare to take avoiding action by breaking left should there be a risk of collision". This appears to contradict what the SK76 pilot actually did, as it did indeed appear to cross ahead of the AW109.

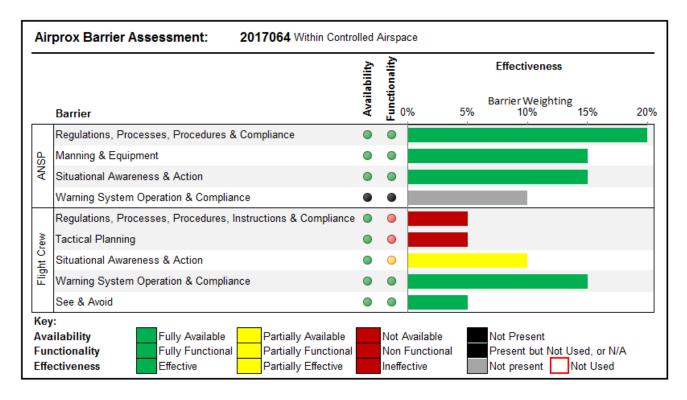
In assessing the effectiveness of the safety barriers associated with this incident, the Board concluded that the key factors had been that:

Regulations, Processes, Procedures, Instructions & Compliance was assessed as **ineffective** because the SK76 pilot did not adhere to the UK AIP by maintaining to the right of the heli-route.

Tactical Planning was assessed as **ineffective** because the SK76 pilot did not enact his plan to not cross the AW109s track.

Situational Awareness & Action was assessed as **partially effective**, both pilots were given Traffic Information, although neither acted upon it until the last minute.

See and Avoid was assessed as **fully effective** because, in the end, both pilots took appropriate avoiding action.
